# FINAL REPORT AIRCRAFT SERIOUS INCIDENT

**Smoke in flight deck and cabin, engine  
shut down and an emergency landing**

**M-01409/AIG-09**

**Boeing 757-200**

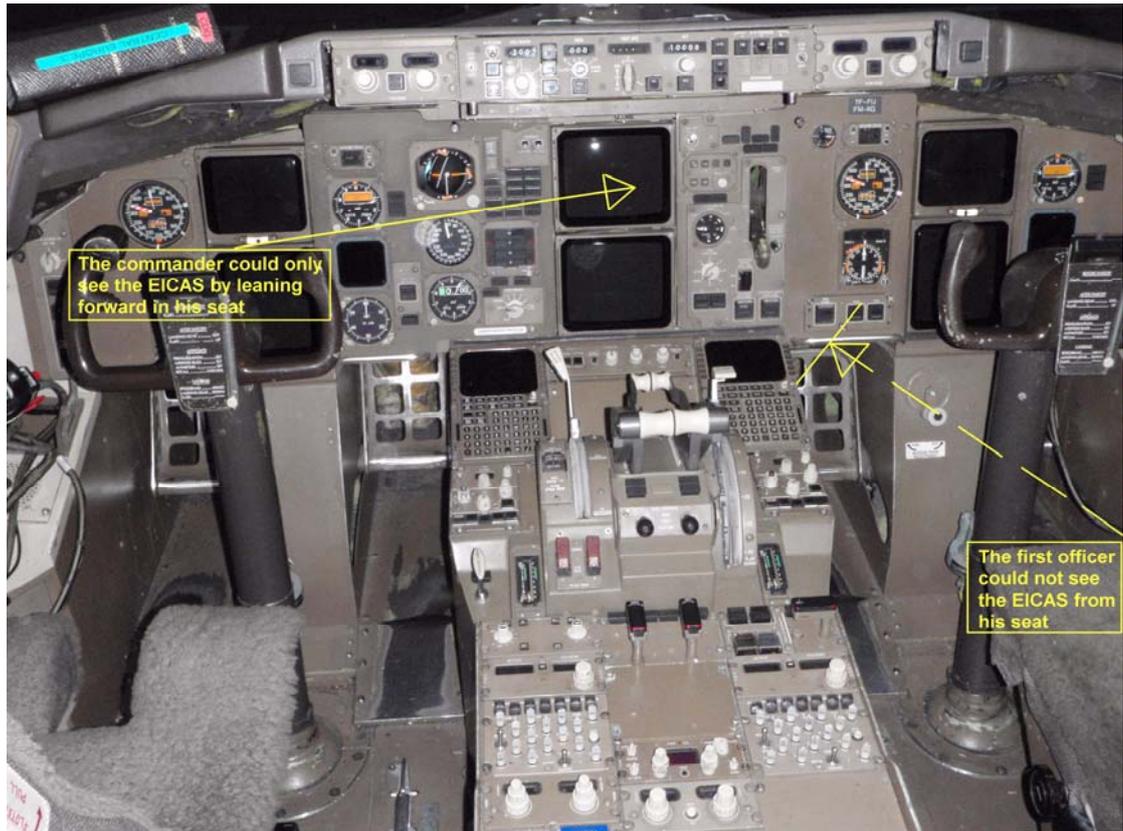
Figure 1 – View of the EICAS panels (commander leaning forward in his seat)

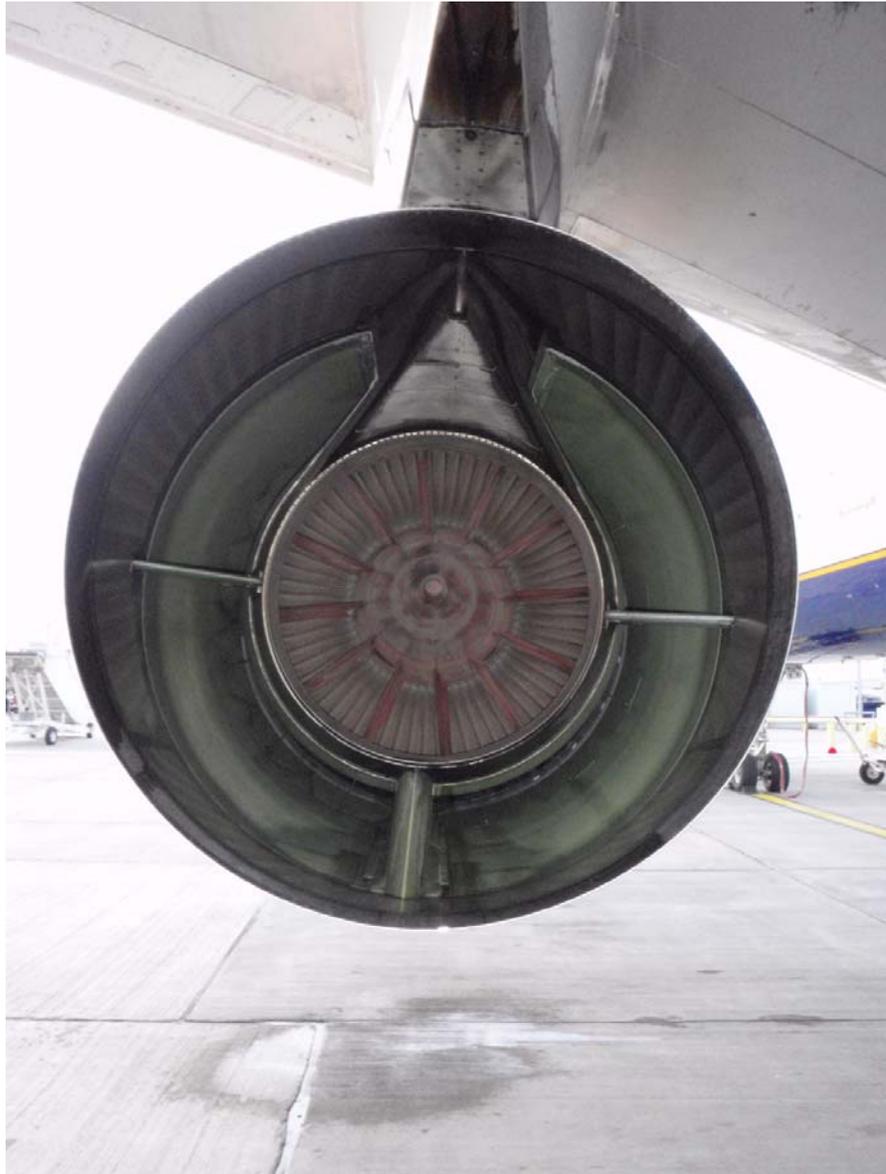
During the field investigation, fluid was found leaking onto the apron under engine #1 cowlings. See Figure 4.

**Figure 4 – Fluid seen leaking onto the apron under engine #1**

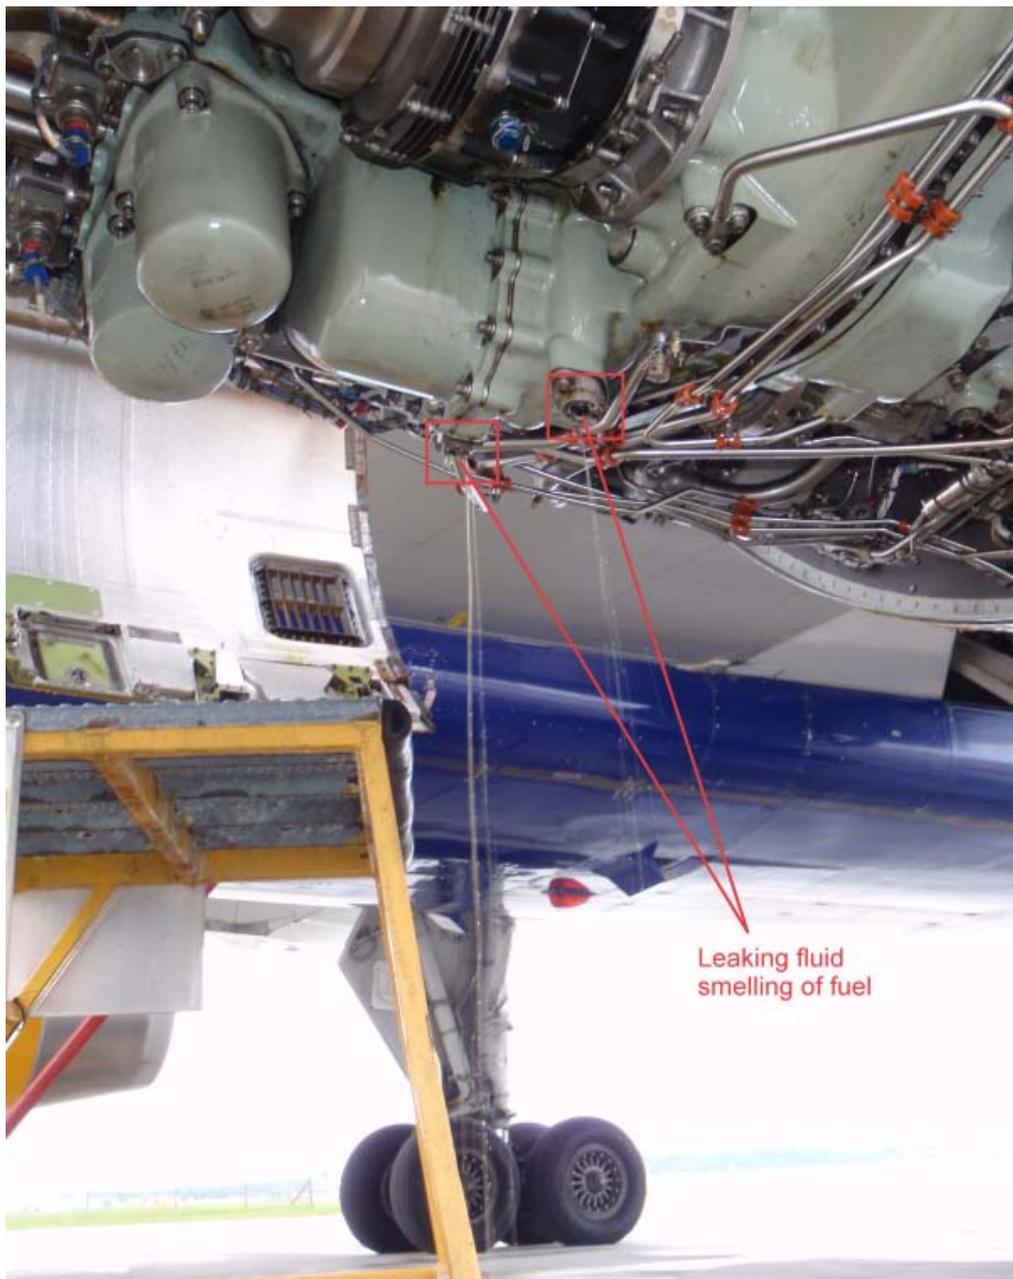
The engine cowlings were opened and fluid smelling of fuel was seen leaking from the location of two Magnetic Chip Detector (MCD)<sup>12</sup> plugs on the high speed external gearbox located in the lower part of the engine. When the MCD plugs were removed the leak continued and the MCD plugs were found to contain extensive debris. This can be seen in Figure 5 and Figure 6. The seats for the magnetic chip detectors in the high speed gearbox should be self-sealing.

Figure 5 – Fluid leaking from the MCD plug locations on the high speed external gearbox

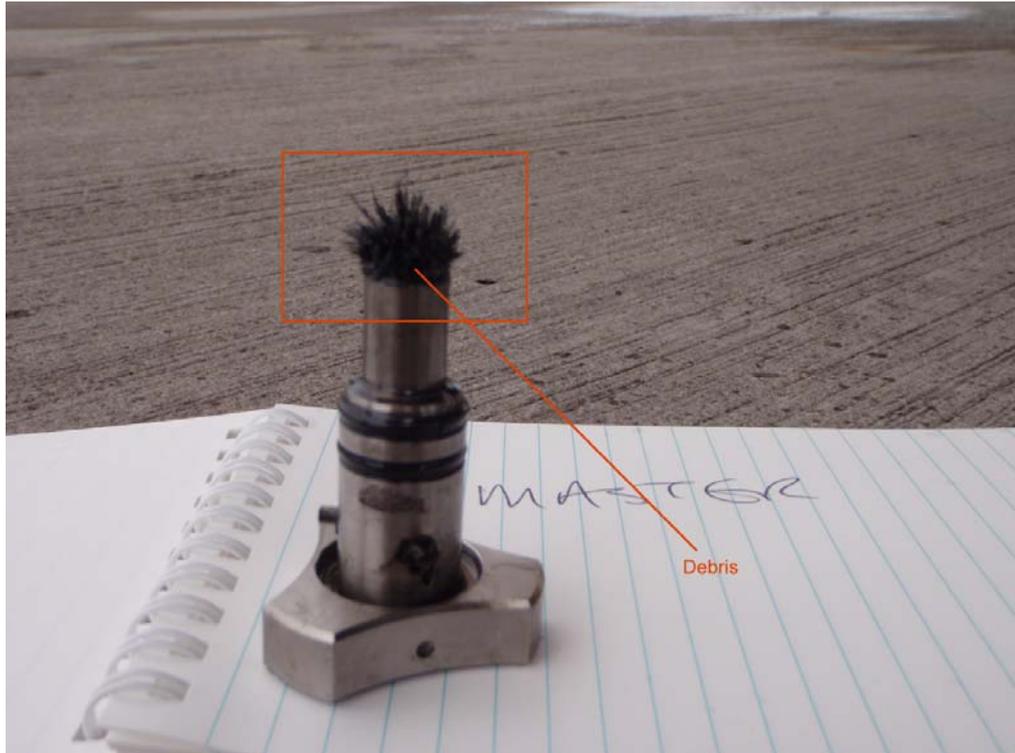
**Figure 6 – Debris found on one of the MCD plugs**

The magnetic chip detectors were removed and analysed by Rolls-Royce laboratory. The debris found on the MCDs consisted of large thin strands of debris, up to 10 mm long. The laboratory had difficulty identifying some of the material types found due to the percentage of alloy elements. According to the laboratory, the material found that could be identified on the MCDs was likely from a locking nut, a stepped sleeve, a carbon face seal and from a cup washer.

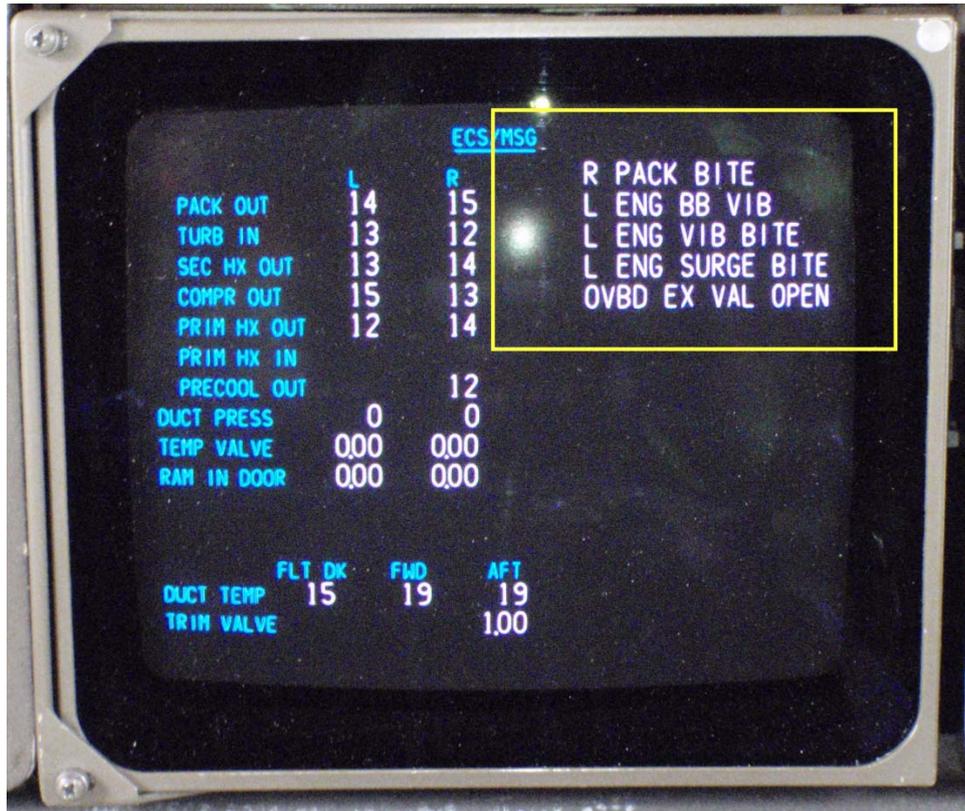
In the flight deck the field investigation revealed the following EICAS messages, as seen in Figure 7:

- R PACK BITE
- L ENG BB VIB
- L ENG VIB BITE
- L ENG SURGE BITE
- OVBD EX VAL OPEN

Figure 7 – EICAS messages

The “R PACK BITE” EICAS indicates that the Right Pack Temperature Controller had a critical controller fault or any LRU fault stored in its last flight fault memory.

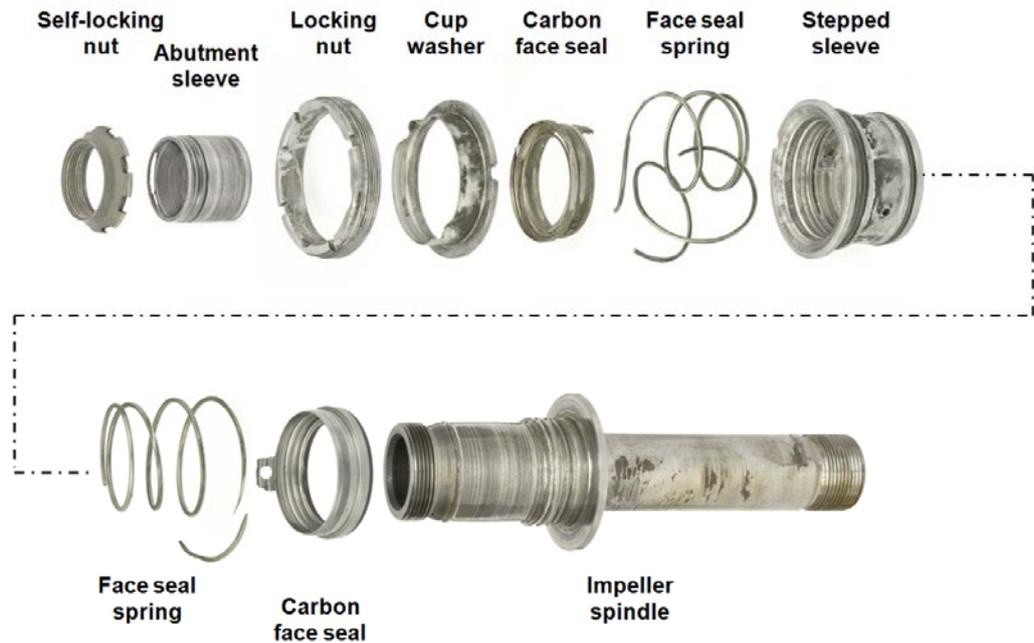
The low pressure (LP) fuel pump, P/N BPU200MK2 of S/N B1167, was sent to its manufacturer, Goodrich in Birmingham, for teardown. The low pressure fuel pump was found to have internal damage as seen in Figure 9.

**Figure 9 – Internal damage of the low pressure fuel pump**

Inside the low pressure fuel pump, the self-locking nut, abutment sleeve, cup washer, carbon face seals, face seal springs, stepped sleeve and retaining pin were all found to be damaged. It is likely that the debris which was identified on the magnetic chip detectors came from these parts. In addition, 15 cm long blockage of carbonaceous material was discovered in the fuel drain tube for the low pressure fuel pump. See Figure 10 for details on the internal parts of the low pressure fuel pump.

The teardown analysis of the low pressure fuel pump at the manufacturer indicated that the failure was initiated with the breakup of the carbon seal insert in the seal assembly between the low pressure fuel pump and the high speed gearbox.

- Safety Recommendation 01-2009  
Icelandair should check history of all LP Fuel Pumps and take appropriate action if they have excessively exceeded the optimum life TSN or TNO. This check should be completed no later than 30 November 2009.

- Safety Recommendation 02-2009  
Icelandair should implement a procedure that ensures compliance with CMP 040 recommended work packages following line maintenance removals of BPU 200 LP Fuel Pumps. Procedures should also be implemented to ensure compliance of other accessory units of the Rolls-Royce Engine Management Program.

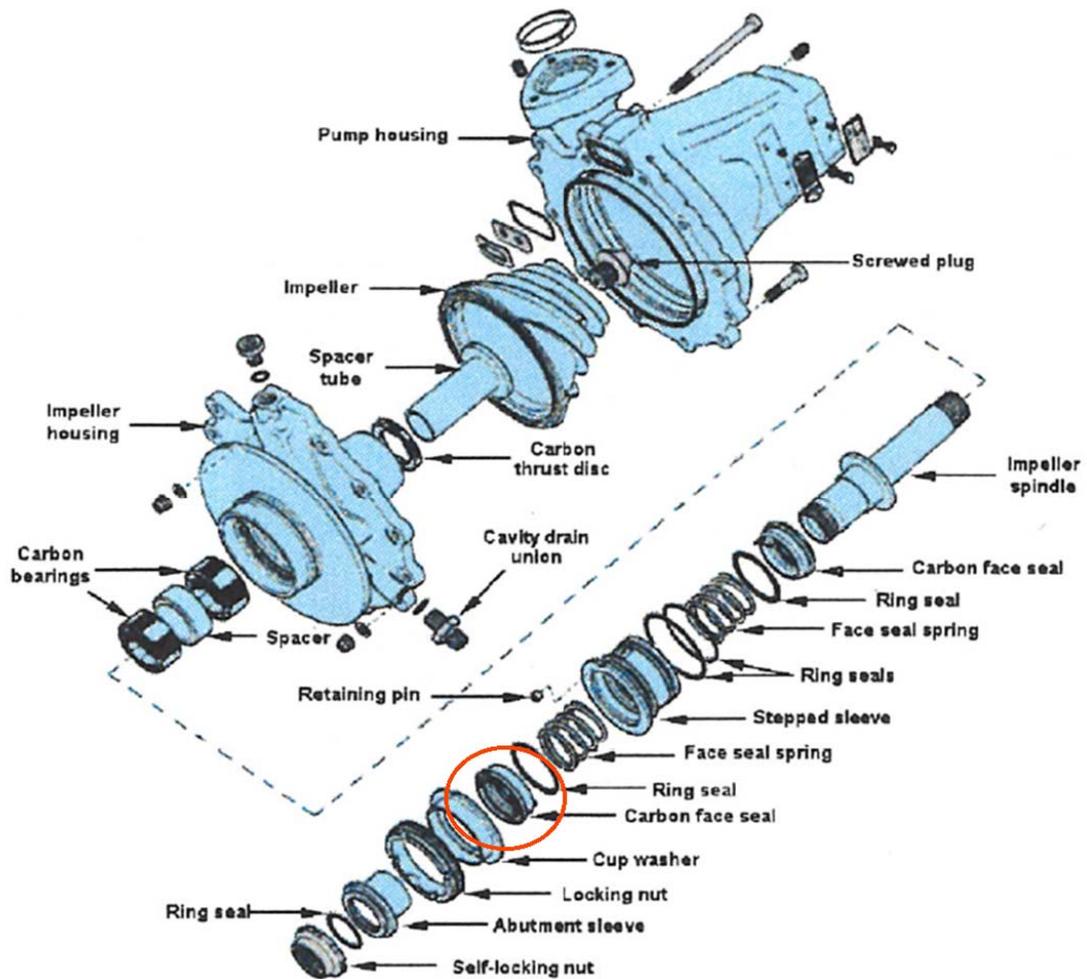
Figure 10 – Component setup of the low pressure fuel pump (primary damage in red circle)

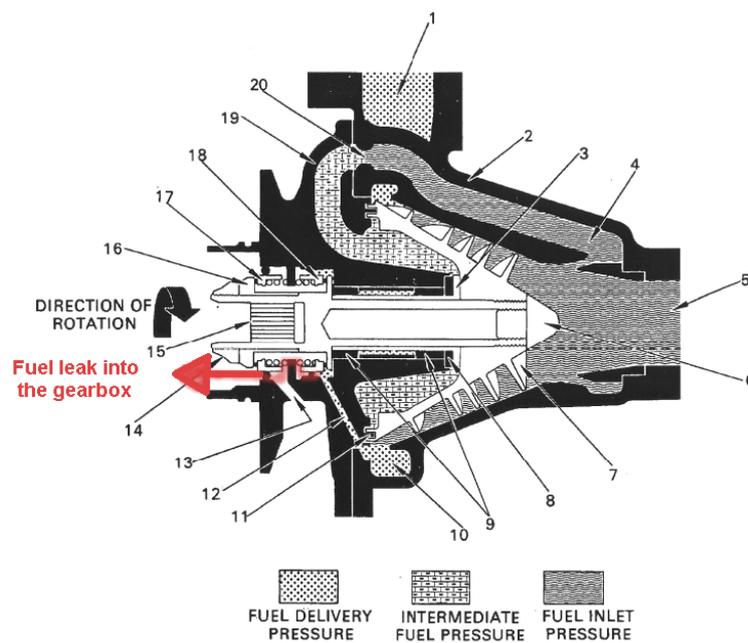
The analysis of the low pressure fuel pump indicated that the failure initiated with the breakup of the carbon seal insert in the seal assembly between the low pressure fuel pump and the high speed gearbox. It is believed that this

lead to metal-to-metal contact between the seal body and the abutment sleeve, which then due to increased friction caused torsion loading that generated rotation of the spring and the seal body. It is also believed that this lead to heavy wear in the area until the seal spring had turned to such an extent that the abutment shoulder in the stepped sleeve was passed. This caused the preload in the seal spring and the carbon seal assembly to be released, which resulted in a fuel leak into the seal cavity. As the fuel drain tube was blocked, the fuel passed from the cavity and into the high speed gearbox, contaminating the engine oil system. See Figure 11 for details.

Figure 11 – Cross section view of the low pressure fuel pump and the leak path into the gearbox

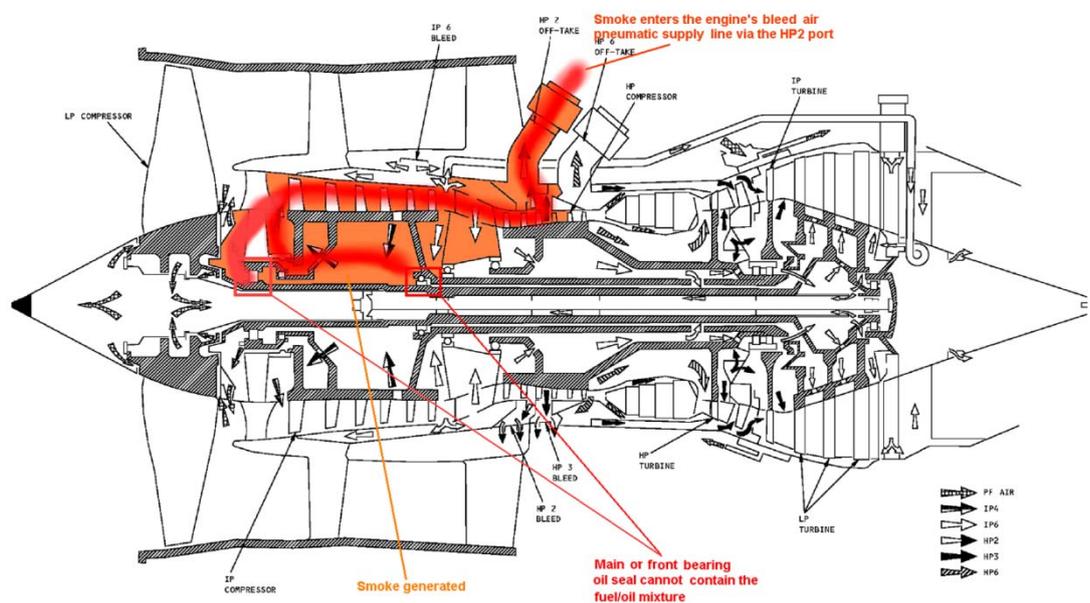
Based on this and the cooling air path of the engine<sup>21</sup>, shown in Figure 12, the probable path of the smoke can be backtracked from the HP2 port back to main bearing and/or front bearing seal in the Intermediate Pressure (IP) compressor section of the engine.

Figure 12 – Smoke propagates to the bleed air valves and enters via the HP2 port

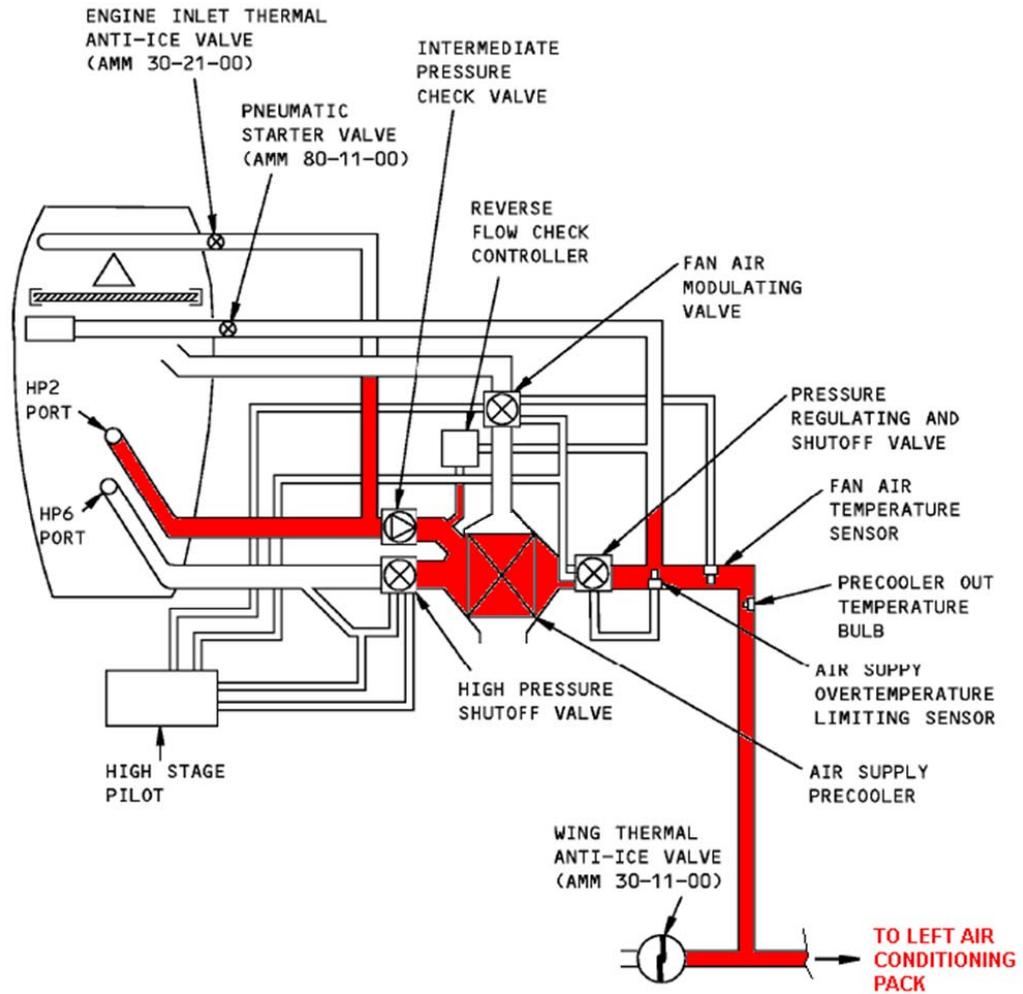
It is therefore believed that the fuel/oil mixture entered the compressor section of the engine as the main bearings and/or front bearing oil seals could not contain the contaminated fuel/oil mixture. Inside the engine's compressor, the fuel/oil mixture generated smoke. From the compressor section of the engine the smoke distributed via the air paths of the engine. Once at the HP2 port, smoke entered the bleed air system of the engine and then propagated to the airplane's left air conditioning pack. See Figure 13 for details.

Figure 13 – Smoke propagates from the HP2 port to the left air conditioning pack

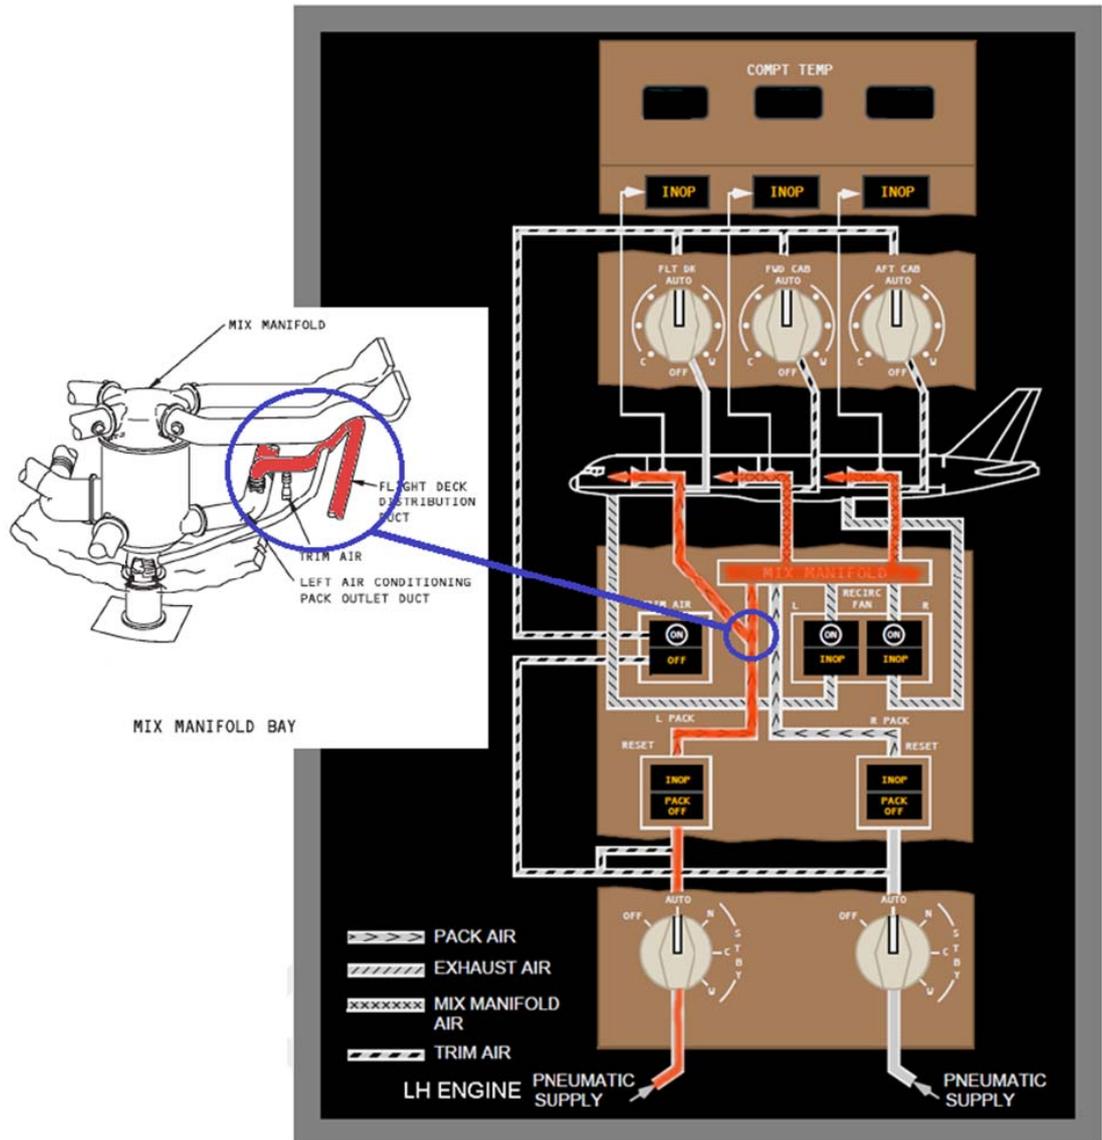
mix manifold<sup>23</sup>. This explains why the smoke entered the flight deck prior to entering the cabin.

When the left air conditioning pack is inoperative the flight deck receives air from the mix manifold. Figure 14 shows this in detail.

Figure 14 – Smoke travels to the left air conditioning pack and then to the flight deck and cabin
