AIRCRAFT ACCIDENT REPORT

Fire during landing roll

M-01508/AIG-04

**TF-ARS
Air Atlanta Icelandic
Zia International Airport
Dhaka, Bangladesh
March 25, 2008**

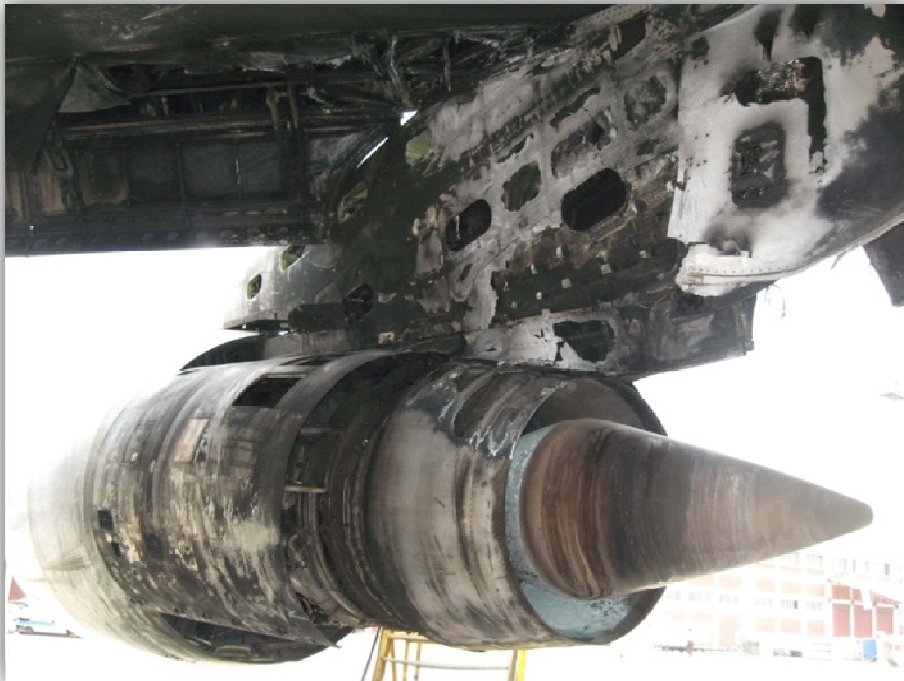
Soon after landing, the fire started in the strut/engine area No. 3. The commander shut down all engines and the aircraft remained on the taxiway until all passengers and crew members had evacuated the aircraft and the fire had been extinguished. The aircraft was damaged in the strut/engine area No. 3 as well as in the surrounding sections of the right hand wing. The aircraft was evaluated beyond economical repair. Figure 2 shows the damage to the aircraft at the fire area (strut and engine No. 3).

Figure 2: Fire damage to right hand wing, strut and engine No. 3

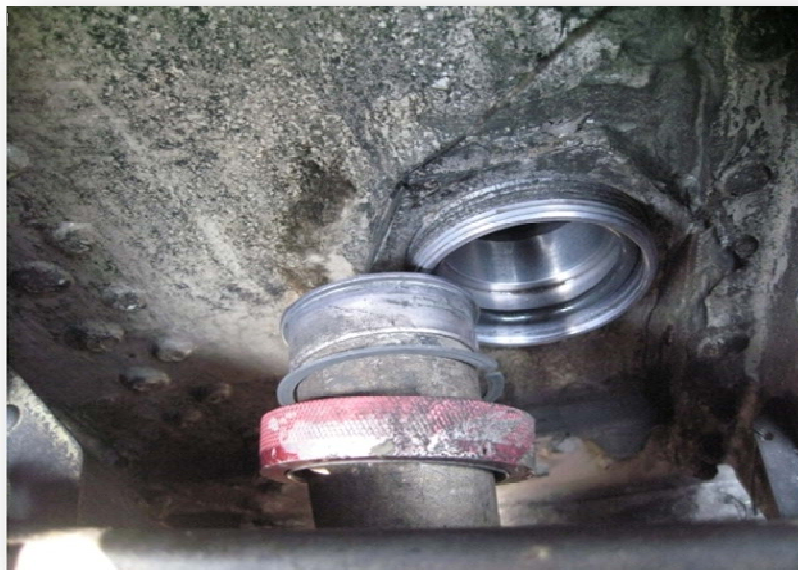
1. The O-ring and one retaining ring placed as found in engine area No. 3 of TF-ARS (see Figure 8.), i.e. one O-ring within the fitting end and one retaining ring on the ferrule.

Figure 8: Placement of O-Ring and Retaining ring in test 1.

The fuel line was assembled this way and couplings secured hand-tight. The fuel line was pressurized using only one fuel boost pump. The engine ignition circuit breakers were pulled and the engine start lever was placed in the “On” position to open the engine fuel shut-off valve. There was an initial squirt of fuel from around the coupling, a few drops, and then it stopped. The second fuel boost pump was then turned on. No further leak occurred. When the pumps were turned off, fuel started to drip a little for a few seconds from the coupling and then it stopped. The coupling nut was then

loosened by three turns (1/12 to 1/6 of a round each turn). The fuel line was pressurized using one fuel boost pump. No leak occurred. The second fuel boost pump was turned on and the fuel line was gently agitated by hand. No leak occurred. The coupling nut was loosened once more and then fuel started to leak. Gentle agitation by hand of the fuel line increased the rate of fuel leakage. The spar coupling was retightened slightly (by ½ a turn) and the engine/pylon was shaken by pushing against the nose cowl. Only minor dripping was observed.

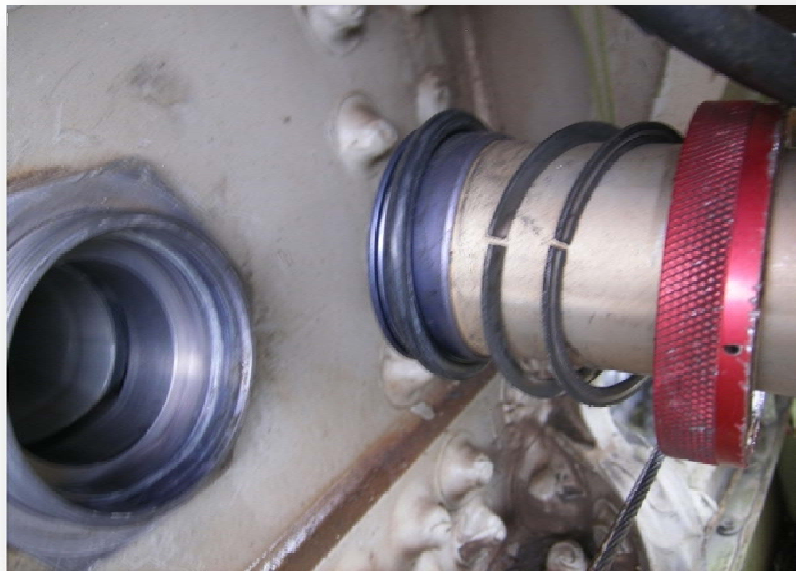
2. One O-ring and two retaining rings (as found in engine area Nr. 4 of TF-ARS). One O-ring on the front of the ferrule and two retaining rings together also on the ferrule.

Figure 9: Placement of O-Ring and Retaining ring in test 2.

The fuel line was assembled and the coupling nut was secured hand-tight. The fuel line was pressurized using forward and aft fuel boost pumps. The engine ignition circuit breakers were pulled and the engine start lever was placed in the “On” position to open the engine fuel shut-off valve. No leak was evident at this time. The fuel line was also gently agitated by hand. No leak occurred.

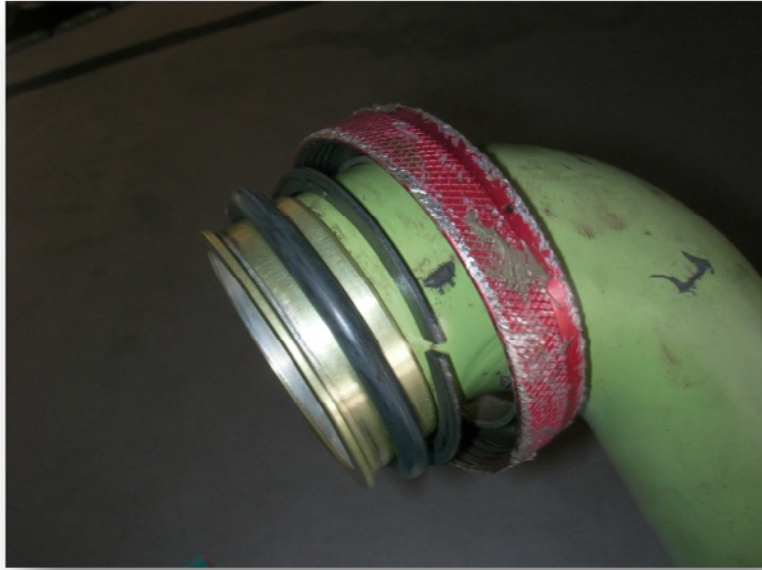
3. One O-ring and one retaining ring both on the ferrule

Figure 10: Placement of O-Ring and Retaining ring in test 3.

The purpose of this test was to see if the coupling had been assembled in this way and later the O-ring had moved into the fitting. The fuel line was re-installed and both couplings re-connected and secured hand-tight. It was observed however, that the fuel line moved forward slightly out of the spar coupling when fuel pressure was applied. The fuel line was also gently agitated by hand. No leak occurred.

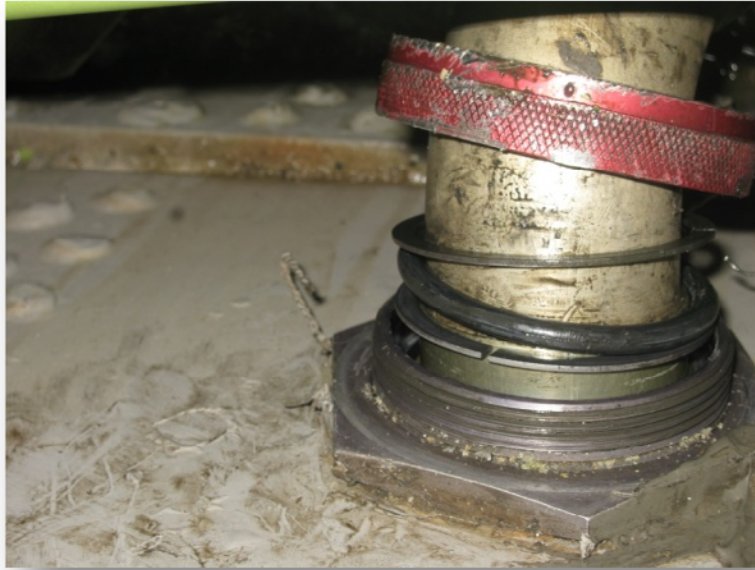
4. One O-ring in between two retaining ring. Correct assembly.

Figure 11: Placement of O-Ring and Retaining ring in test 4.

The O-ring and two retaining rings were placed correctly in accordance with AMM configuration. The coupling was re-connected and secured hand-tight. The fuel line was pressurized using both fuel boost pump. The coupling nut was then loosened a little more than in test "1". No fuel leak occurred. The fuel line was gently agitated by hand and still no leak.

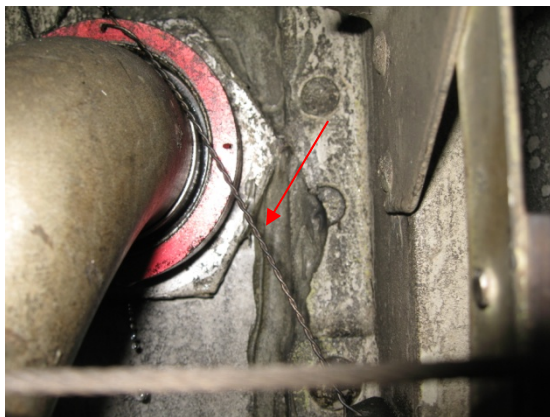
Furthermore the lock wire connected to the coupling nut that was leaking (Figure 12), was fastened in such a way that the coupling nut could rotate slightly.

Figure 12: Lock wire in in such a way that the coupling nut could rotate slightly

Referring to the tests as listed in chapter 1.16, test and research, IAAIB concludes that the fuel leak test, that was performed during the “C”-check before the accident, may not have revealed visual evidence of fuel leak through the coupling even though it was incorrectly assembled. Later the coupling nut might have rotated slightly due to the fact that the nut was secured with a lock wire in such a way that it was possible for the nut to rotate enough for the fuel to leak, see Figure 12.

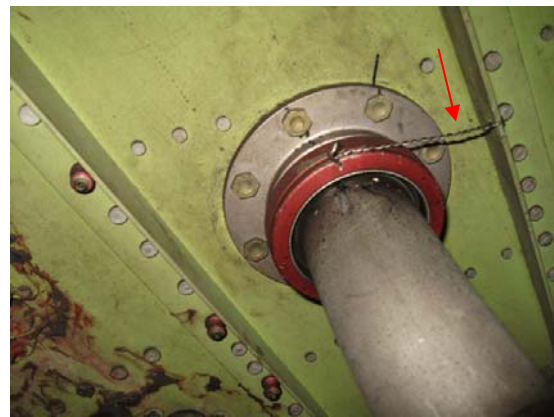
Figure 13: Lock wire in such a way that the nut is less likely to rotate

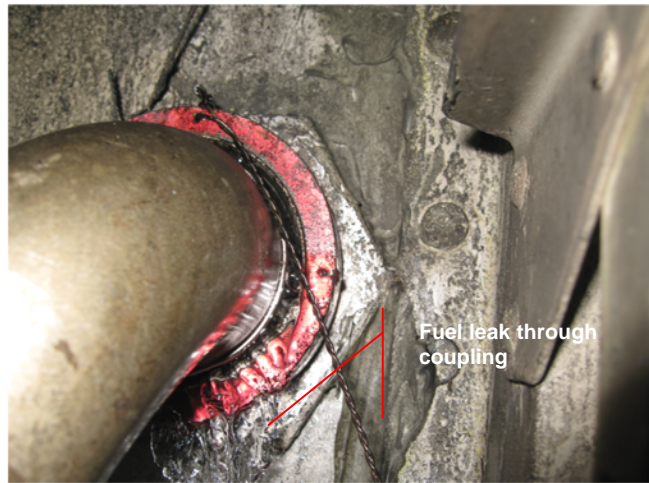
During the on-site investigation, a fuel leak was discovered at one of the main fuel line couplings. The leak was found where the main fuel line is coupled to the front spar for engine No. 3. By moving the fuel line a little by hand, a fuel leak was observed (See Figure 14). After opening the coupling it was discovered that one of the two retaining rings was missing (See Figure 15) and the O-ring was in the wrong position (not on the fuel line). Therefore the O-ring was probably not sealing as it should when correctly installed. Figure 16, shows a comparable coupling in the front spar for engine No. 2. In Figure 16, the O-ring is correctly installed on the fuel line, i.e. between two retaining rings.

Figure 14: Coupling at front spar for engine No. 3

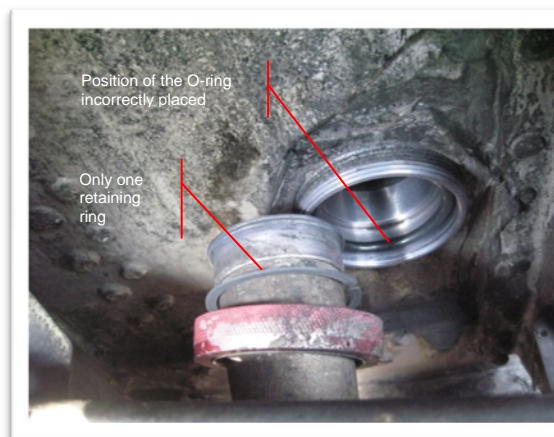
Figure 15: Coupling at front spar for engine No. 3 (where the fuel leak was detected)

The cause of the fire was that fuel was leaking through the flexible half coupling to the hot surface of the engine. The fuel leak was because the O-ring and retaining rings were not properly assembled within the coupling and one retaining ring was missing.

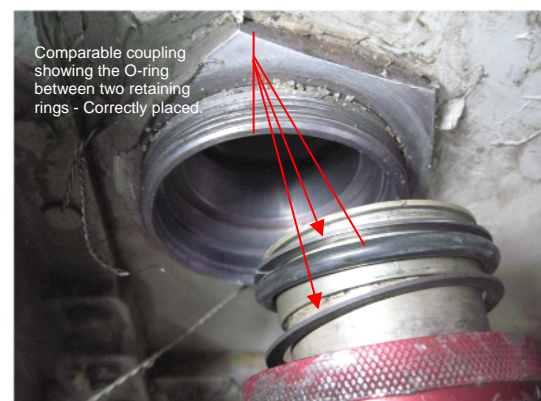
Figure 16: Coupling at front spar for engine No. 2

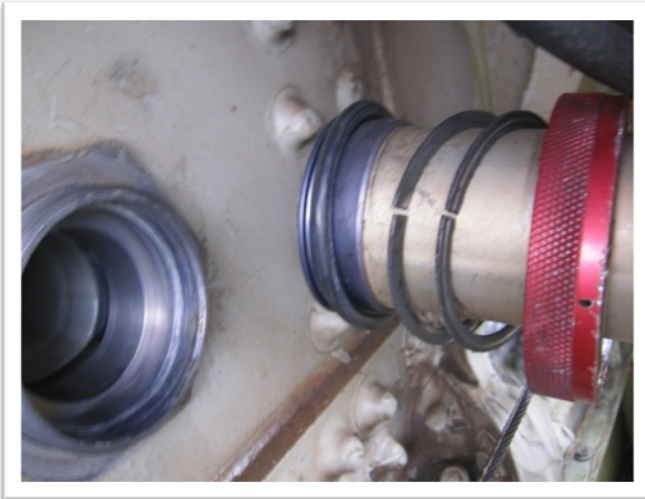
Figure 17: Coupling at front spar for engine No. 1

Examination of other couplings on the aircraft revealed that the coupling at engine No. 1 was also incorrectly assembled. The coupling was found with two retaining rings and one O-ring; however, the O-ring was incorrectly placed, see Figure 17.

Another incorrect installation was also found at the flexible half coupling at the front spar for engine No. 1. However there were no signs of a fuel leak in that area, most likely due to the fact that both the retaining rings and the O-ring were within the coupling even though they were incorrectly placed.

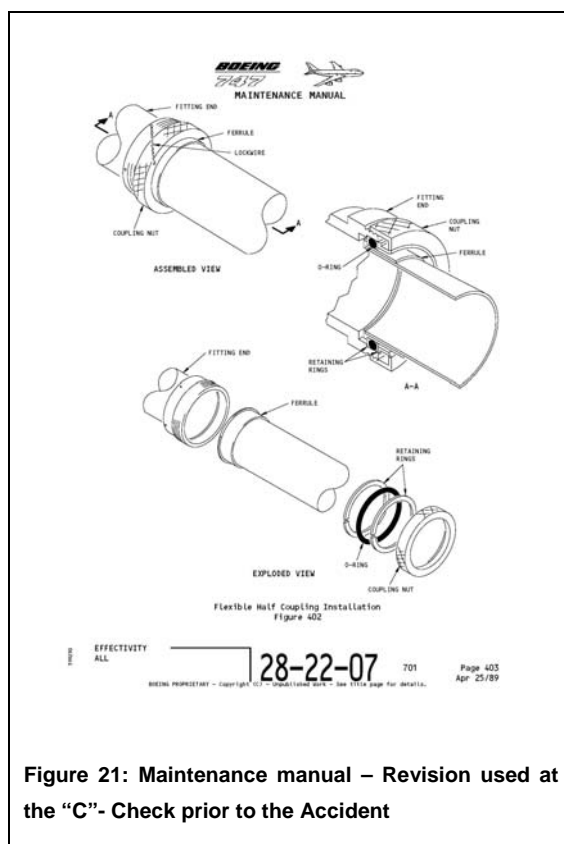
When working on the coupling at the front spar, the work instructions for flexible half coupling should be used. IAAIB finds that the instructions in the aircraft maintenance manual (AMM) were not clear on which type of coupling should be used at different locations.

Figure 21: Maintenance manual – Revision used at the “C”- Check prior to the Accident

The investigation team recommended to the manufacturer that this should be made clearer and in greater detail in order to eliminate the possibility of accidentally confusing the coupling at the front spar with another type of coupling. The aircraft manufacturer responded by sending out a revision in order to give a clearer picture of the coupling at the front spar, see Figure 22.

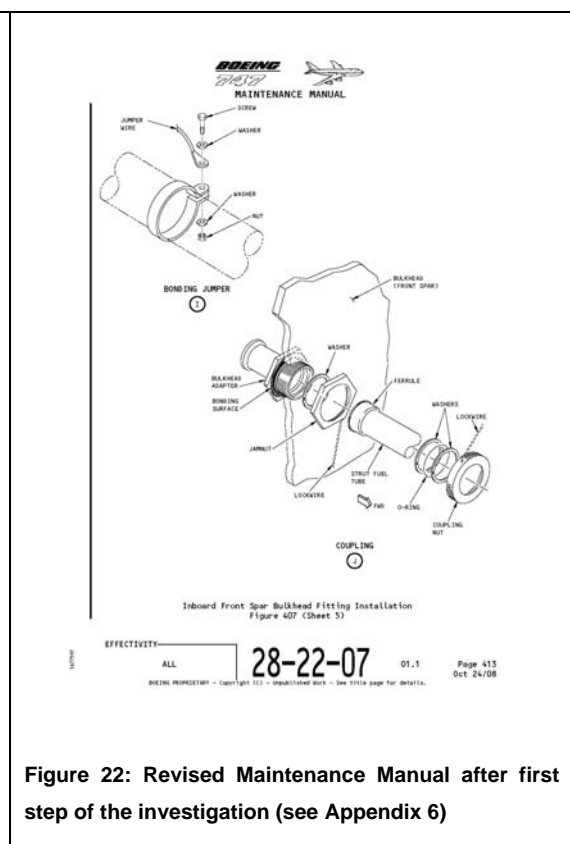
Figure 22: Revised Maintenance Manual after first step of the investigation (see Appendix 6)

1. The aircraft manufacturer made changes to the maintenance manual in order to avoid mixing rigid coupling with flexible half coupling.
2. Changes to the maintenance manual illustrate the placement of the lock wire.
3. Following the accident, a Fleet Team Digest (FTD) was prepared by Boeing and sent out where Boeing recommends that operators review list of “Service Bulletins” (SB’s) and “Safety Letters” (SL’s) to ensure proper maintenance actions to prevent any further strut fire events.
4. The operator has re-written emergency procedure Section 5, with special emphasize on evacuation techniques, initiative, and assessment of existing emergency situations¹⁰.
5. The operator has re-written chapter 2¹¹ in the Safety & Emergency Procedures manual (SEP).
6. The operator has been using this accident as a case-study for training.
