FINAL REPORT AIRCRAFT ACCIDENT

Ditching

TF-SIF

Aerospatiale SA 365N

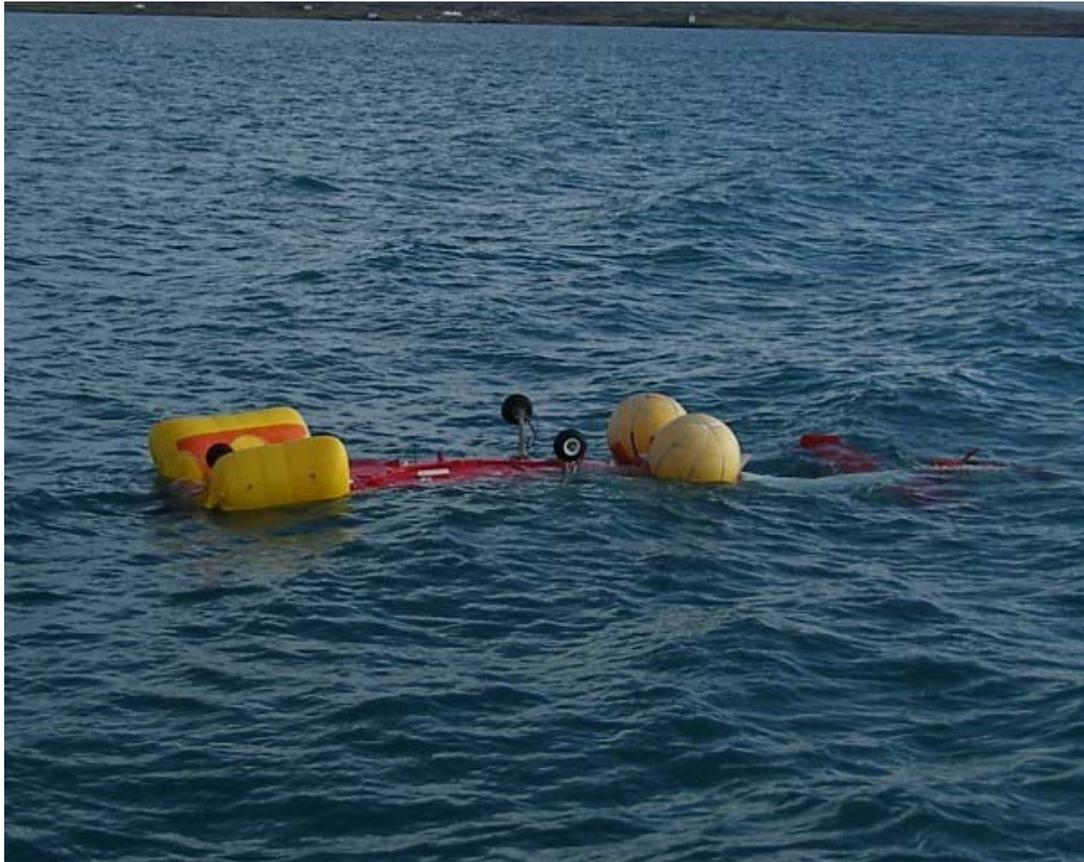
After evacuating the aircraft, the crew noticed that the front floats were rubbing against the pitot antennas (pitot tubes). A few minutes later, the forward most chamber of the right front float deflated. The aircraft started to tilt and finally rolled to the right and capsized, approximately 18 minutes after ditching.

Figure 1: The aircraft capsized approximately 18 minutes after ditching

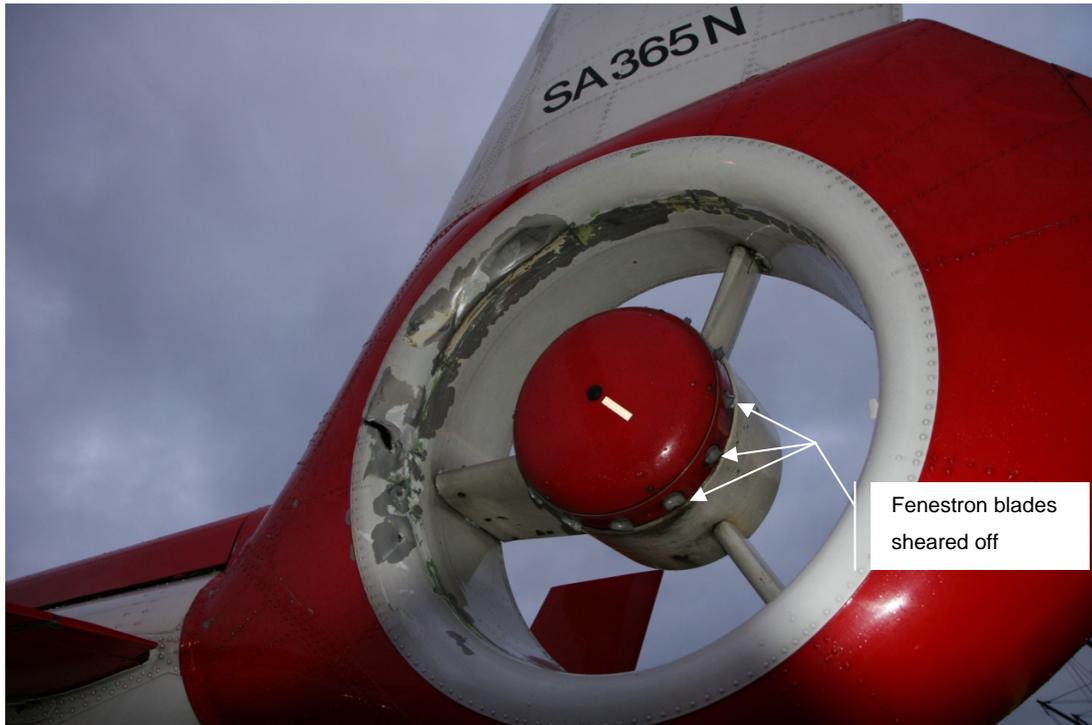
All fenestron (tail rotor) blades were found sheared off. The tail rotor blades were not retrieved from the ocean. Holes were found on the tail rotor fan case (see Figure 2) as well as small damage in one of the main rotor blades. This damage was evaluated to be caused by some of the tail rotor blades hitting the tail boom and the main rotor blade.

Figure 2: All fenestron (tail rotor) blades sheared off

According to the crew as well as witnesses, the ditching was smooth and in a level attitude. The tail rotor most likely hit the water right after the aircraft landed and before the crew shut down the engines. Due to the impact with water, the tail rotor blades sheared off and did some damage to one of the main rotor blades as well as the tail rotor fan case.

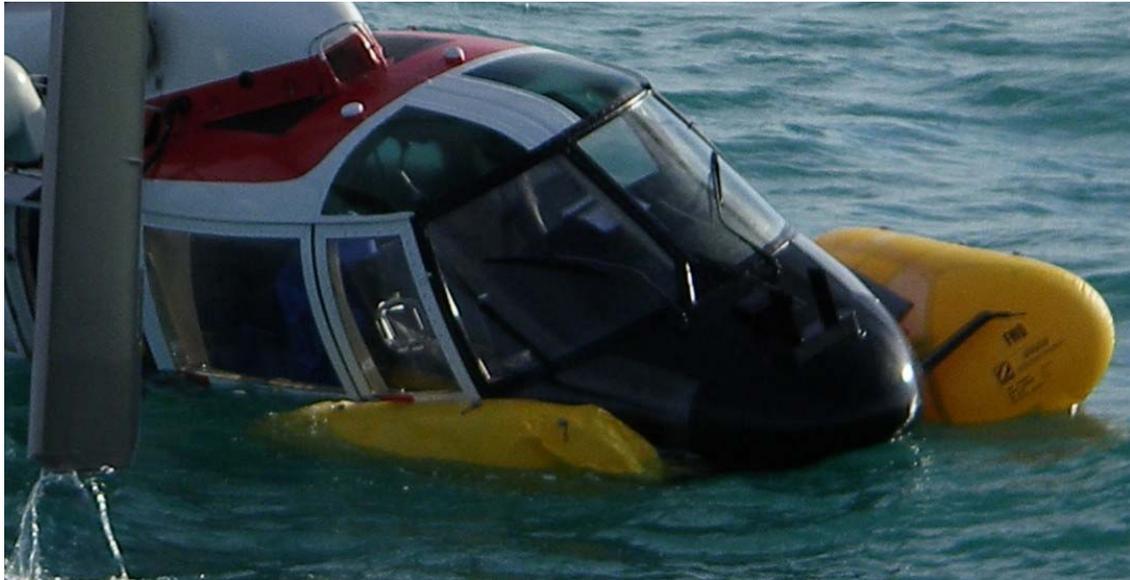
The forward most compartment of the right front float was found damaged and deflated. According to witnesses, the float inflated correctly and kept the aircraft afloat in a level position, long enough for the crew to evacuate the aircraft. A few minutes after ditching, the forward most compartment of the right float deflated due to rubbing with the pitot antenna.

Figure 3: Aircraft with right front float deflated

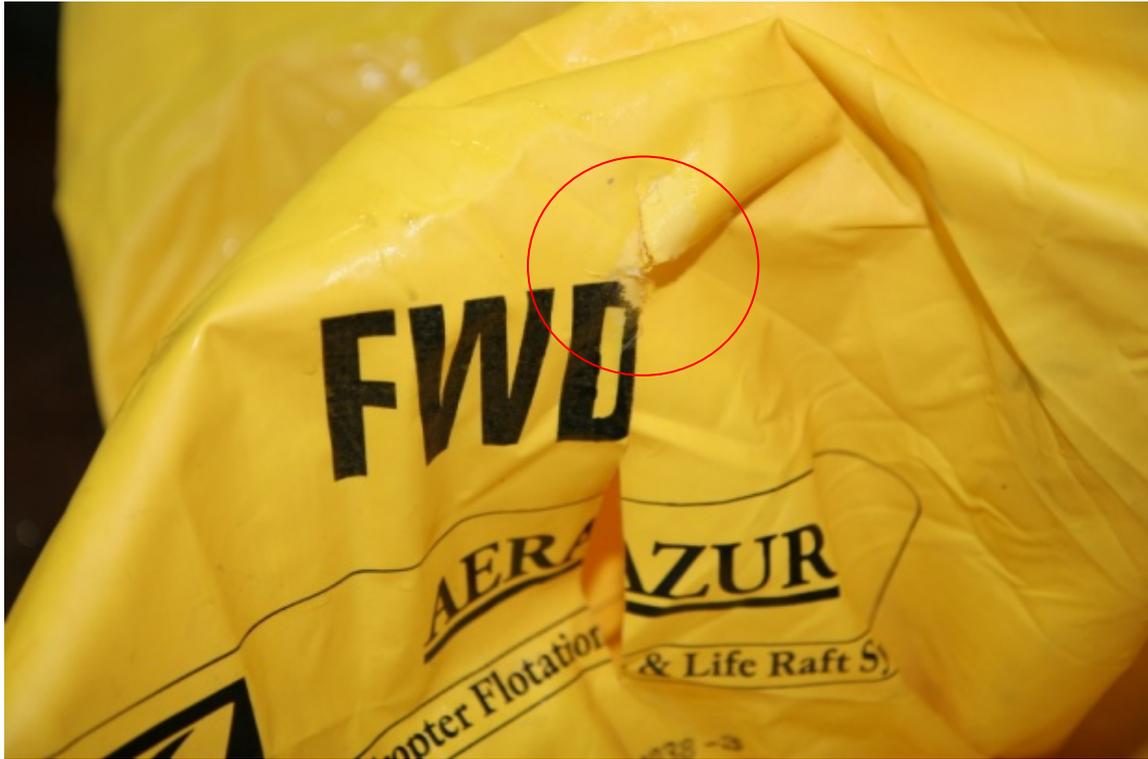
During the investigation, scratches were found on forward part on both front floats, where the pitot antennas contacted the floats and the right float was torn (see Figure 4 and Figure 5).

Figure 4: Damaged (deflated) right front float

On TF-SIF, the pitot antennas were originally fitted in location (A). At the time of the accident, the left pitot antenna was in accordance with its original delivery but the right antenna was replaced in 2004 due to a crack. The replaced antenna contained a metallic drain valve on the rear of the antenna that eventually ruptured the float.

The technical investigation did reveal that the rupture of the float was due to interference between the pitot antenna and the inflated float. In 1992 the manufacturer changed the design of the pitot antennas to correct this problem. After this improvement, the pitot antennas will not contact the floats while inflated.

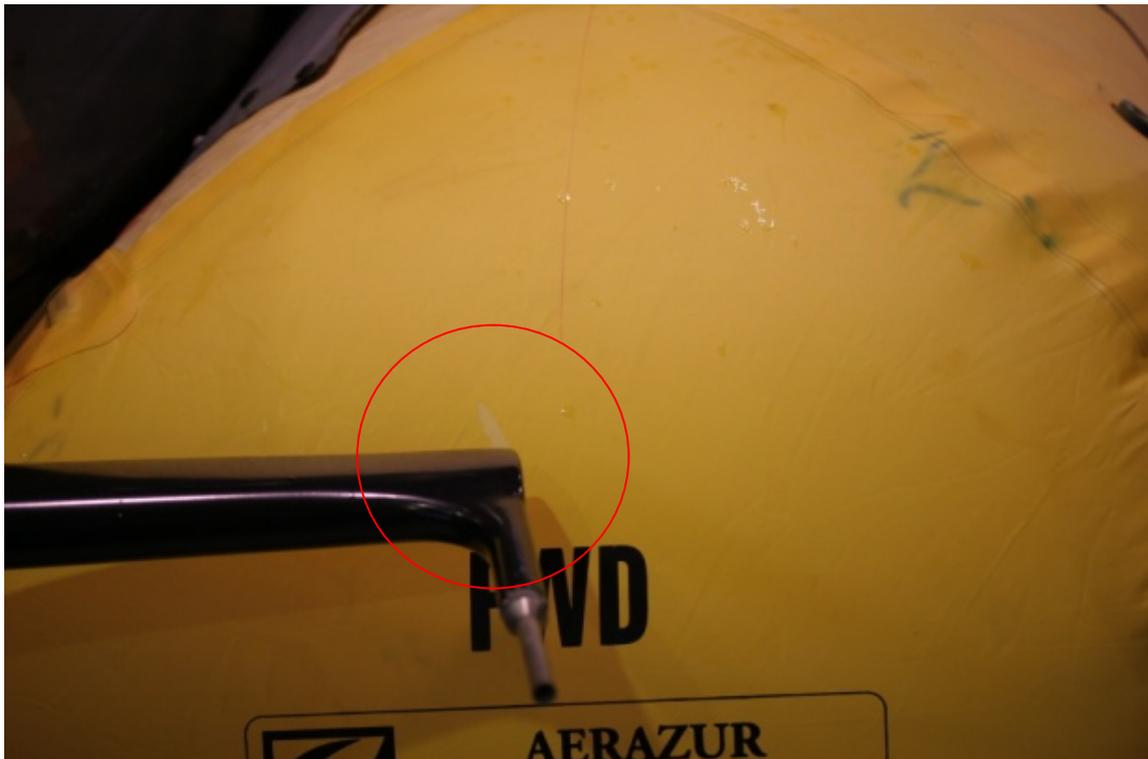
Figure 5: Scratches on left front float (not deflated)

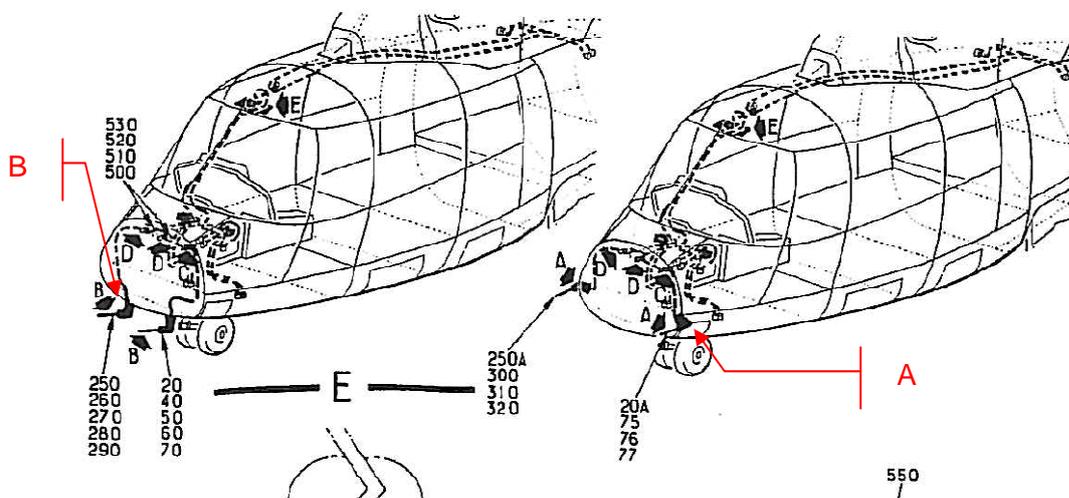
There are two possible locations for the pitot antennas on the SA 365 models (see Figure 6). One on each side (A), or both under the nose (B).

Figure 6: Two different location of Pitot antennas

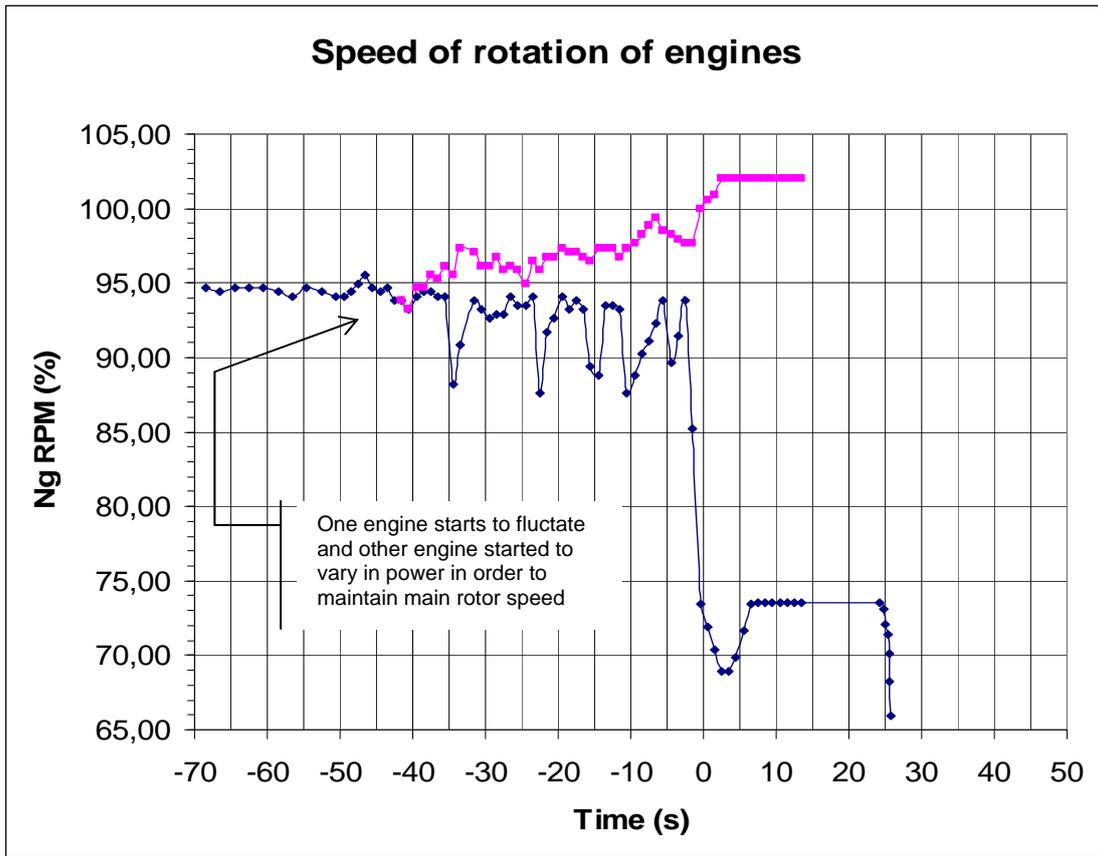
Furthermore, it was possible to identify the sound of each engine where it shows that one of the engine's rotation speeds started to fluctuate about 45 seconds before the ditching. At the same time the other engine started to vary in power in order to maintain main rotor speed (see Figure 9). When the rotation speed for one engine suddenly decreased to or below idle, the rotation speed for the other engine increased to its maximum and remained there until the engines were shut down. It was not possible to determine which engine spooled down. However according to the crew's statement it seemed that the right hand engine was not responding normally when they were shutting down the engines. The crew did not notice any fluctuation or any engine failure prior to the drop of main rotor speed.

Figure 9: Estimated rotation speed of the two engines read out from the CVR.

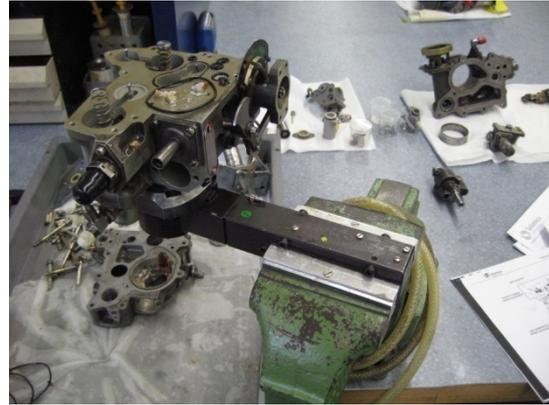
Both fuel control units (FCU) were opened and inspected (see Figure 11).

Figure 11: Disassembled FCU unit

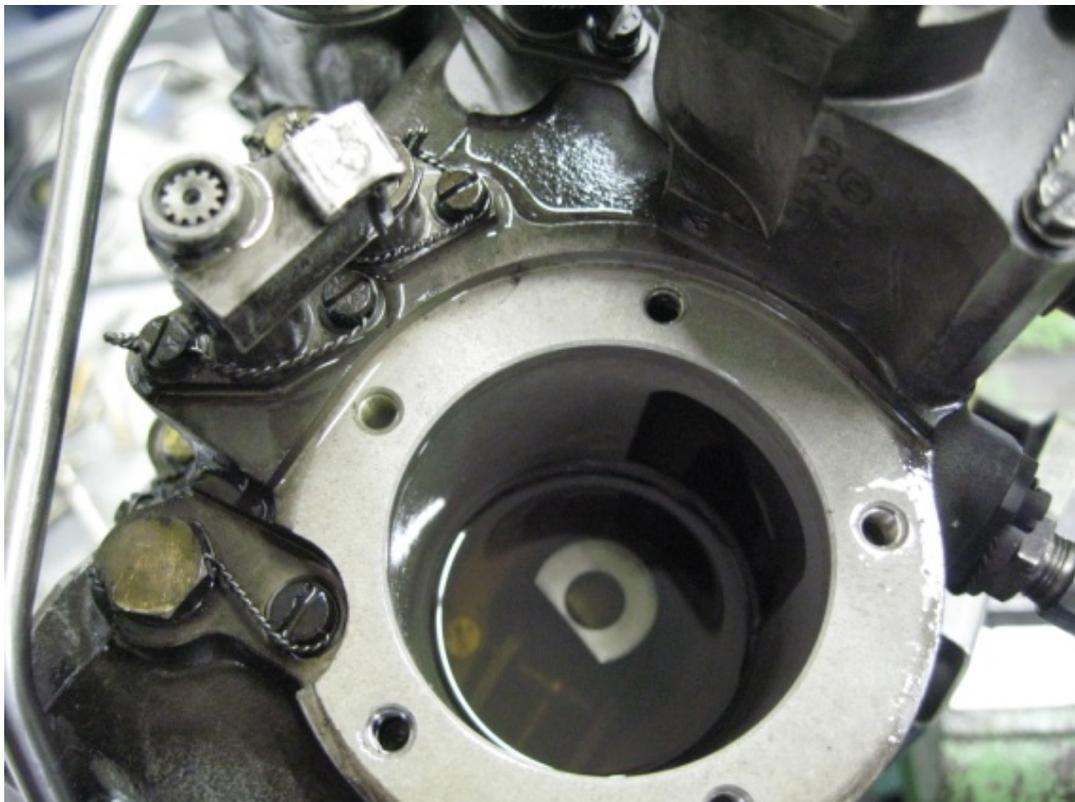
The FCU unit (S/N B708B) on left hand engine contained some fuel in its P2 chambers, i.e. where fuel should normally not be found. This was a known finding within the FCU according to the engine manufacturer and could be traced to an

O-ring that should be replaced with a different type. According to the engine manufacturer, it was concluded that this would not cause loss of engine power.

Figure 12: P2 Chamber with fuel

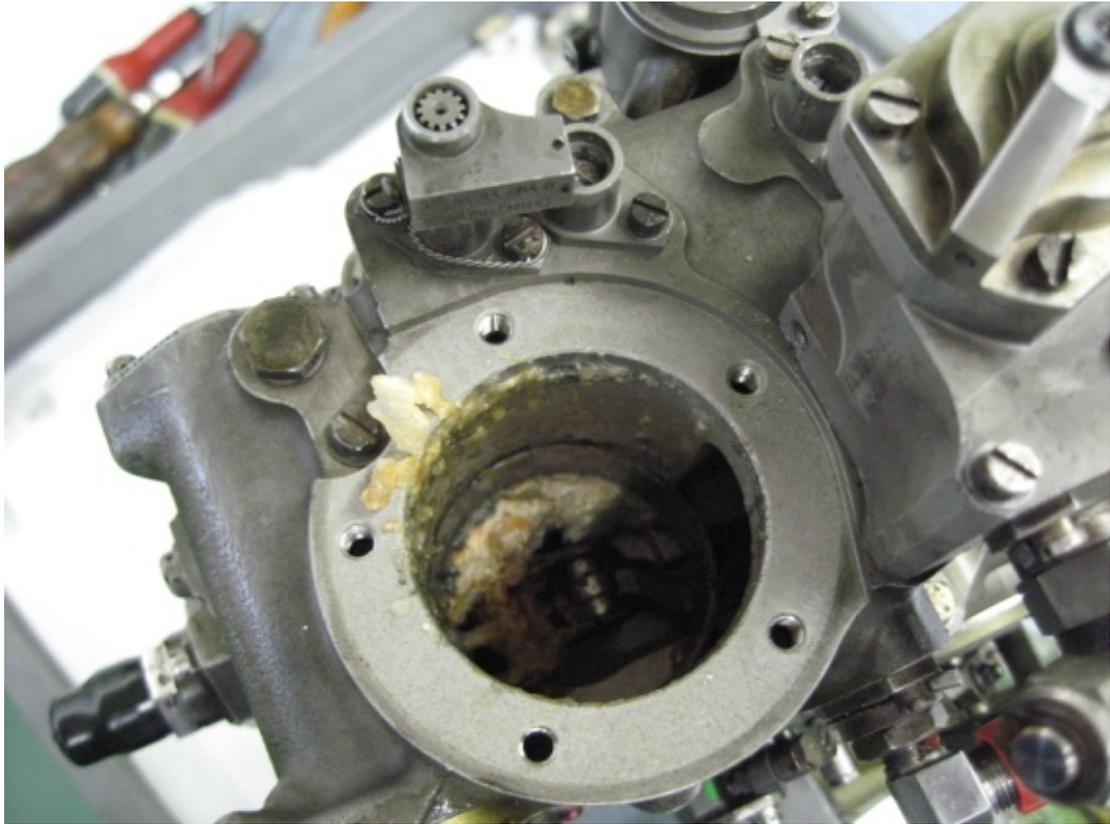
The FCU unit (S/N 105B) on right hand engine contained some substance in its P2 chamber. The substance was analyzed to be salt and grease. According to the manufacturer, the grease should normally be within the capsule but the technical examination could not determine the reason why the salt substance was found within the P2 chamber. Figure 12 and Figure 13 show the two different chambers.

Figure 13: P2 Chamber with salt and grease

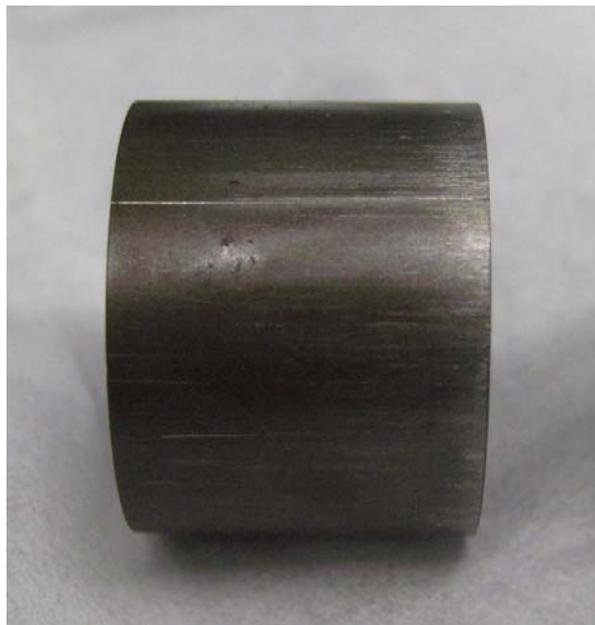
The FCU with S/N 105B had light scratches on its working piston, see Figure 14. The scratches were determined to be within manufacturer's limits.

Figure 14: Working piston of FCU unit S/N 105B
