REPORT ON SERIOUS INCIDENT

Runway Excursion

M-03707/AIG-19

JetX
Boeing 737-800, TF-JXF
Keflavik, Iceland
October 28, 2007

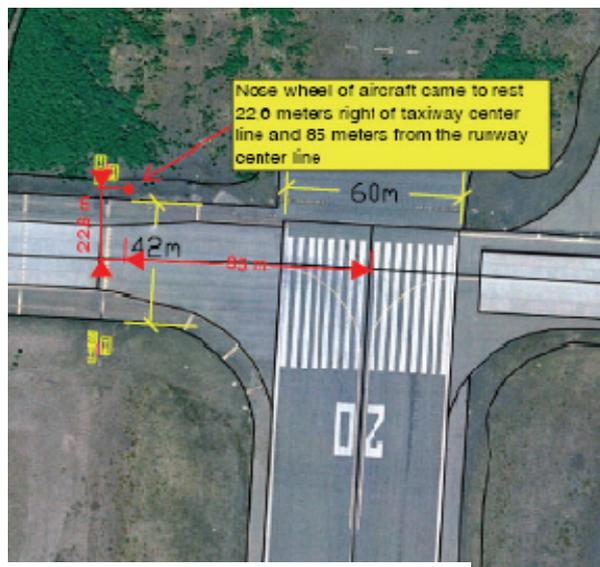
Figure 1: Area where aircraft came to rest

At this point, reverse thrust was increased with engine N_1 's rising to 80%. The ground speed was 25 knots and the heading was decreasing through 360 degrees. The wheel brake pressures then decreased through 19 knots ground speed, and nose-left rudder pedal was applied as the aircraft turned through 340 degrees. The aircraft came to rest on a final heading of 288 degrees with the right main landing gear and nose wheel off the paved surface of taxiway N-4.

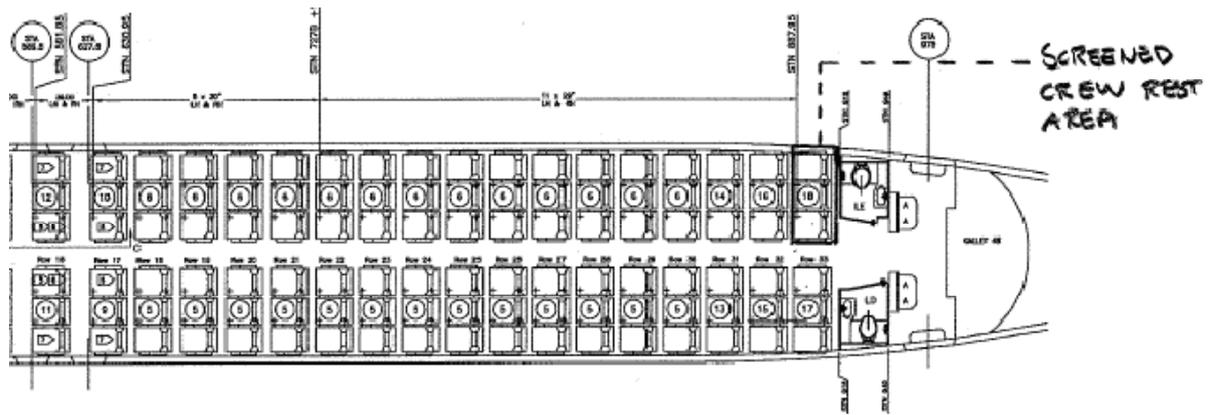
Figure 3: Aft section of cabin showing location of crew rest area

According to the pilots in the augmented flight crew, they preferred to rest in the cockpit as they felt the crew rest area was inadequate given their height and body size, making it impossible to sleep.

- 4.1.2 *Recommendation to EASA: Ensure operators have adequate on-board rest facilities when required by regulations. The crew rest facility should ensure a dark and quiet (most silent area on-board aircraft) environment where the skeletal muscles can fully relax in a horizontal position.*

- 4.1.8 *Recommendation to ICAA: Ensure operators have adequate on-board rest facilities when required by regulations. The crew rest facility should ensure a dark and quiet (most silent area on-board aircraft) environment where the skeletal muscles can fully relax in a horizontal position.*

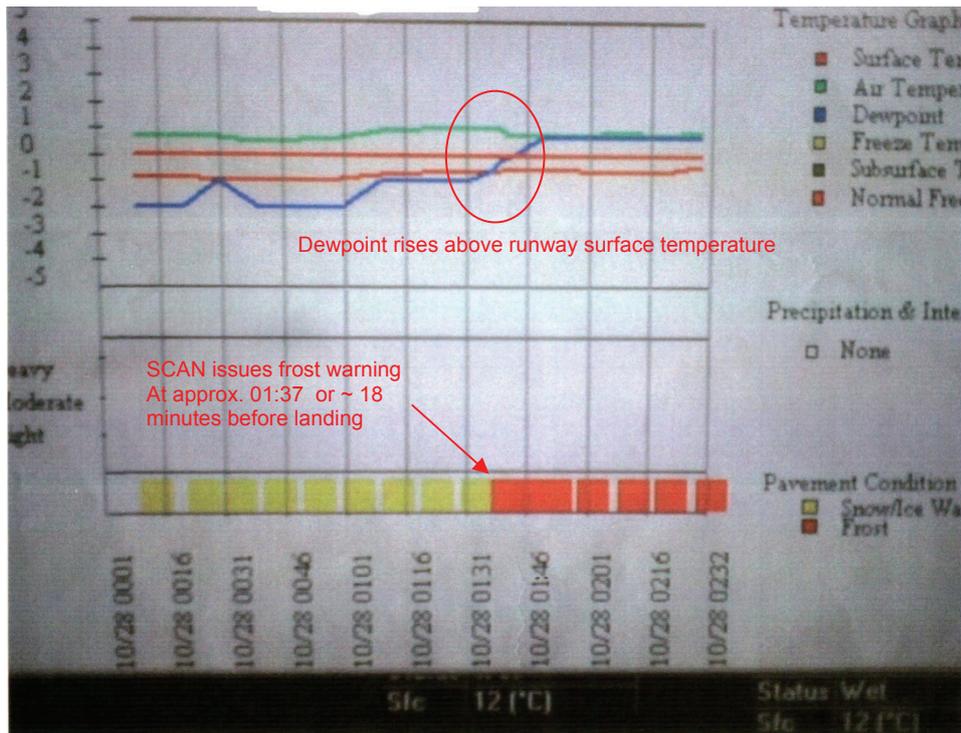
Figure 5: Screen capture from SCAN system. Blue line shows the dew point rising from -1°C to 1°C and the system issues a frost warning.

It is likely that during the time period the SCAN system issued a frost warning at 01:37 and until the aircraft landed at 01:55 the runway surface conditions were changing. The outside air temperature was around the freezing point of water. There was a sharp rise in the dew point temperature which reached the temperature of the runway surface. These conditions could have encouraged the formation of ice on the runway.

The SCAN system at Keflavik Airport was not actively monitored and the frost warning that the system issued at 01:37 went unnoticed (see Figure 5). The friction measurement for runway 02 was 2 ½ hours old and was thus outdated information. The Airfield Services division procedure do not require constant monitoring of the SCAN system. The SnowKing’s active monitoring out on the runways have been considered adequate supervision.

- 3.1.11 *The SnowKing used a non-standard technique to measure the braking action of runway 02.*
- 3.1.12 *The SCAN system issued a frost warning at approximately 01:37 that went unnoticed.*

- 4.1.6 *Recommendation to ICAA: Ensure the SCAN system monitor at Keflavik Airport is actively monitored and its warnings are made available to the SnowKing.*

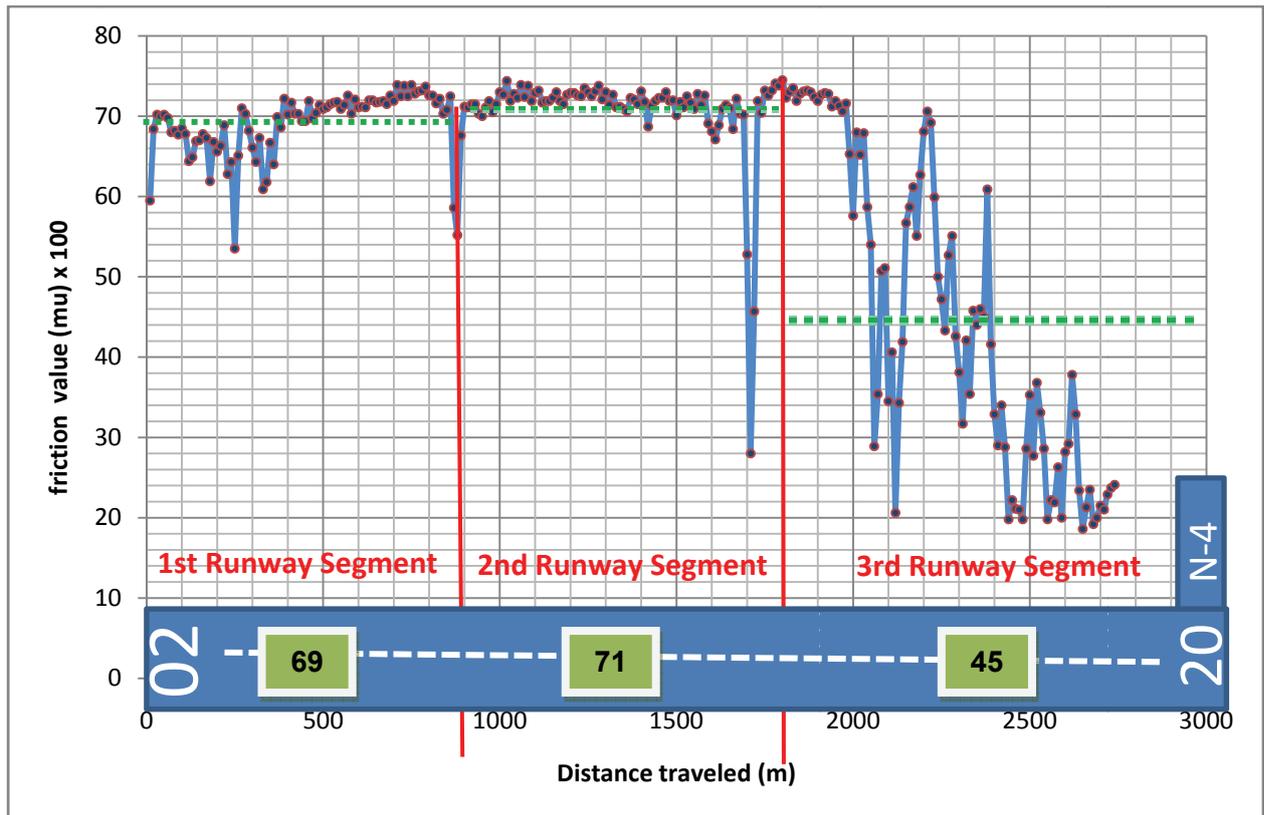
A regenerated graph (see Figure 6) of the Mu-meter run report (see appendix 5.1) that indicates the friction values for runway 02 can be seen in the figure 6 below. From the graph it can be seen that there is a great deal of variation in the measured friction values for the last third of the runway as compared with the other previous thirds. Also there is a considerable drop in the friction values which should indicate the braking action is deteriorating towards the north end of runway 02.

The method of measuring runway friction by towing a Mu-meter in a single winding course around the centerline of the runway is not according to the Airfield Services division's procedure and not in accordance with ICAO Annex 14 Airport Services Manual Part 2 Pavement Surface Conditions that stipulates that:

Figure 6: Measured friction values at 23:12 UTC by Mu-meter. Average values for each segment shown in by horizontal green dashed lines. The average friction values for each third shown in the boxes (69, 71, 45).

- 3.1.1 *The variation in the data collected by the Mu-meter for the third section of runway 02 was high and surface conditions were poor at the end of the runway.*

- 4.1.5 *Recommendation to ICAO: Review the limitations of the use of the mean value in runway friction measurements. Make it a design requirement for runway friction measurement systems to report the deviation in the measured values and issue a warning when the deviation from the mean value becomes large.*

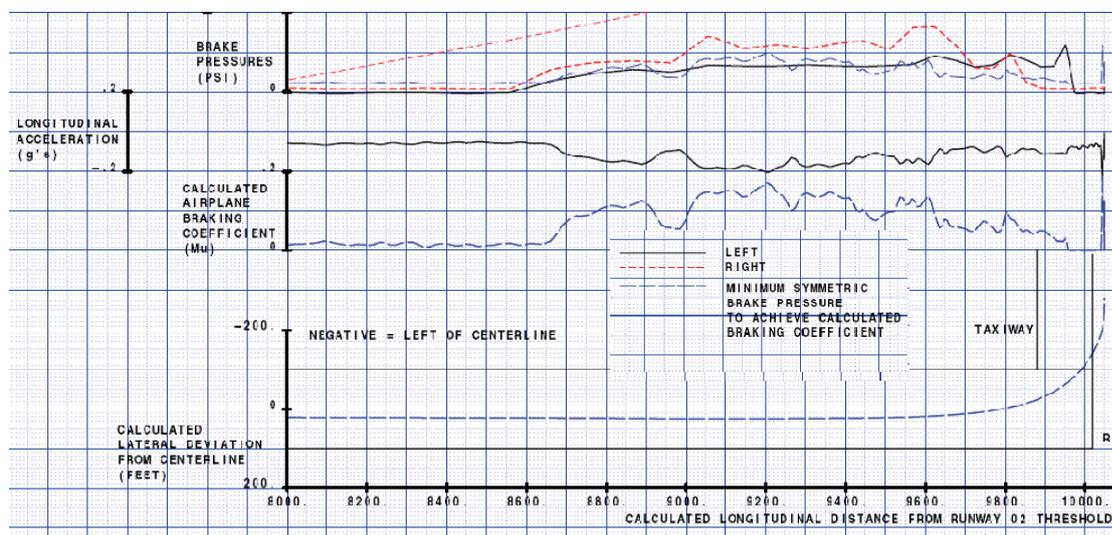
Between 400 and 200 feet from the end of the runway, the calculated symmetric brake pressure falls below the applied brake pressures suggesting a friction limited condition. The calculated aircraft braking coefficient was approximately 0.07 in this region.

After this point, the airplane was in a left turn and the right commanded brake pressure drops with asymmetric braking. The airplane does not appear to be friction limited in this region.

Figure 7: Braking action and deceleration of aircraft

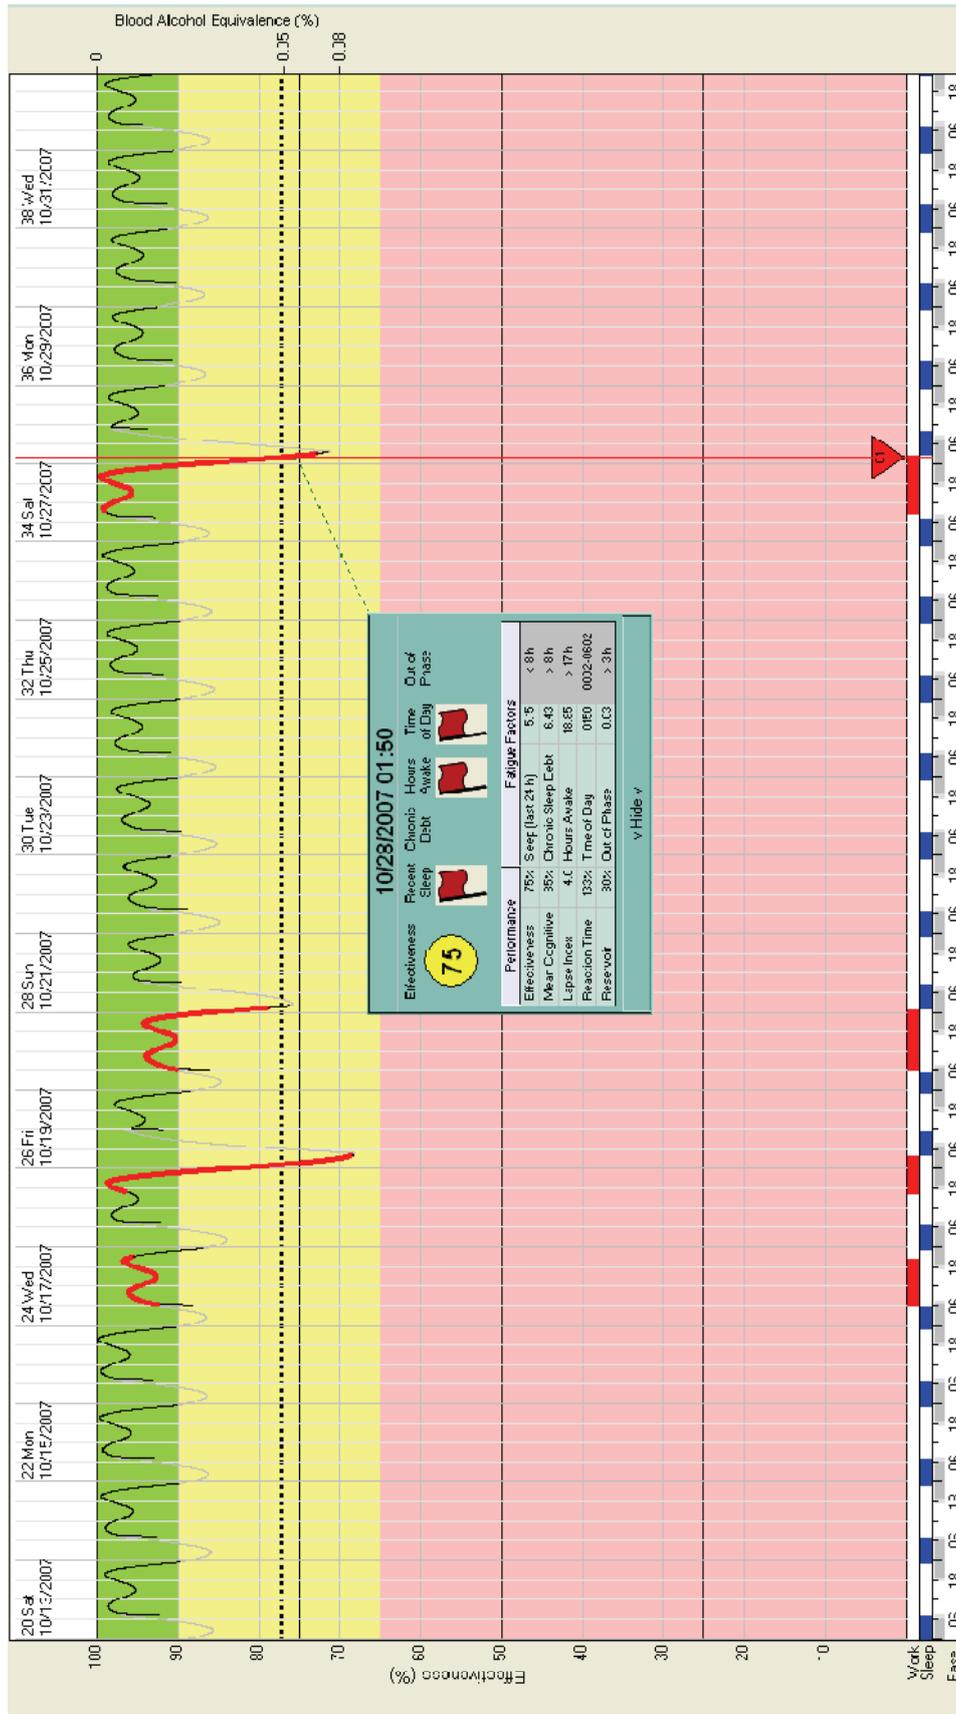
- 75% or lower Effectiveness (ability to maintain focus)
- 85% or lower Mean Cognitive (average speed of mental operations)
- 4.0 or greater Lapse Index (lapse in attention). Pilot is 4 times more likely to suffer from lapse in attention.
- 133% or longer Reaction Time

Figure 8: FAST prediction for pilot flying

These results support the previous statement regarding the pilot's performance and risk of fatigue related performance errors. Furthermore, the FAST analysis demonstrates that the pilots were likely fatigued and performing poorly in comparison to the performance that would be predicted for normally rested people.

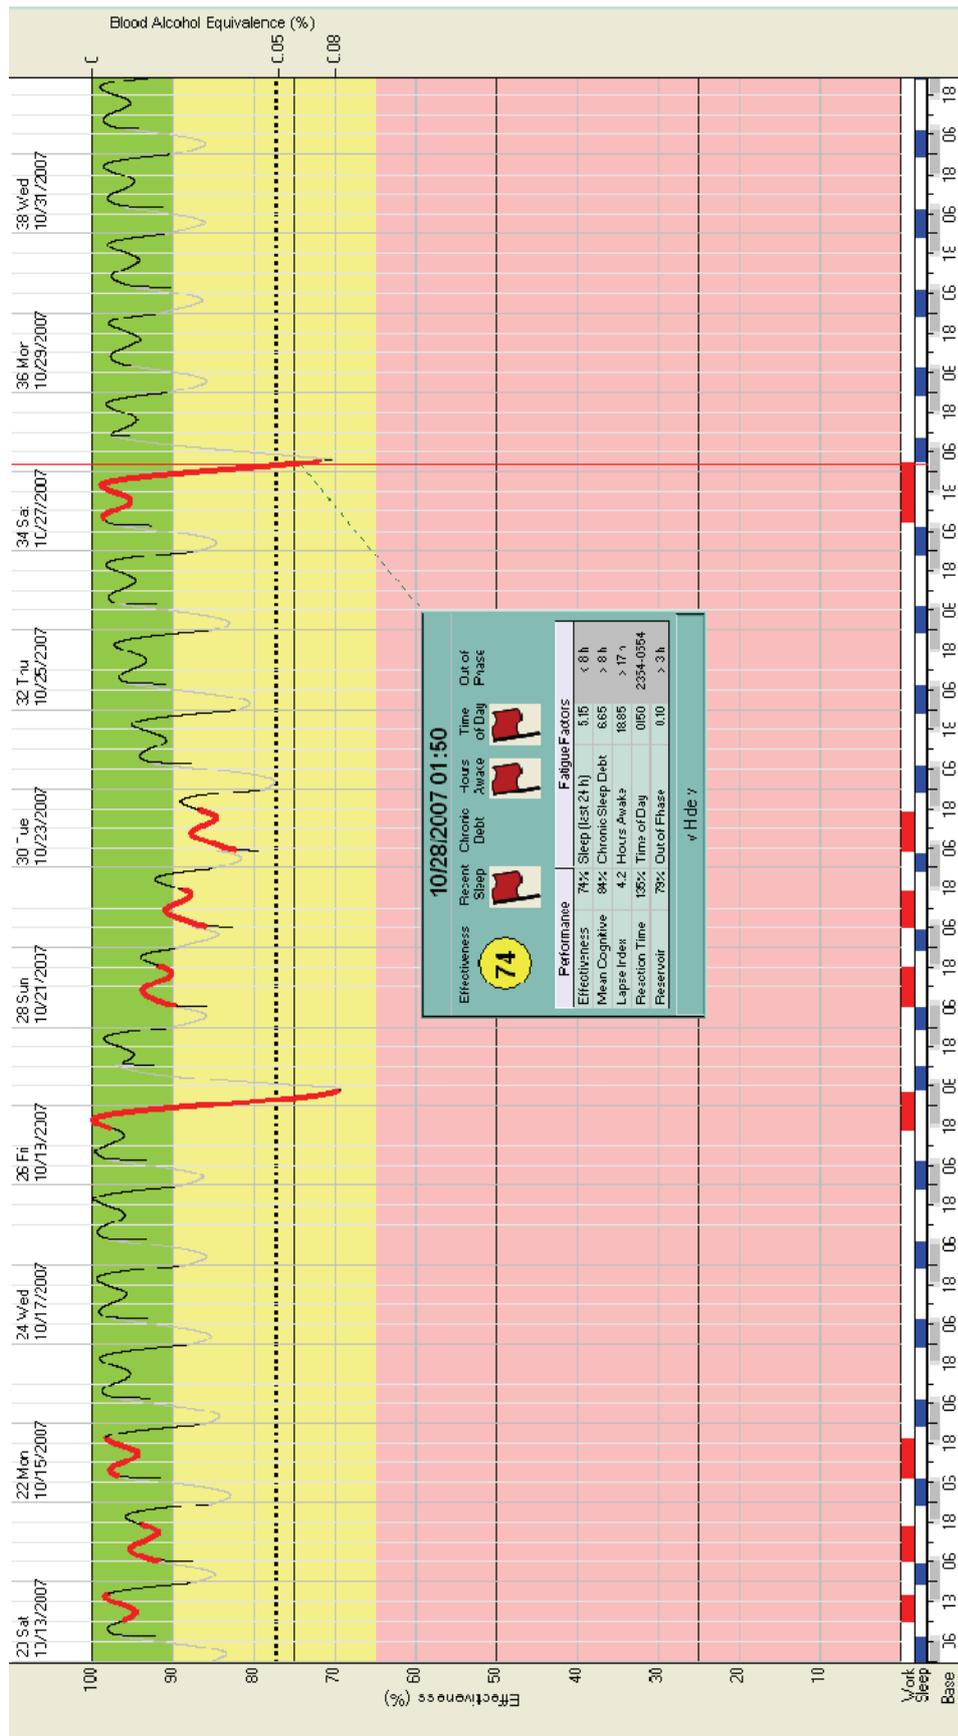
Figure 9: FAST prediction for pilot-not-flying
