FINAL REPORT ON ACCIDENT

**Front engine power loss and left main landing gear
collapse during landing**

M-02307/AIG-11

Cessna 337

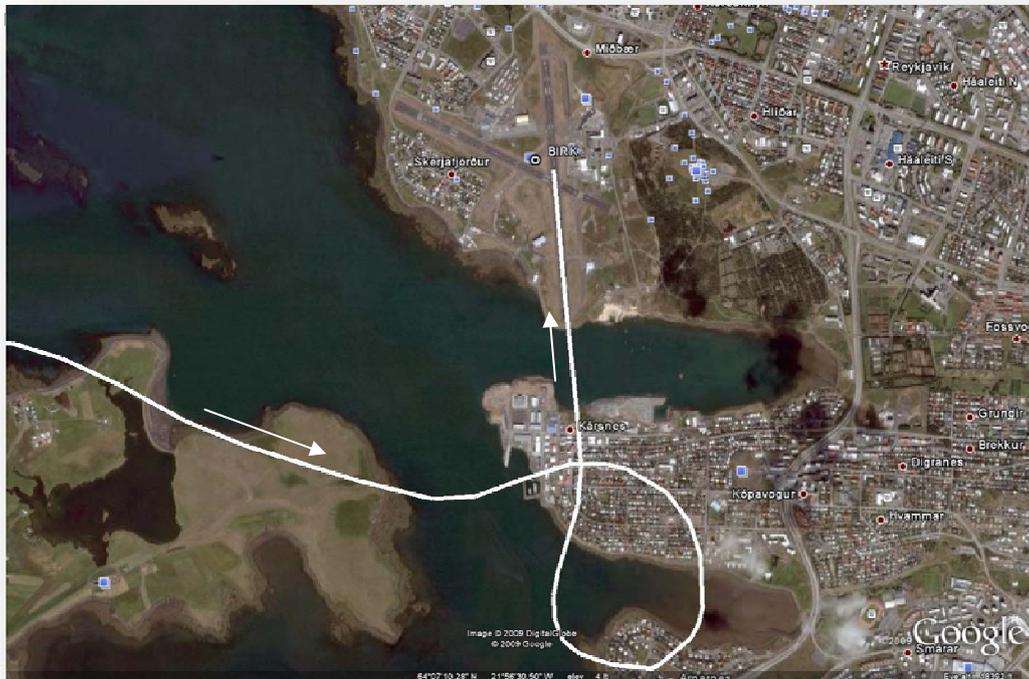
Figure 1, right turn before approaching RWY 01

At 2.000 feet the pilot received a clearance from Reykjavik Airport tower to land on runway 01. According to the pilot, he was very high on the approach, so he requested a right 360° turn to lose altitude (see figure 1).

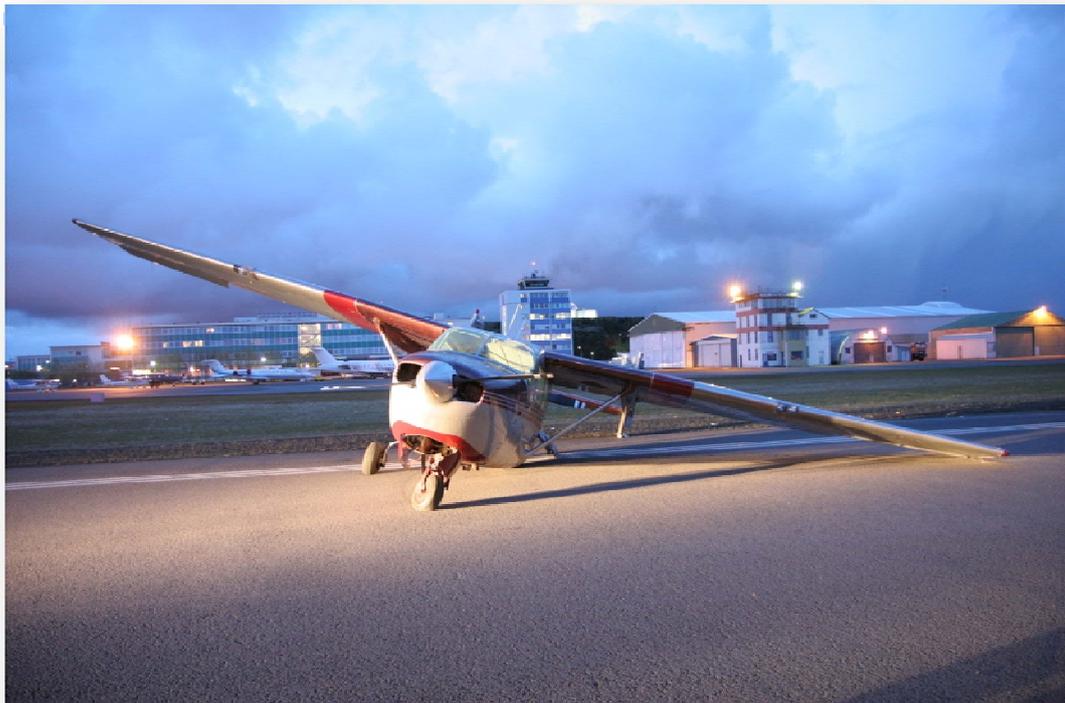
Figure 2, the aircraft where it came to a rest

During the landing roll on runway 13 the left main landing gear collapsed and the aircraft went off the runway, over a grassy area and came to a rest on runway 01 (see figure 2). The pilot and the passenger were not injured.

AAIB-Iceland considers that left main landing gear was not in a locked position during landing, most probably because the pilot or his passenger failed to manually extend the gear until all wheels were in locked position.

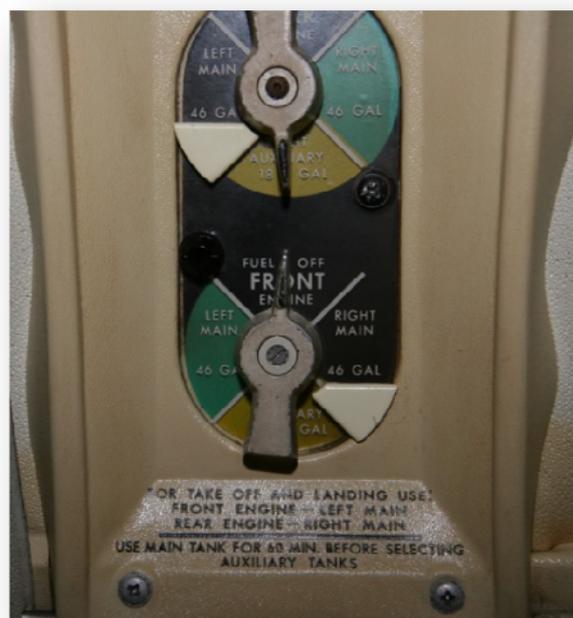
Figure 4 fuel selectors

At field investigation, the fuel selector's of N442MT were in the following positions (see figure 3):

Front engine in OFF position

Rear engine in AUX right

AAIB-Iceland believes that the front engine stopped running due to fuel starvation.

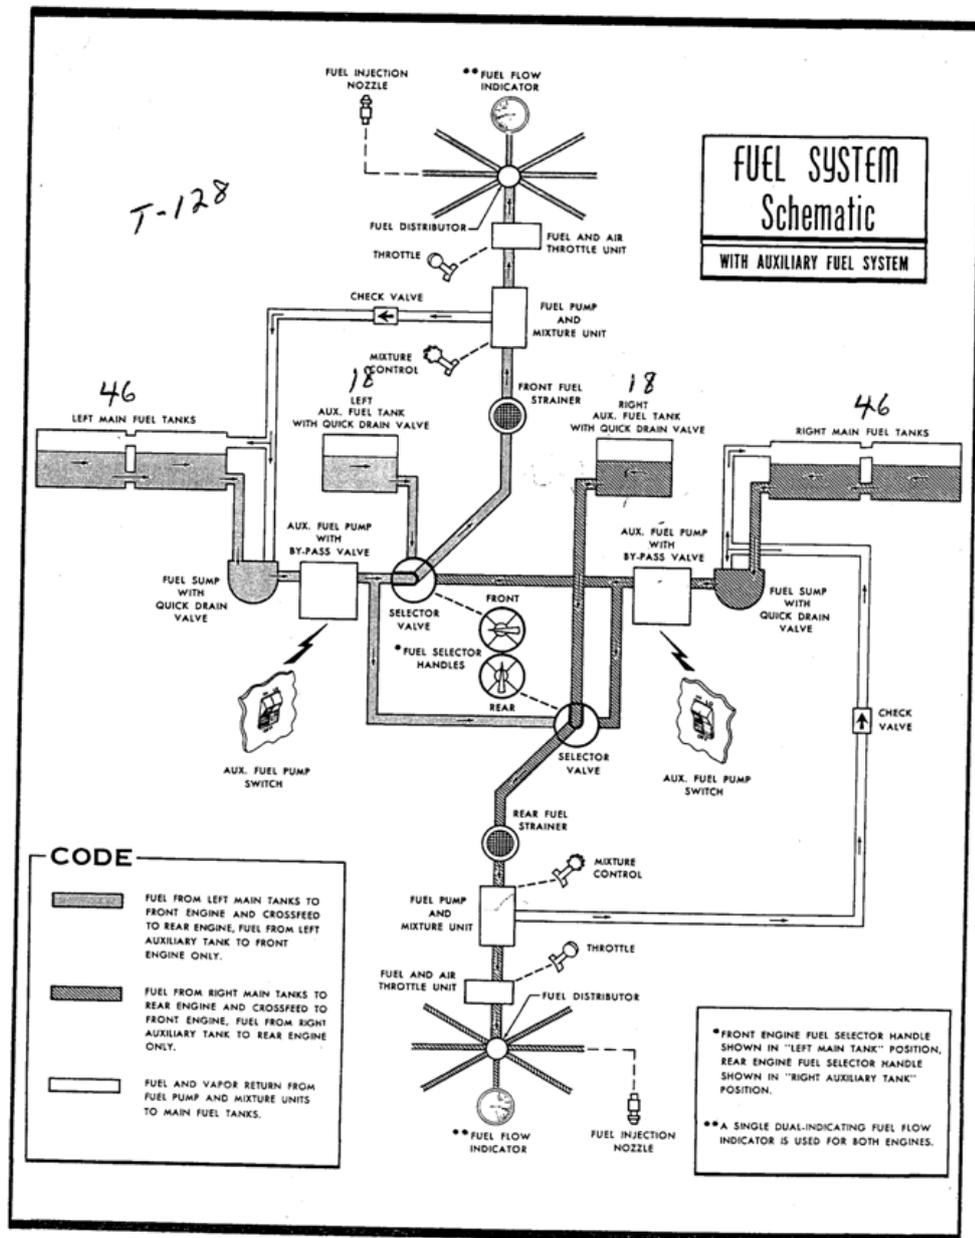
Fuel system on Cessna 337

According to the fuel system schematic (see figure 4), the front engine receives fuel from left AUX tank as well as right or left MAIN tanks. During the investigation, it was not possible to determine which MAIN tanks were selected during the flight. After refueling the aircraft, both engines worked normally.
