REPORT ON AIR TRAFFIC INCIDENT

M-04906/AIG-26

**Loss of separation between TF-AIR/FUA701W
Socata Tobago TB-10/Boeing 737
During approach to Keflavik Airport runway 20
17 August 2006**

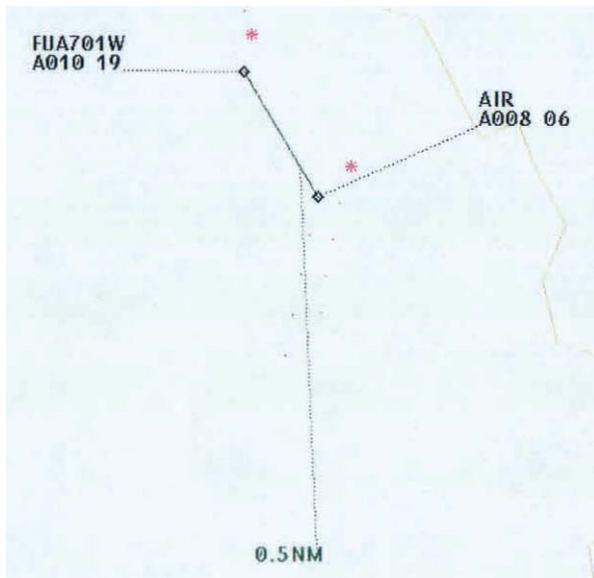
After the incident the tower controller radioed to aircraft A that they had not followed his instructions. According to radar data (see figures 1-3) the minimum horizontal separation was 0.3 Nm and the minimum vertical separation was 200 feet.

Figure 1: Separation 0.5 Nm, 200 feet

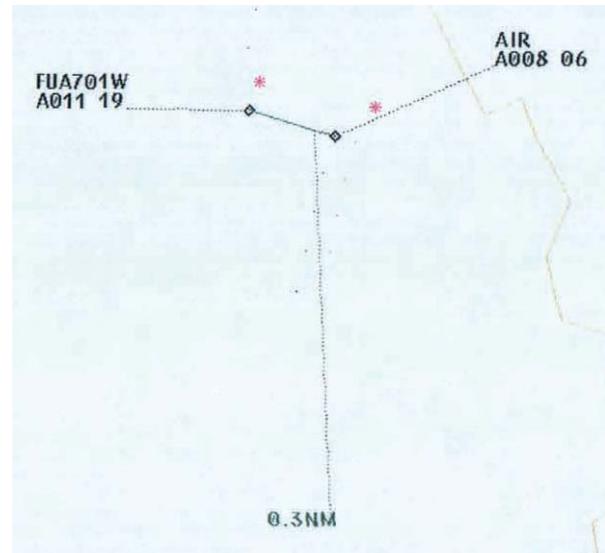
Figure 2: Separation 0.3 Nm, 300 feet

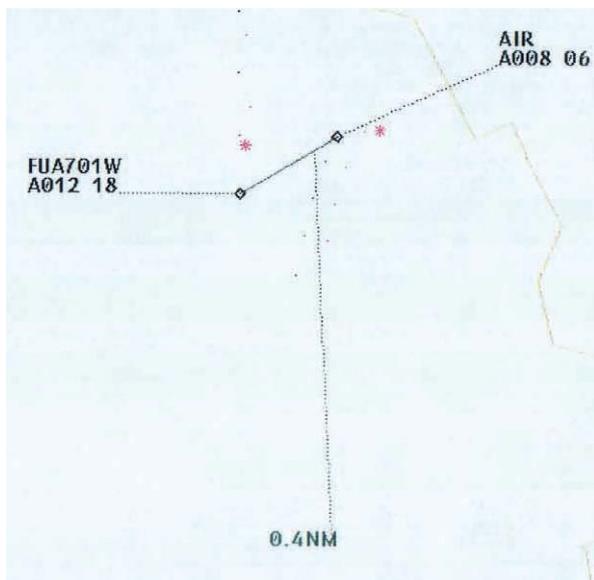
Figure 3: Separation 0.4 Nm 400 feet
