AIRCRAFT INCIDENT REPORT

**Report by the Swedish Accident Investigation Board into
the incident between aircraft LN-RON and TF-FIP in the
airspace above Stockholm/ Arlanda airport, AB County,
Sweden on 25 January 2002**

Report RL 2003:01e

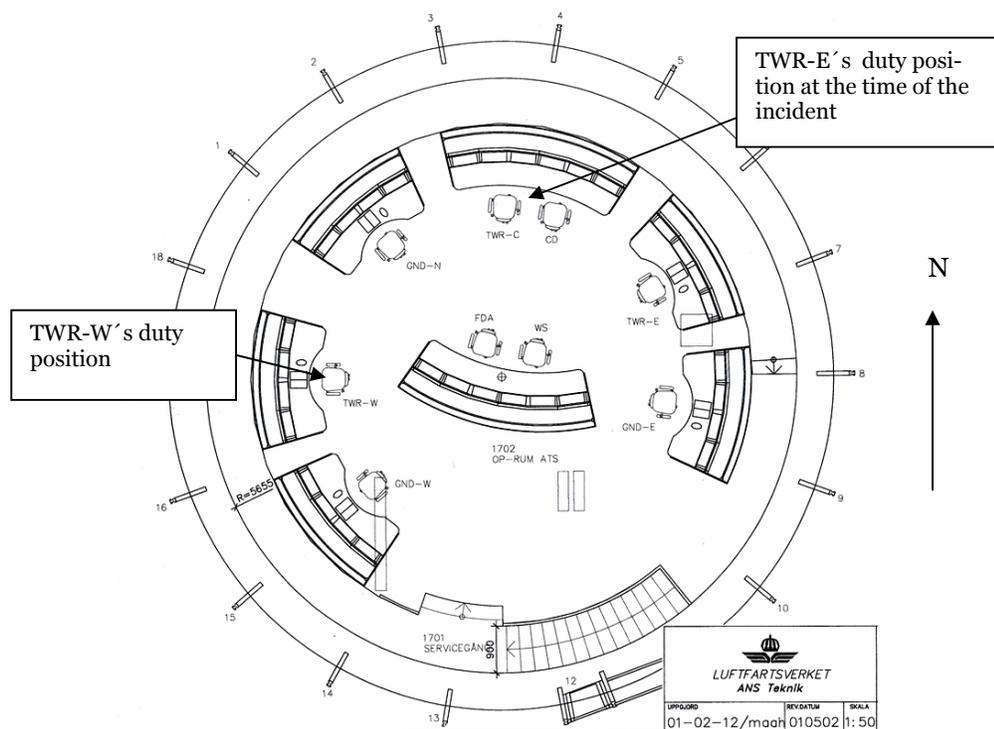
The duty position chairs in the tower are adjustable in height. At the time of the incident the controller at position TWR-W was standing in order to observe landing aircraft on runway 26. The tower controller in position TWR-E was seated at his position and from there he was not able to see departing traffic from runway 01L, which however is not a requirement.

Image: Depicts duty position placement when runway three is in use. At the time of the actual occurrence TWR-E was working from TWR-C's duty position, see arrow. (Source: LFV 2002-1843-002)

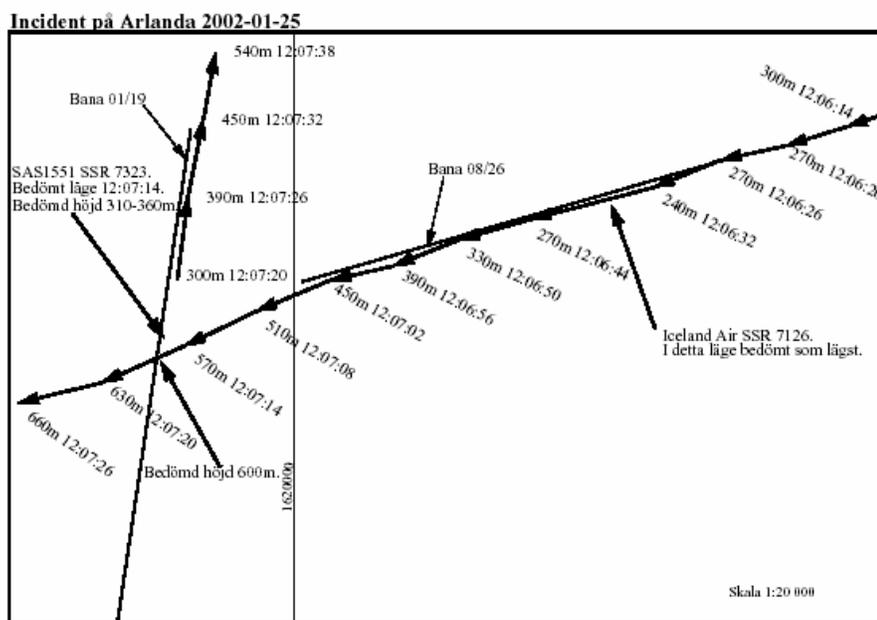
The route of flight of both aircraft has been registered by MUST and presented according to the diagrams below. From the registration, it has been calculated that the minimum distance between the aircraft horizontally was 75-100 meters and vertically about 300 meters. This took place at time 12:07:14. (See below)

Note: ICE 306 had already passed overhead SAS 1551's departure path when SAS is seen for the first time on IOR (update nr 1).
