AIRCRAFT INCIDENT REPORT

**Report by the Danish Accident Investigation Board into the
incident to Boeing 757, TF-FIJ at Kastrup Airport, Denmark on 28
June 2001**

M-04001/AIG-09

HCL 40/01	Accident	
Aircraft type:	Boeing 757-208	Aircraft registration: TF-FIJ
Engines:	2 Rolls Royce RB211-535E4	Type of flight: Scheduled, IFR
Crew:	8 – no injuries	Passengers: 182 – no injuries
Place of occurrence:	Copenhagen Airport, Kastrup (EKCH)	Dato og tidspunkt: 28.06.2001 at 2001 hrs UTC

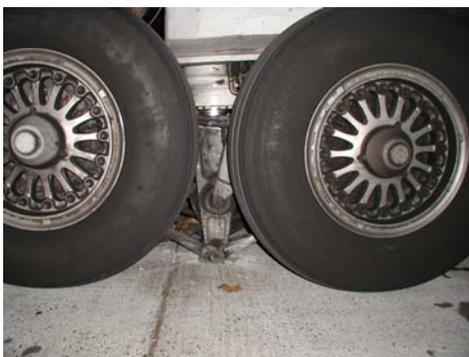
The boarding of the aircraft was almost completed when the right hand main landing gear's truck beam failed. As the right hand truck beam failed, the aircraft's right side rested on the shock strut instead of on the wheels. The photo below shows the failed truck beam and the aircraft resting on the shock strut.

The failure of the truck beam is considered as being substantially damage to the aircraft.

The pavement was damaged where the right hand main gear's shock strut had been in contact with the ground.

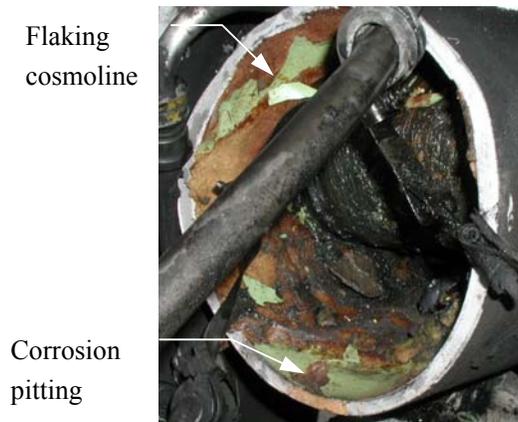
When disassembling the landing gear in order to get hold of the truck beam for further examination, it was noticed that the cosmoline (a corrosion inhibiting compound) was flaking off the inner diameter of the beam. At some areas, the primer was missing and the presence of corrosion pitting could be identified.

“ *The fracture in the truck beam was a fast fracture initiated by a 39 mm long crack located at the beam bottom.*

The pre-existing crack in the beam is caused by hydrogen induced stress corrosion, starting from the beam's inside. It is the corrosion processes inside the truck beam that give rise to a hydrogen generation and some of this hydrogen (atomic) will diffuse into the steel ”

“ *Metallurgical analyses have concluded that the fracture mode was due to Stress Corrosion Cracking (SCC). A thorough examination of the finishes on the ID showed that the Ti-Cad plating was thin or non-existent, primer adhesion on ID Surface was poor and that pivot bore rework did not receive the requisite shot peening, LHE (low hydrogen embrittlement) cadmium plating or primer prior to bushing installation. Chemical analyses did not produce any evidence to indicate that any foreign or external substances, solutions, or compounds had contributed to the deterioration of the protective finishes. Our investigation concluded that the subject truck beam fracture occurred due to improper overhaul. The truck beam did not appear to have been stripped of the original suspect Cad-Ti plating prior to refinishing per the Boeing CMM 32-11-56. Commonly, the enamel and primer layers are stripped using plastic media blasting (PMB) per SOPM 20-30-02 (Standard Overhaul Practices Manual). Removal of organic finishes by PMB damages chemical conversion coatings and can remove plating. Boeing CMM's & SOPM's provide instructions for overhaul and there was no option for retaining original Ti-Cad plating. The result, in this case, was inadequate-to-no cadmium protection and poor primer adhesion to the substrate. Subsequent loss of these finishes led to premature and severe corrosion in service, and eventual fracture. “*

During the investigation made by Boeing, they conducted an audit of the service provider of overhauls. At this audit, Boeing noted some findings about the overhaul procedures. These findings showed that overhaul of the truck beams were improper and did not follow the CMM. The improper overhaul resulted

in an inadequate corrosion protection of the inner diameter of the truck beams, which lead to the occurrence. The overhaul procedures were corrected after the audit.

By identifying this, Boeing issued a revision 2 of the SB 757-32A0135 dated 16 May 2002, which summarized the events with truck beams. The SB revision 2 provided for inspection of previously overhauled gears, so it was established from the records that truck beams had been correctly overhauled.
