Final report on aircraft serious incident

Case number: M-01514/AIG-12

Date: **4. July 2014**

Description: GBYLP (Rand KR-2), Temporary loss of control/ Disorientation in clouds

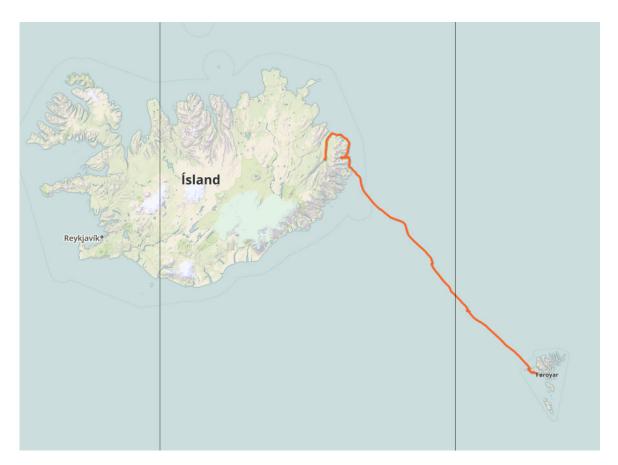
Figure 1: The Aircraft's GPS track from the Faroe Islands to Iceland

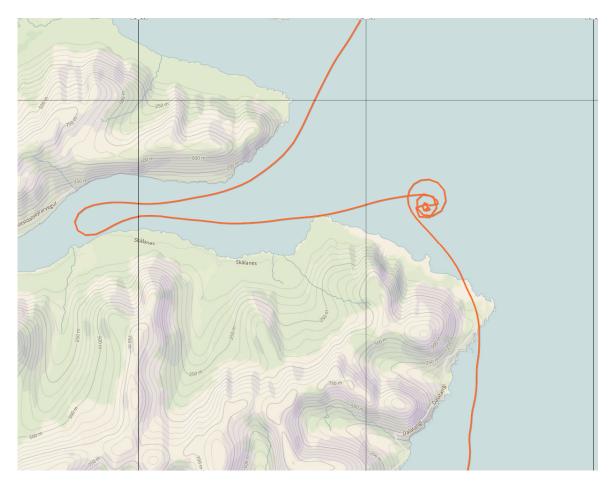
At 16:47, the AFIS at Egilsstadir airport received a MAYDAY call with no further information. According to the pilot statement, he declared an emergency when he was unsure of the aircraft's attitude. Following the MAYDAY call, he then placed the controls so the aircraft should descend in a spiral flight. He descended in a spiral (see figure 2) until he got below the cloud base at 200 feet.

When below clouds, the pilot levelled out of the spiral and flew below the clouds, heading north, until he managed to fly visually to Egilsstadir airport. He landed uneventfully at Egilsstadir airport at 17:25.

Figure 2: GBS track of the aircraft during spiral

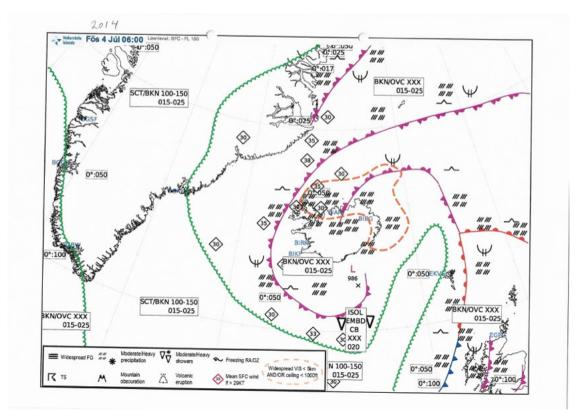
IMO produces, three times a day, a low level SIGWX chart (see picture above) from surface up to FL150. This is, as for others, to service ferry pilots. It is available on the IMO web, both on the English and Icelandic.
