Case nr.: **19-072F016**

Date: **27. May 2019**

Location: **During holding over Patterson, near Keflavik Airport**

Description: **Not able to restart left engine after inflight shutdown**

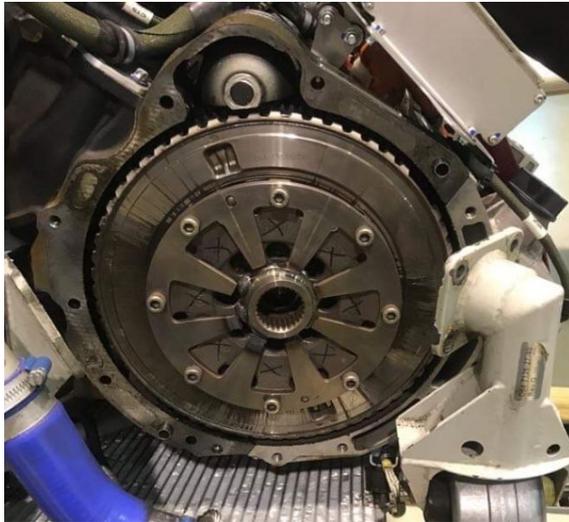
Subsequent maintenance action revealed that the two-mass flywheel on the left engine had fractured around the hub section. This was the second hub section fracture the flight school had endured on this kind of two-mass flywheel, but the other occurred on a Diamond DA-40 airplane in January 2019 during a ground running after maintenance.

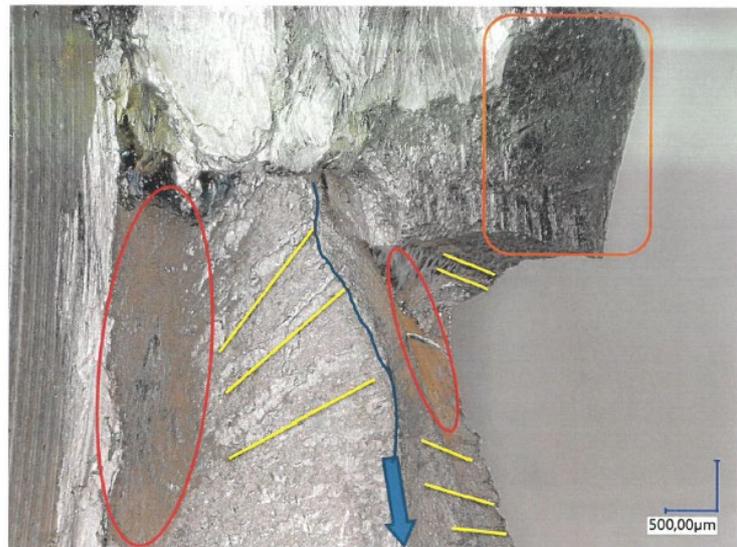
fig 1.2:4 schematic overview of the initial crack

Detailed inspection revealed that the two-mass flywheel failure mode occurred due to overstressing at the point of highest bending moment, resulting in hair cracks. Stress crack corrosion benefited the notch effect, which led to

- Orange shows zones fast fracture
- Red shows zones of crack corrosion
- Yellow shows rest lines
- Blue shows the direction of force
- After narrowing the cross section through corrosion, characteristic rest lines of fatigue failure show the advance of the damage until the critical cross section was reached and the fast crack appeared.

further expand of the cracks.⁴ The crack damage grew until a critical cross section was reached, resulting in failure of the two-mass flywheel.

- Changed the design of the hub area of the two-mass flywheel
- Set up a program for the replacement of the wheel with the new hub for new engines, spare parts and during engine overhaul
- Wind milling as a restart method has been moved from the normal operation instructions to “emergency procedures” in the engine operation manual

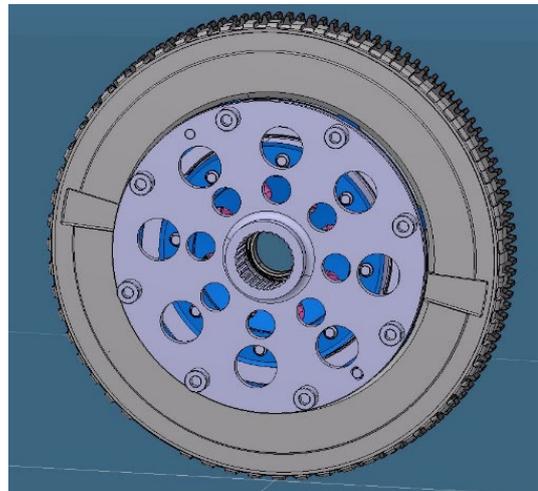
The investigation revealed that the engine manufacturer had issued an upgrade to the two-mass flywheel. This upgrade was initially intended to a correct failure mode⁵ that had occurred to the engine's timing chain, the spring load system between the two wheel parts of the two-mass flywheel. During the upgrade, simultaneous work by the manufacturer, after an incident where cracking in a hub area on another airplane had also been located, had indicated a weak region around the hub area. The manufacturer had therefore performed the following actions proactively:
