### Final report on aircraft serious incident

Case no.: **18-104F018**

Date: **16. June 2018**

Description: **Foreign Object Damage**

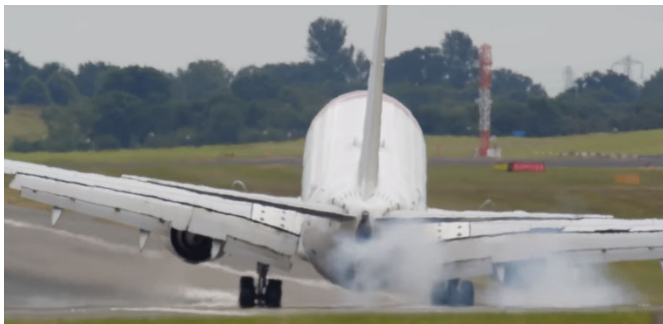
before it also came down on the LH MLG followed by the NLG. During the landing, the left wing ground spoilers did not deploy. In addition tire debris was released from the LH MLG after it touched down on the runway.

**Figure 2: The landing (RH MLG) at Birmingham Airport**

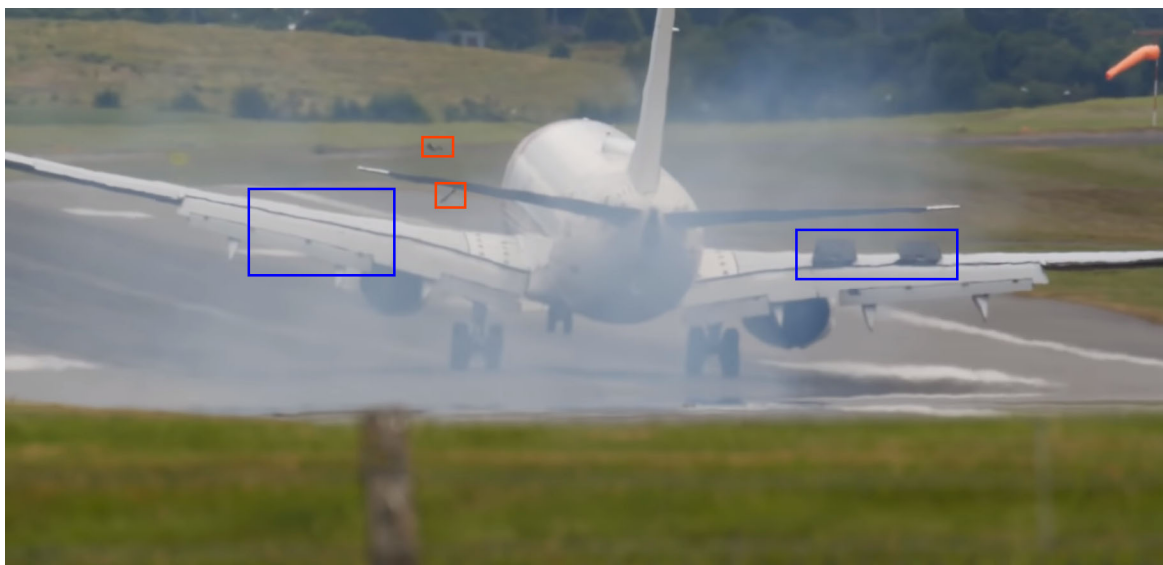
**Figure 3: Spoilers on Left wing did not deploy (blue) and tire debris flying (red)**

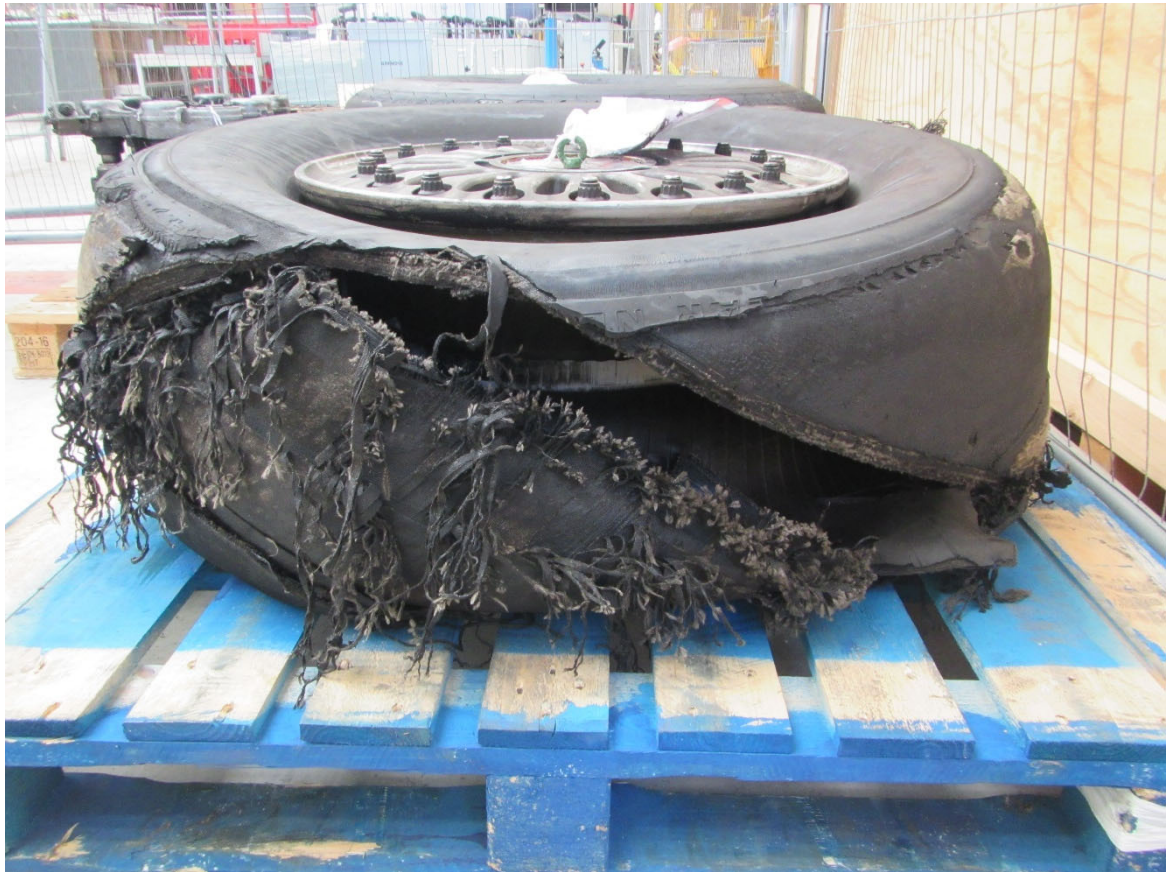
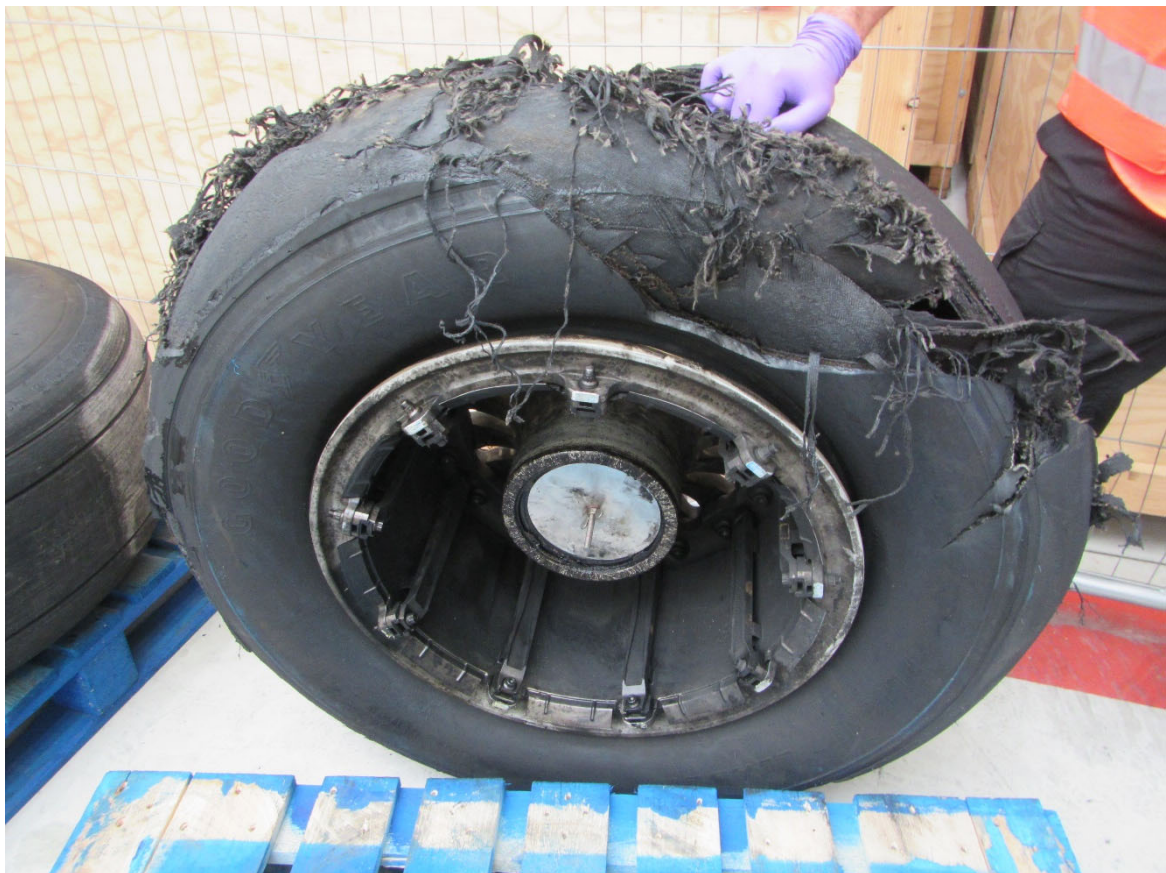
- LH inboard main wheel tire burst
- Four (4) broken spoiler cables
- Downlock sensor system wire cut
- Air-ground sensor system wire cut
- Fuel temperature system wire cut
- Two (2) landing retract/extract hydraulic line broken
- Four (4) tubes to heat exchanger broken
- Three (3) tubes for brake/shimmy damper broken
- One (1) tube for engine driven pump pressure supply dented
- One (1) tube from shut off valve broken
- Flow regulator valve missing from LH wheel well for hydraulic system A
- Aileron pulley broken in wheel well
- Three (3) spoiler pulleys broken
- Fixed trailing edge panel punctured
- Support brackets for hydraulic pipes including fairleads damaged
- Dents on both main and aft inboard flaps
- Dent on LH horizontal stabilizer

**Figure 4: The inboard wheel assembly from the LH MLG**

According to a tire care and maintenance document<sup>14</sup> from the tire manufacturer, the damage to the tire in Figure 4, most closely resembles two kinds of damage:

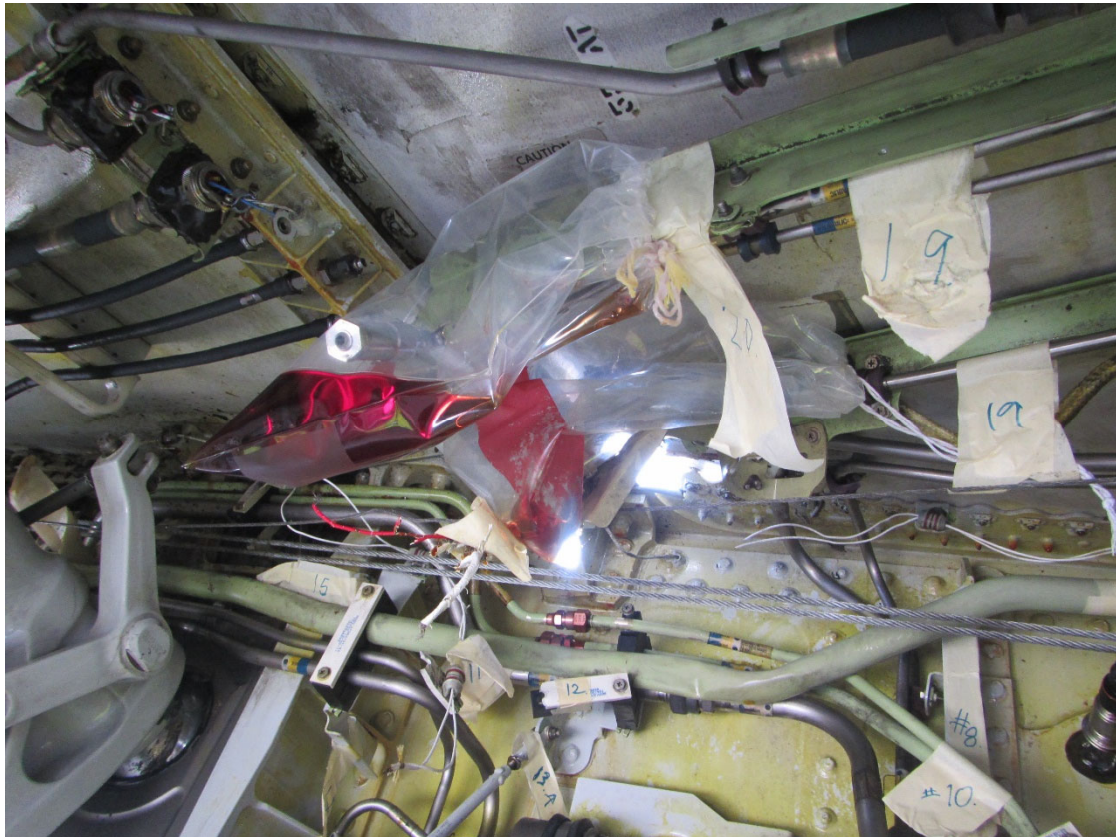
**Figure 5: Damage in the left wheel well**

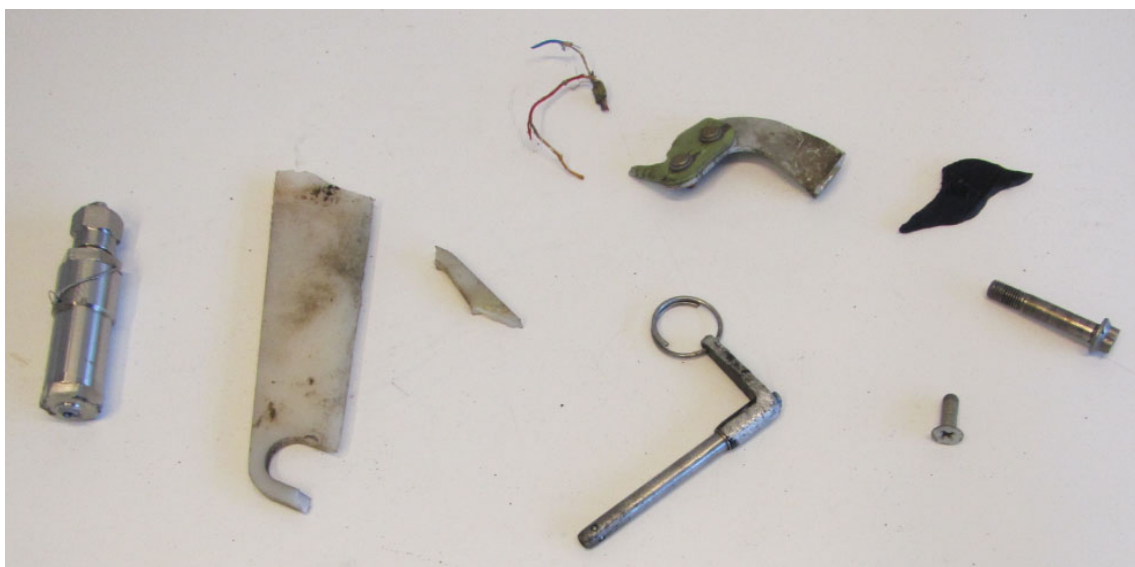
Subsequent to the serious incident both RWY 01 at Keflavik Airport and RWY 15 at Birmingham Airport were inspected and all debris found on or around the runways removed. The ITSB received the located debris from Keflavik Airport along with information about where it was located.

**Figure 6: Objects located at or next to RWY 01 at Keflavik Airport after the serious incident**

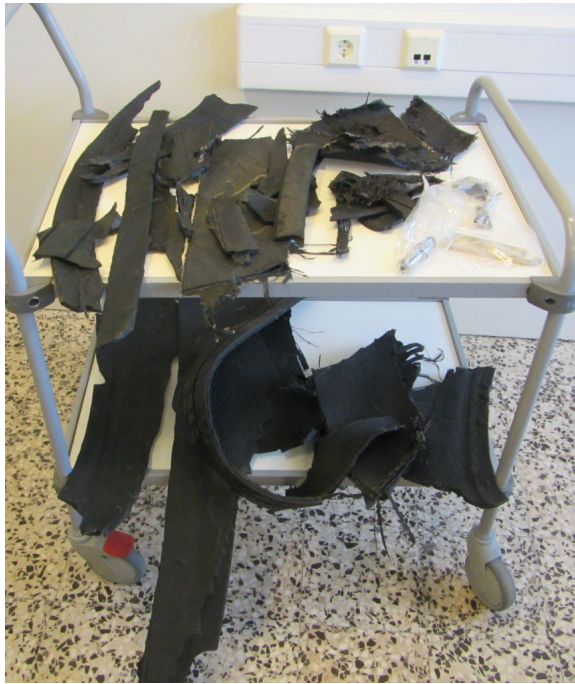
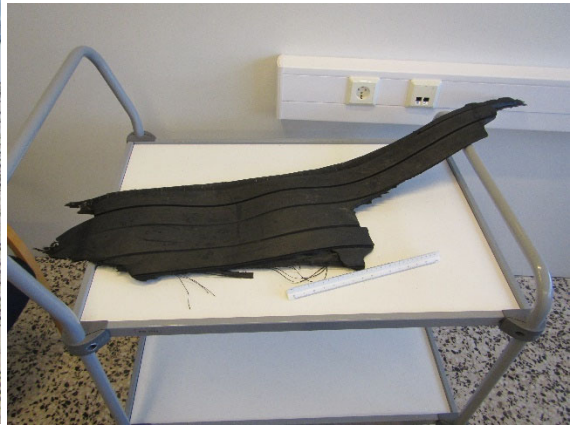
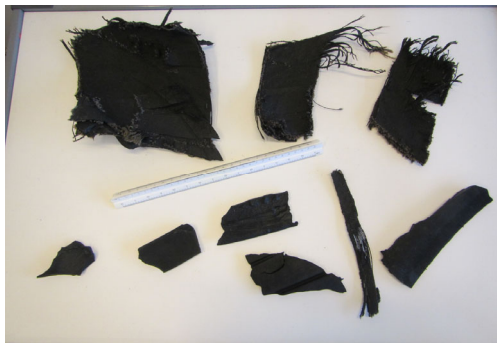
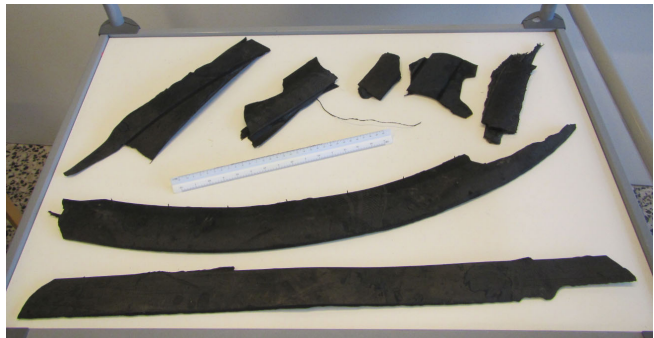
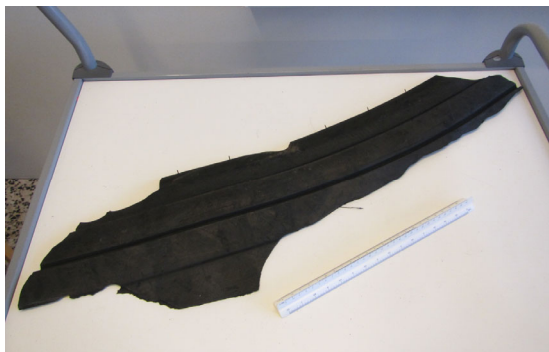
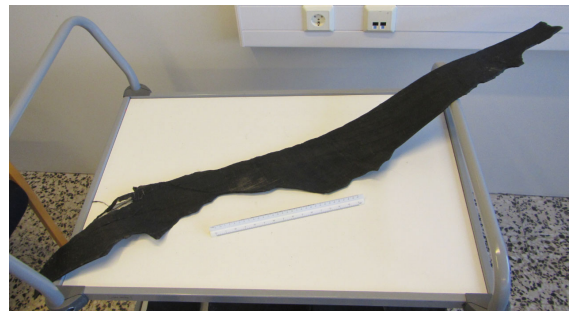
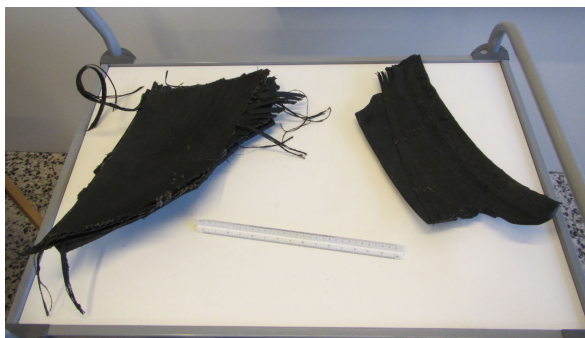
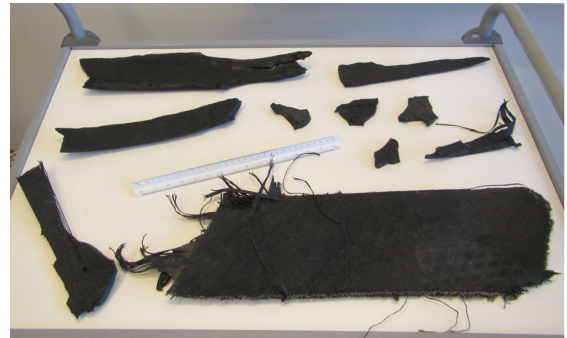
**Figure 7: Tire rubber debris found at Keflavik Airport after the takeoff**

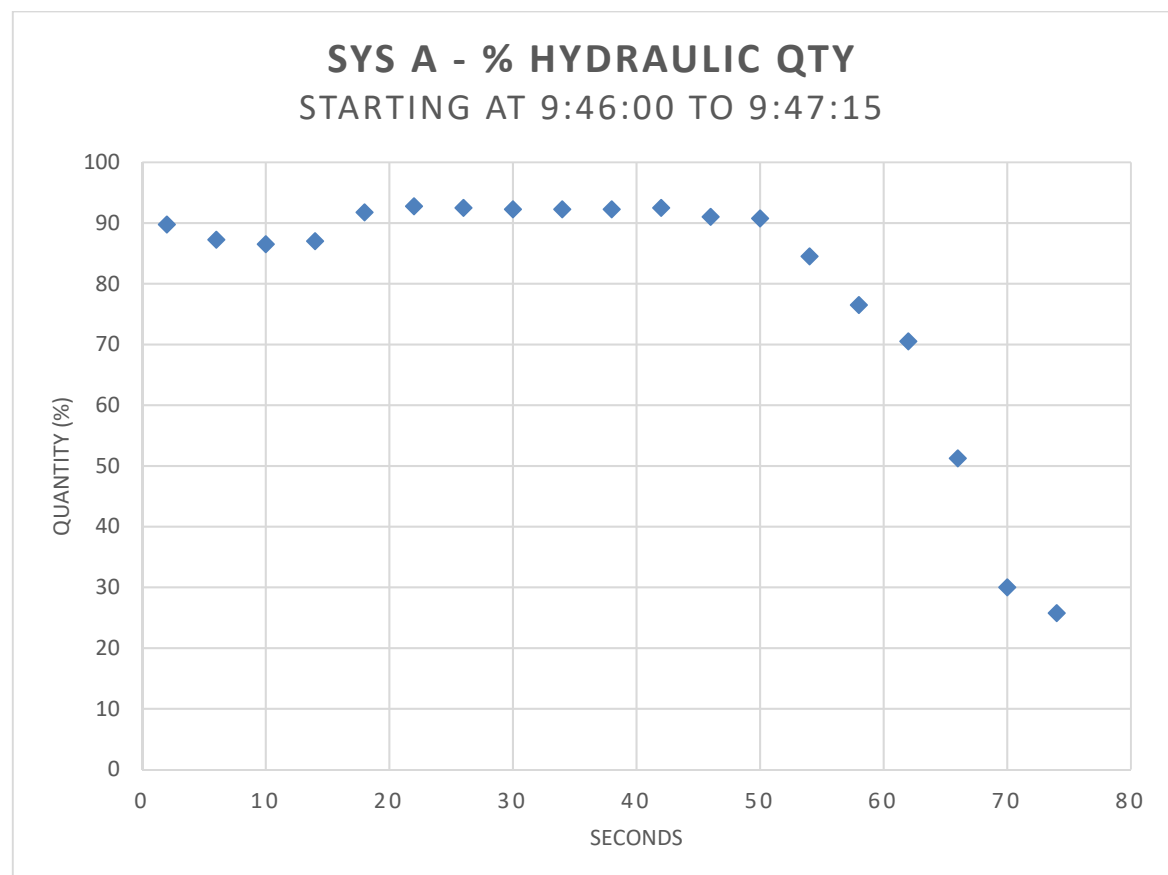
The analysis of the flight recorders confirmed that hydraulic system A started to loose hydraulic quantity at 9:46:50.

**Figure 8: Hydraulic system A leakage started at 9:46:50**

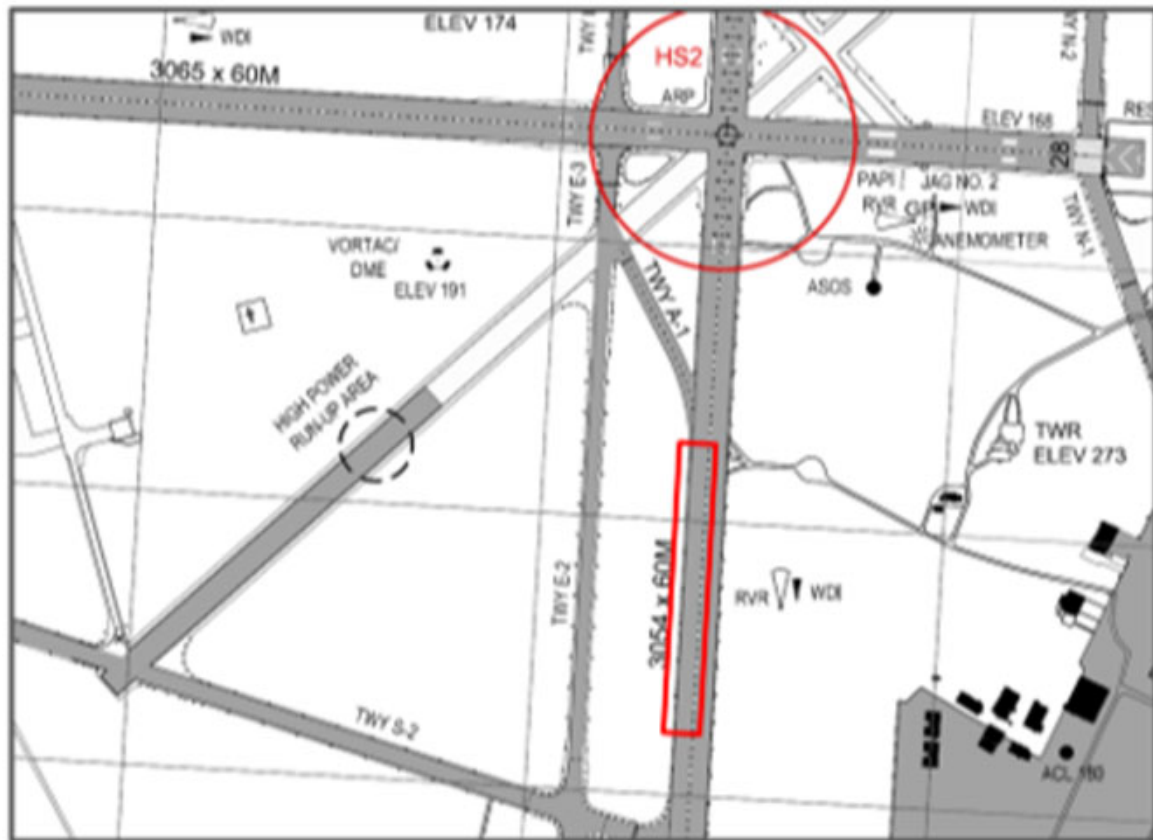
The crew of aircraft EI-FHD reported abnormal vibration during the aircraft's takeoff run at RWY 01 at BIKF airport. In addition, inspection of RWY 01 and its surrounding area revealed debris on the left side of RWY 01 between taxiway S-2 and high speed RWY taxiway A-1.

**Figure 10: Debris located at left side of RWY 01 as shown in the red rectangular box**

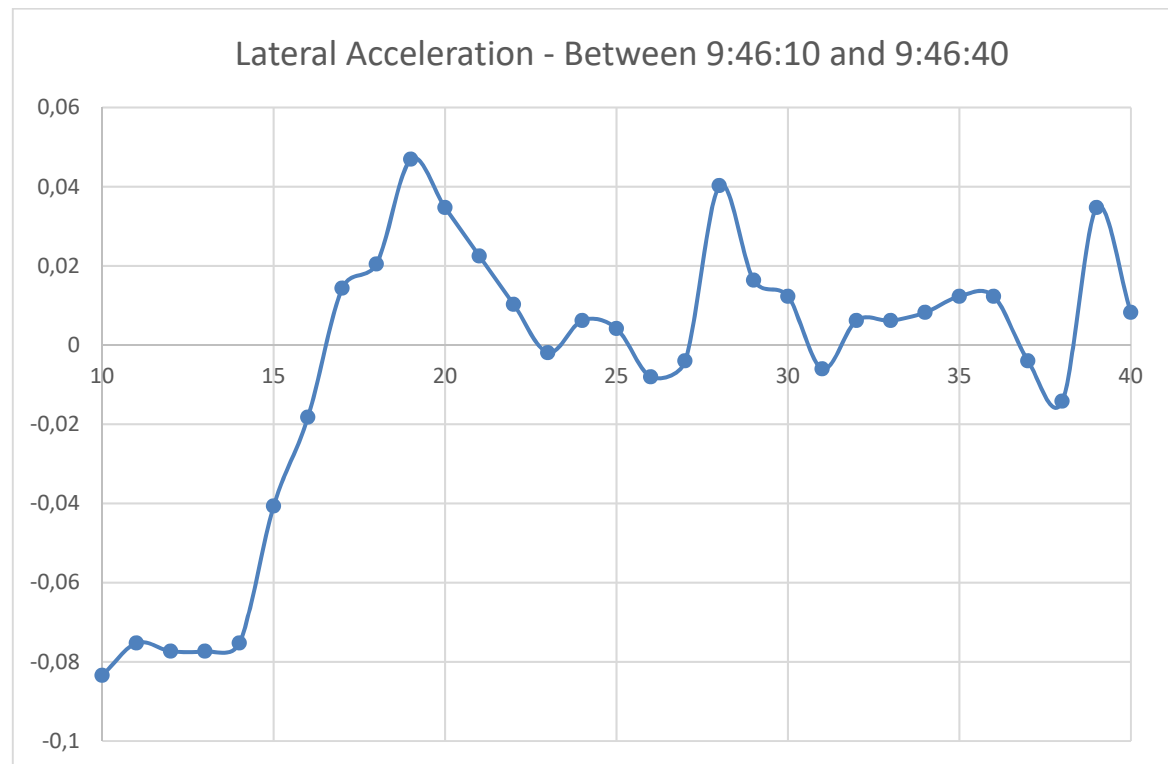
As the ITSB was interested in any unusual movement during the takeoff run the lateral acceleration of the aircraft was graphed over the takeoff run. Lateral acceleration peaks were noted as can be seen on the graph in Figure 12.

**Figure 12: The lateral acceleration of the aircraft during the takeoff run**

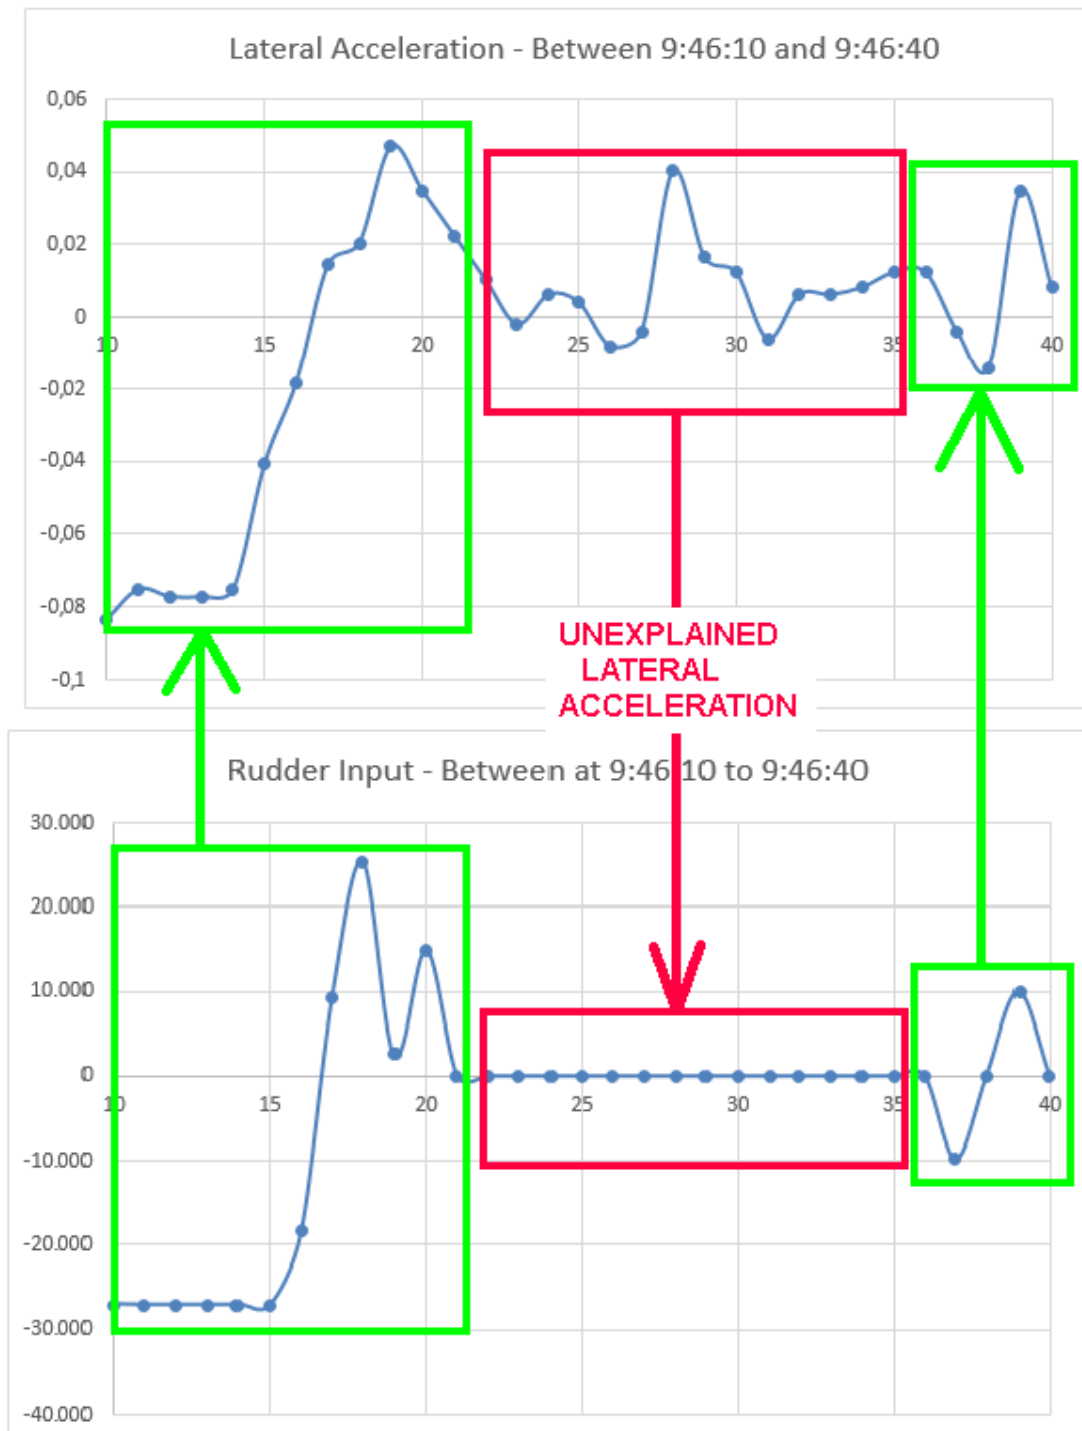
The rudder input explained some of the lateral acceleration (seen in green in Figure 14). It could however not explain the lateral acceleration in the area where the debris was located between taxiway S-2 and high speed RWY taxiway A-1 (seen in red in Figure 14).

**Figure 14: Unexplained lateral acceleration as the aircraft passed the area of the debris**

The ITSB believes that a tire rupture by debris on the runway may have caused the lateral acceleration in the red box in Figure 14.

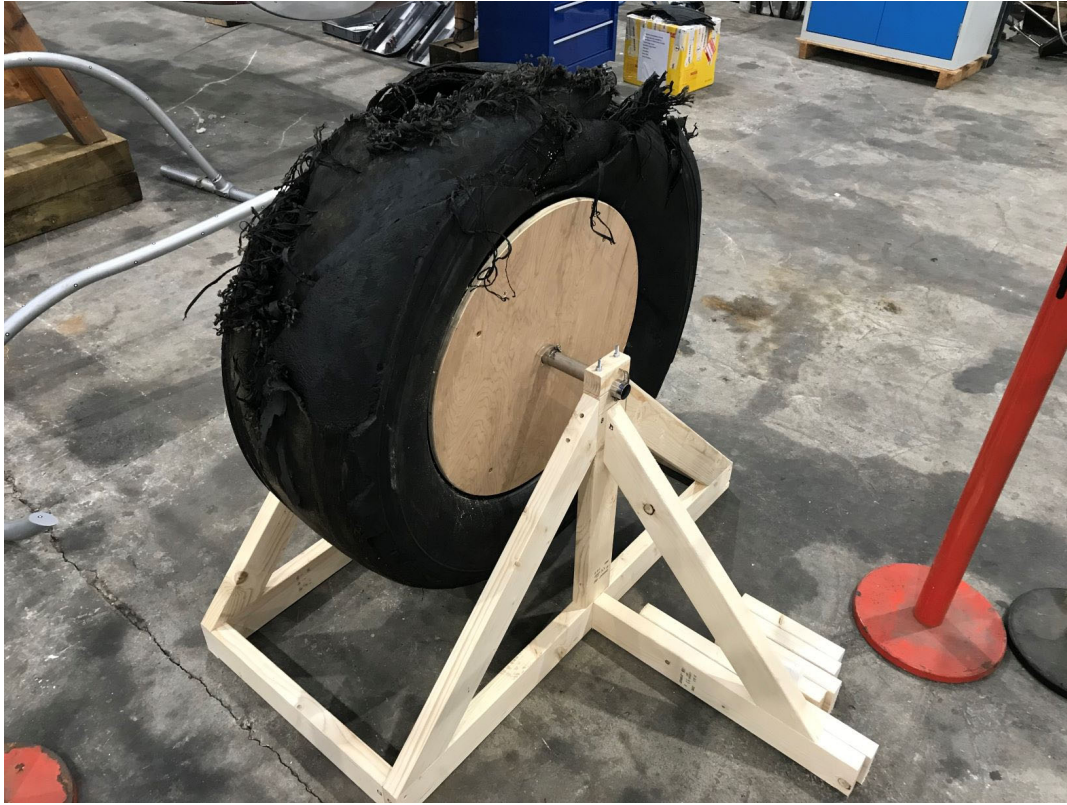
The damaged tire (LH inboard) was assessed by the ITSB and the UK AAIB and compared with information from the tire manufacturer.

**Figure 15: Tire and tire debris reassembled in a jig**

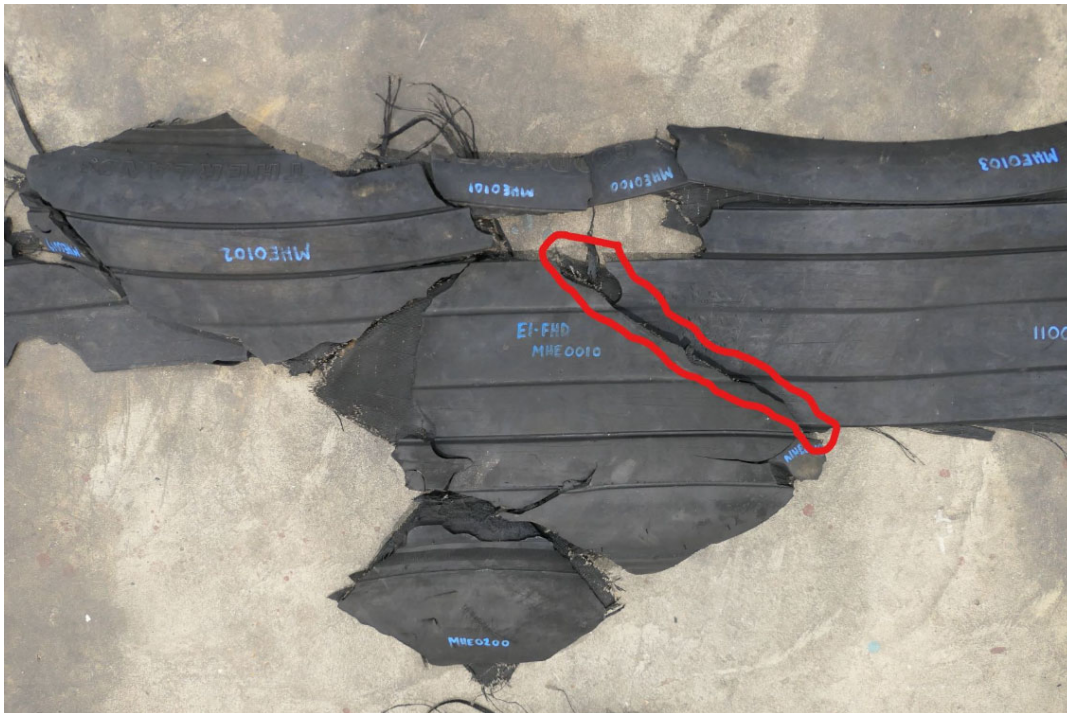
**Figure 16: Probable initial failure – Recovered from landing gear wheel well**

Investigation of the tire debris revealed the probable initial failure to have occurred by Foreign Object Damage (FOD).

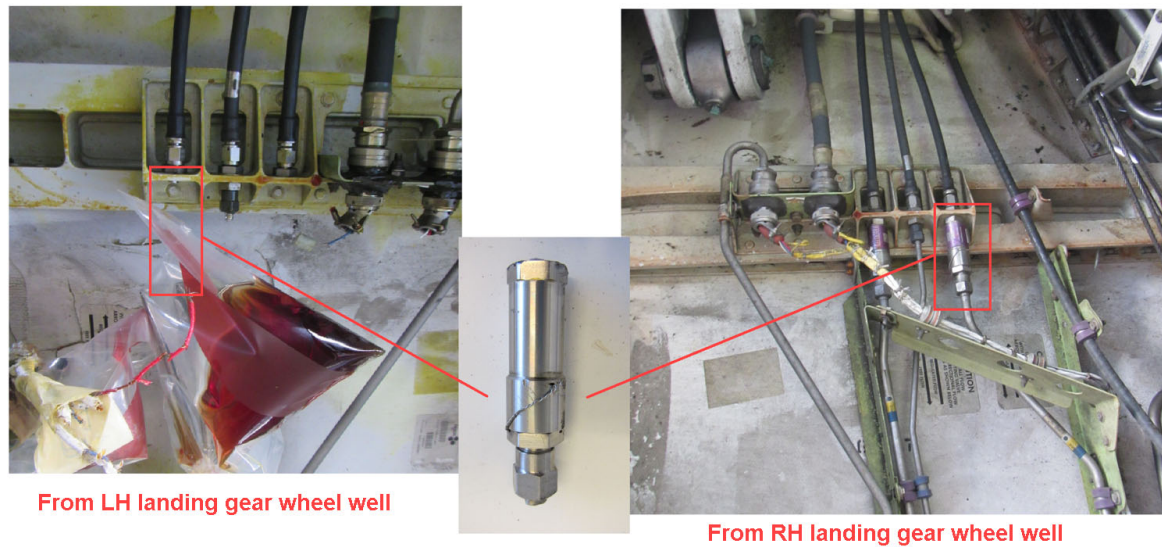
- 9 cm long metal cylinder
  - The ITSB believes that this is the missing flow regulator valve from LH landing gear wheel well for hydraulic system A
  - The ITSB believes that this is secondary damage due to the ruptured tire

**Figure 17: Regulator valve for hydraulic system A missing in LH landing gear wheel well**

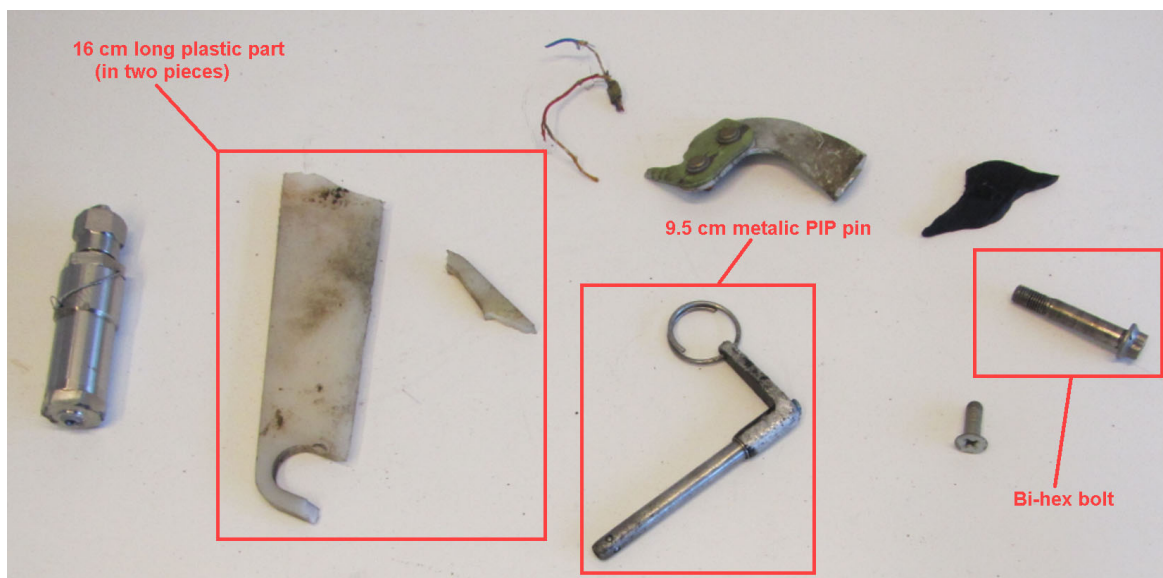
- 16 cm long plastic part (in two pieces)
  - The ITSB could not identify this plastic part
- 9.5 cm long metallic PIP pin
  - The ITSB could not identify this PIP pin as part of the aircraft
- Bi-hex bolt
  - The ITSB could not identify this bi-hex bolt as being missing from the aircraft

**Figure 18: Unidentified objects shown in red boxes**

Review regularly the FOD program and procedures associated, to ensure that runways are as far as possible clear of debris.
