Final report on aircraft serious incident

Case no.: **17-042F012**

Date: **28. April 2017**

Description: **Runway excursion during landing**

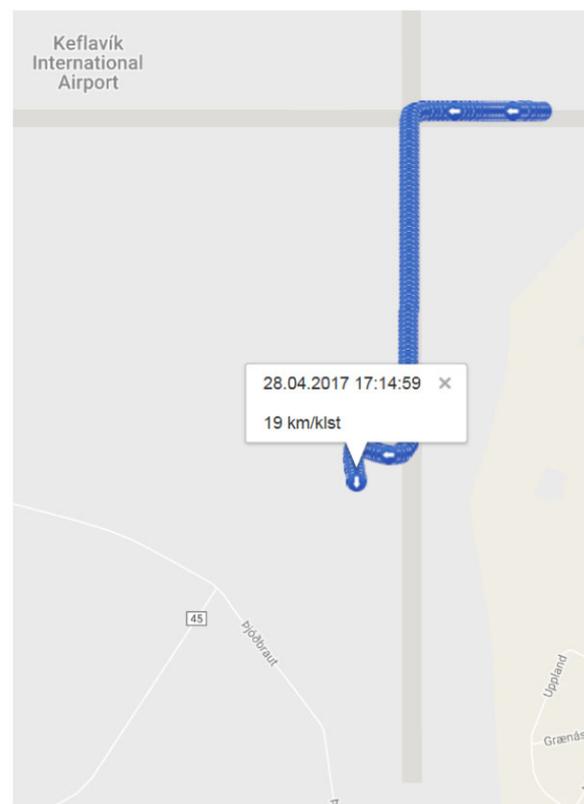
Figure 10: Partial clean of RWY 19 to taxi S-2

The five snowplows therefore only managed to clean a combined width of 25 meters around the centerline of RWY 19 after the first landing attempt, before vacating RWY 19 at taxiway S-2 at 17:14.

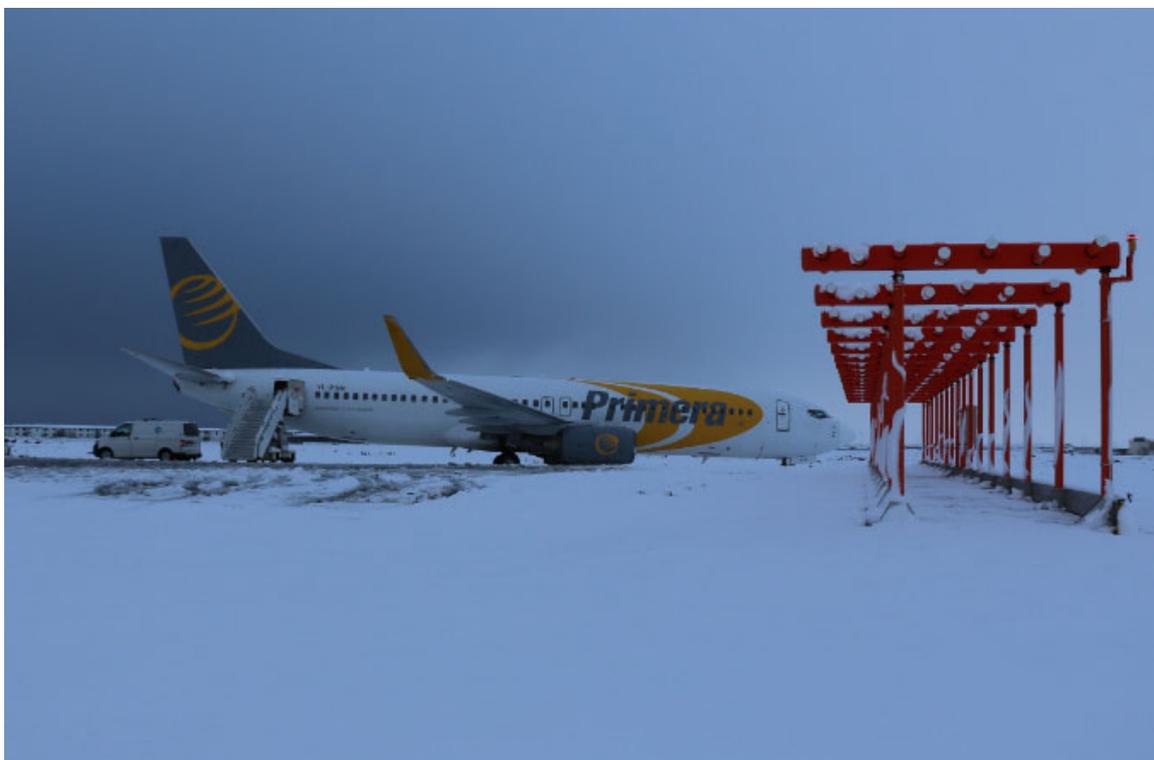
Figure 15: The aircraft stopped next to the localizer structure for RWY 01

According to the PF, he realized about 300 meters before the end of the runway that they would not be able to stop on the RWY. The aircraft passed the runway end lights, at a Computed Air Speed of 48 knots according to the FDR.

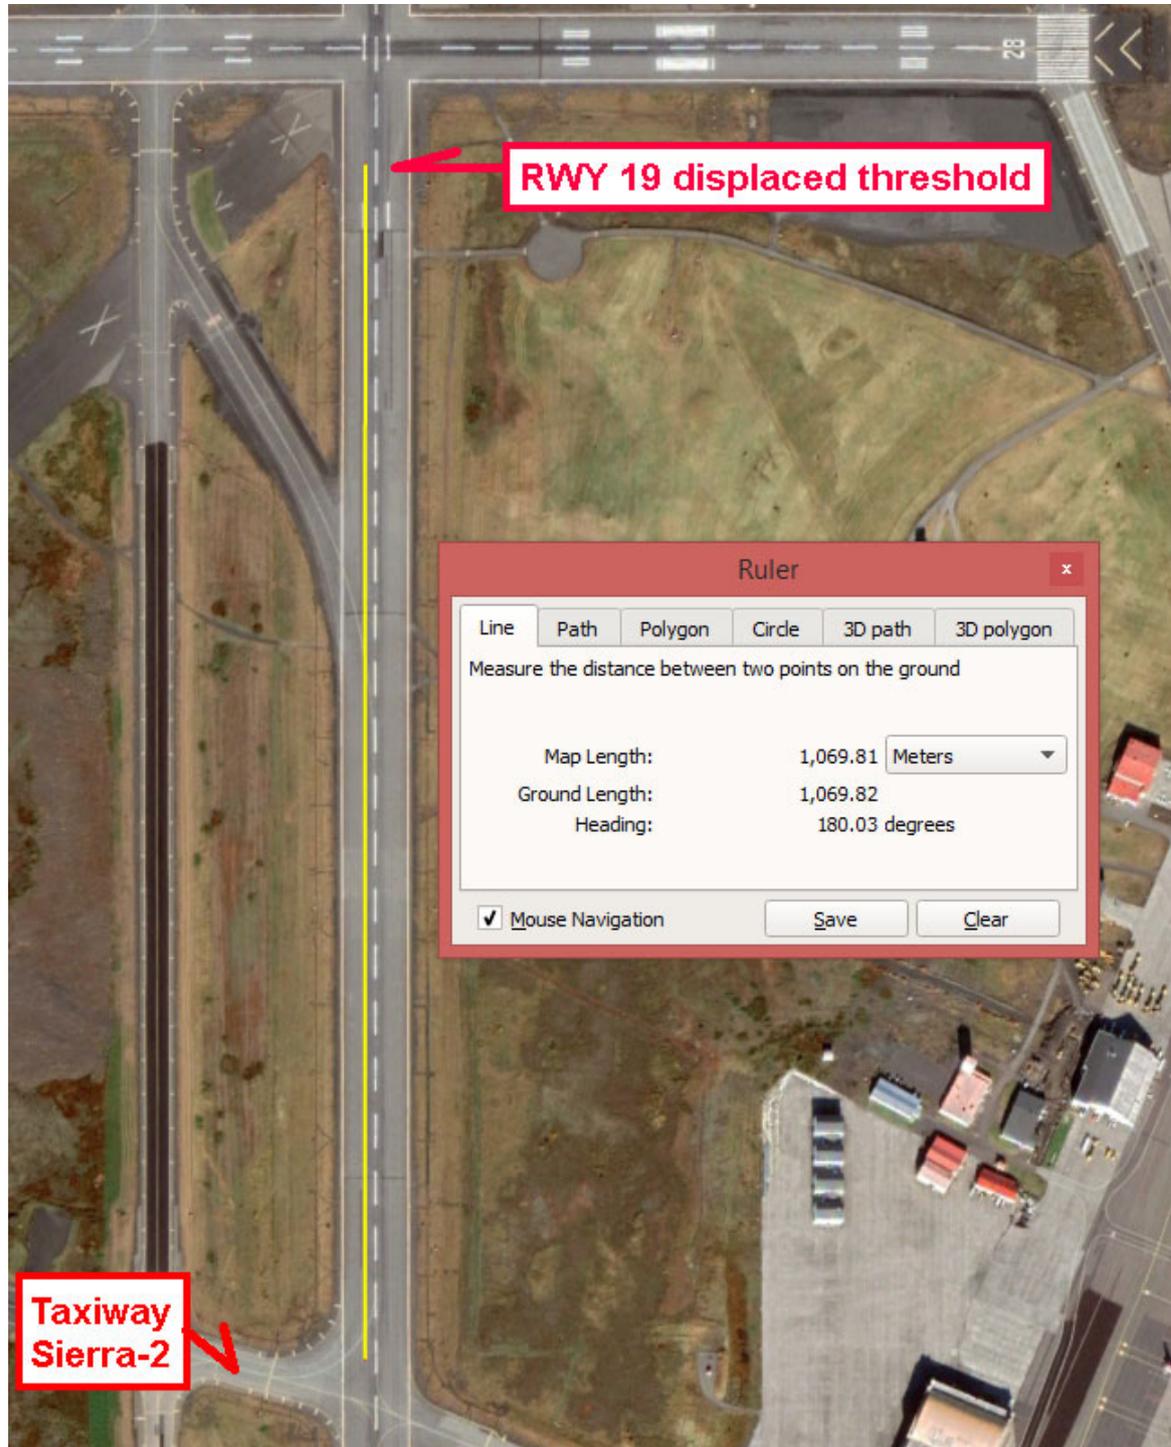
Figure 22: Partial runway clearing between threshold and Sierra-2 (Google Earth)

After the first landing attempt, the five snowplows only managed to clear 25 meter width around the centerline of about 1070 meter length of the runway 19 from the runway threshold to taxiway Sierra-2, before vacating the runway at taxiway S-2 at 17:14.

The aircraft had passed the Sierra-2 exit at 17:22:15, when the Max Manual brakes were engaged, and there the aircraft was in the runway area that had not been cleared of snow since prior to the first landing attempt of the aircraft.

The ITSB recommends that Isavia considers implementing a formal procedure between snow removal supervisors and the ATCOs.

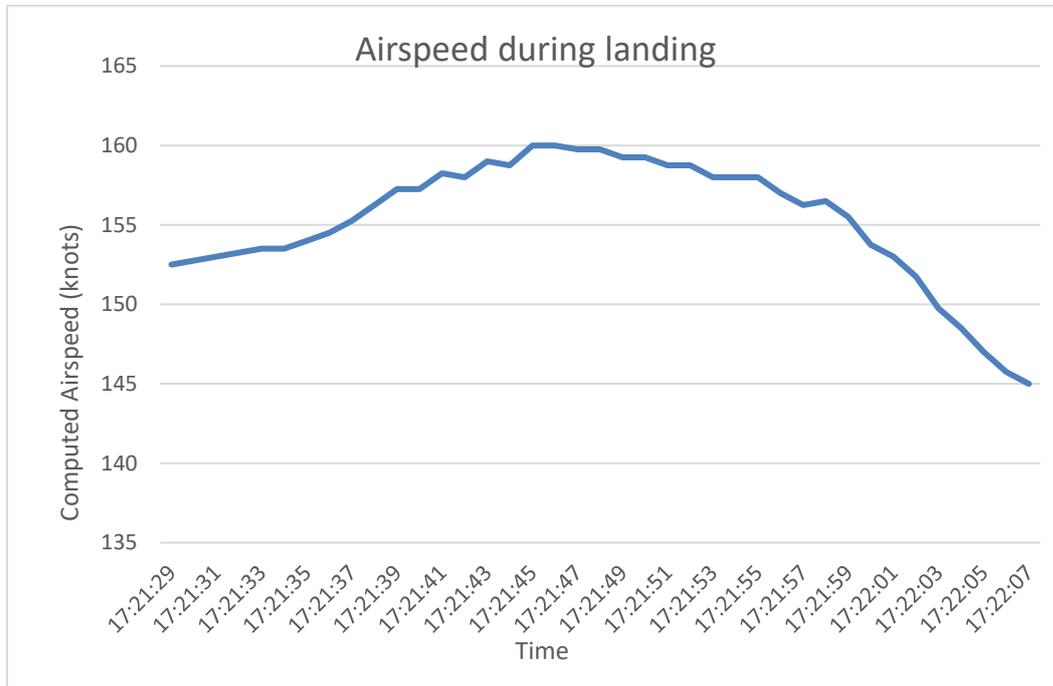
Figure 24: Flight 6F108 - Airspeed during the landing

was within +/- 10 knots for the selected landing speed of 152 knots, as can be seen in Figure 24.

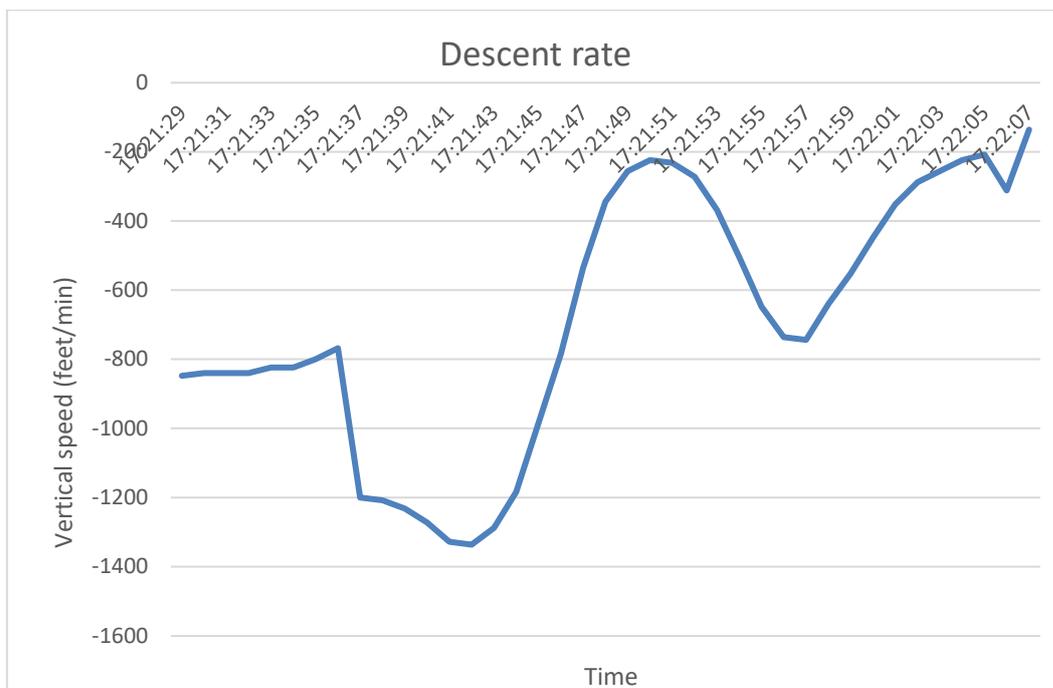
Figure 25: Flight 6F108 – Vertical speed during the landing

The descent rate fluctuated during the landing, explaining both the SINK RATE at 17:21:43 and the float in the last few seconds prior to landing, as can be seen in Figure 25.

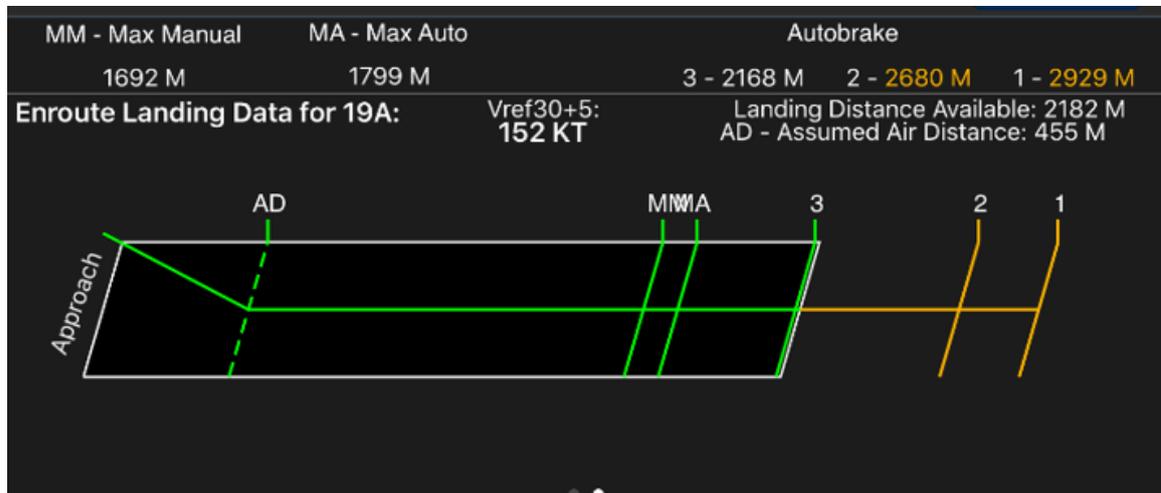
Figure 26: Landing distances required¹⁸ according to the performance calculations

According to the landing performance calculations, the landing distance using Max Manual braking was 1692 meters, 1799 meters for Max Auto braking and 2168 for Autobrake 3. These calculations were based on uncontaminated runway.

According to the flight crew, as the required runway length for autobrake 3 (2168 meters) was very close to the published Landing Distance Available (2182 meters), the PF then intended to change over to Max Manual braking during the landing. This would reduce the required landing distance to a value in between the Max Manual braking (1692 meters) and Autobrake 3 (2168 meters).

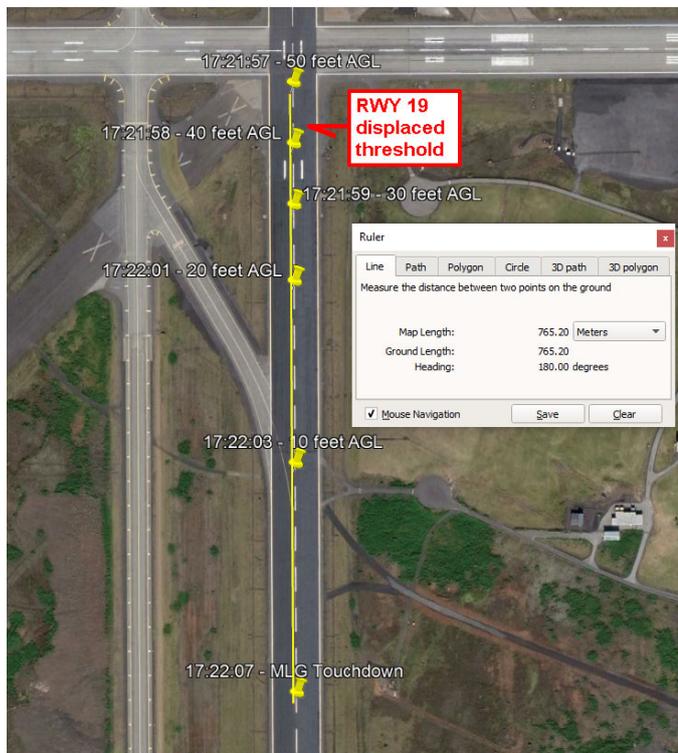
Figure 27: Actual Air Distance (50 ft to touchdown)

The FDR data revealed that the aircraft was down to 50 feet AGL just after having crossed RWY 10/28, about 50 meters prior to reaching the displaced threshold.

The investigation also revealed that the Actual Air Distance travelled, between 50 feet AGL and Main Landing Gear touchdown, was 765 meters.

The Assumed Air Distance (AD) from 50 feet AGL (above threshold) and until touchdown was 455 meters according to the landing performance calculations (see Figure 7 and Figure 26), or 310 meters¹⁹ less than the Actual Air Distance.

It was snowing extensively during the landing of flight 6F108. The ITSB therefore suspects that the depth perception of the PF was most likely degraded due to illusion during the landing, which may have contributed to the extended float.

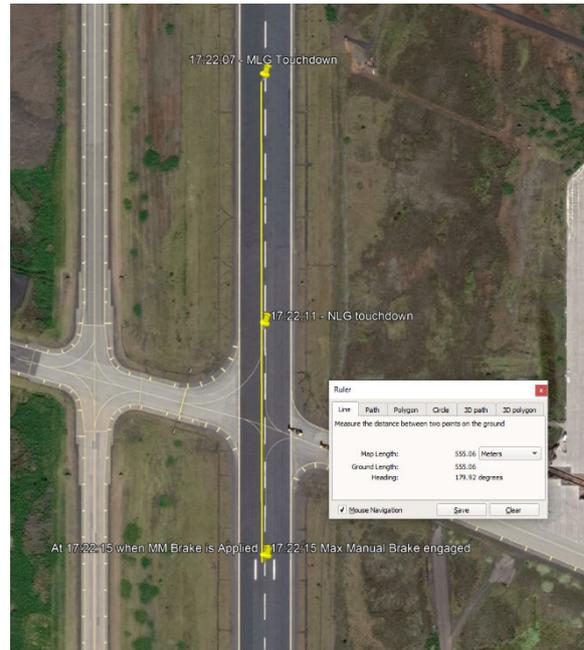
Figure 28: 555 meters from touchdown to MM

The aircraft exited the end of the runway at 17:22:37.
