# AIRCRAFT ACCIDENT REPORT

Private aircraft  
N904WA. Type: Pilatus Britten-Norman BN2A-21,  
Near Innri Njardvik, Iceland.  
17 March 1996

## **Aircraft Accident Investigation Board**

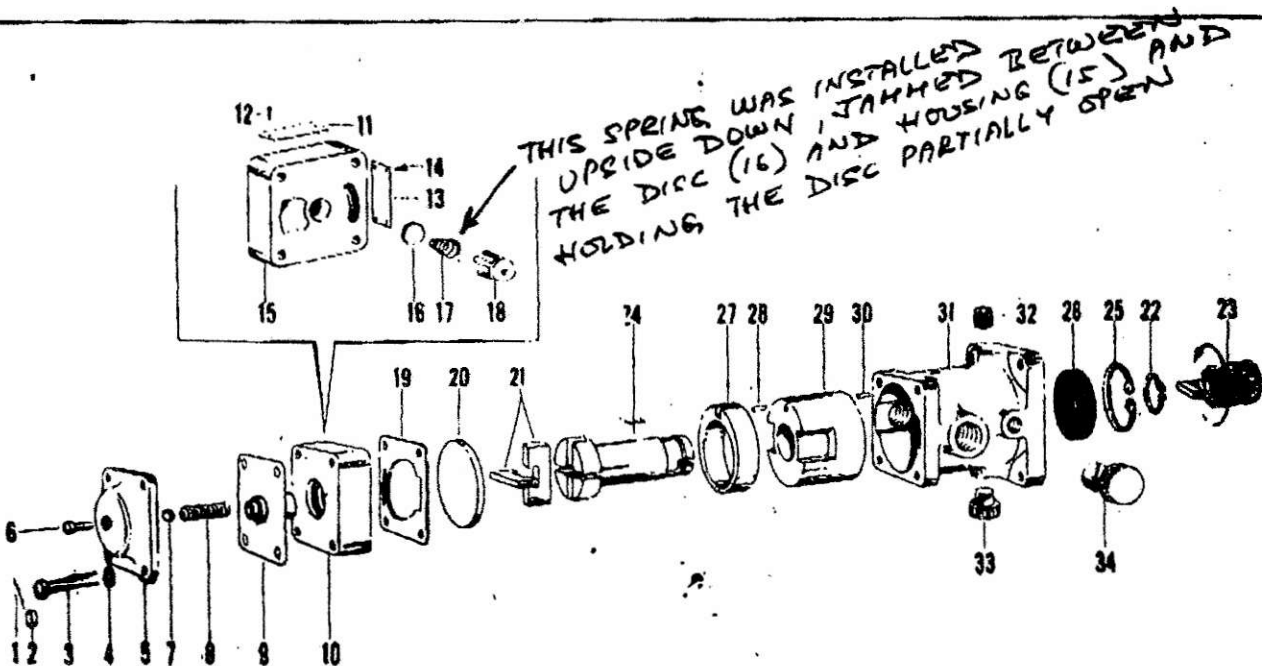
Figure 4. Power Driven Rotary Pump - Exploded View

According to the test report the pump and the fuel injector unit was functionally tested together. The pump did only work after priming and the output pressure was about 6 psi. The pump was then disassembled and inspected. Its by-pass valve spring is cone shaped, the narrow end is down and resting on the valve disc. The spring was found to be installed upside down and jammed between the valve disc and housing, causing by-pass at all times. The pump became functional when assembled correctly. There was no evidence of leaky gasket or diaphragm failure.

The report states as following: "Because the valve was only partially open and stuck in either direction, this may have caused restriction in fuel supplied by the booster pump which I assume was running at the time".

PRESSURE WAS SET @ 6 PSI ONLY
