# AIRCRAFT INCIDENT REPORT

**M-03003/AIG-19**

**LY-ARS  
Piper PA30  
At Reykjavik Airport  
29 June 2003**

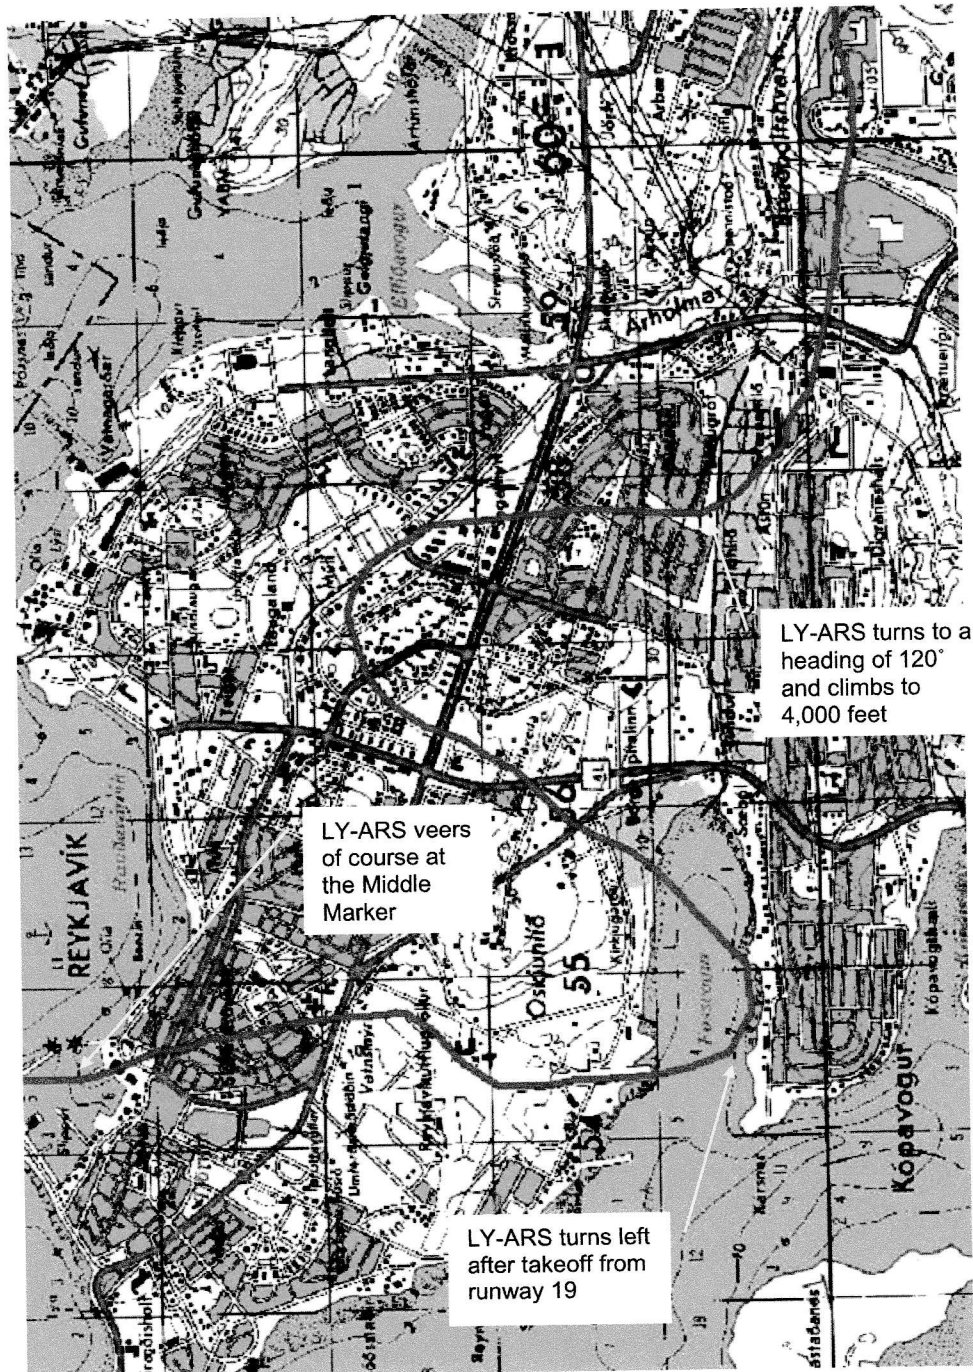
## Appendix B - LY-ARS radar plot

right to manoeuvre the aircraft for a landing on runway 19. The LY-ARS radar plot shows that the aircraft starts to deviate to the left from the extended centreline of the runway at or just before the Middle Marker (MM) (see appendix B).

As the aircraft was breaking out of clouds at the Middle Marker the commander looked up from the instruments and started looking for the runway. The radar recording shows the aircraft turning slightly to the left at this time. When the commander saw a runway in front of the aircraft it had veered of its course and he assumed that this was the runway he had been cleared to land on. When the aircraft neared the airport the commander discovered that he was approaching the wrong runway and instead of performing a go-around he manoeuvred the aircraft towards the runway he was cleared to land on. The aircraft landed past the midway point of the runway and the commander elected to take off again as he considered the remaining runway not sufficient to safely stop the aircraft.

In the opinion of the AAIB the commander should have performed a missed approach at the Middle Marker (MM) when visual reference with the runway was not established. The pilot looked up from the instruments, approaching the Middle Marker (MM), and got visual contact with the ground. He then continued the approach and allowed the aircraft to veer left of course while trying to get visual contact with the runway.

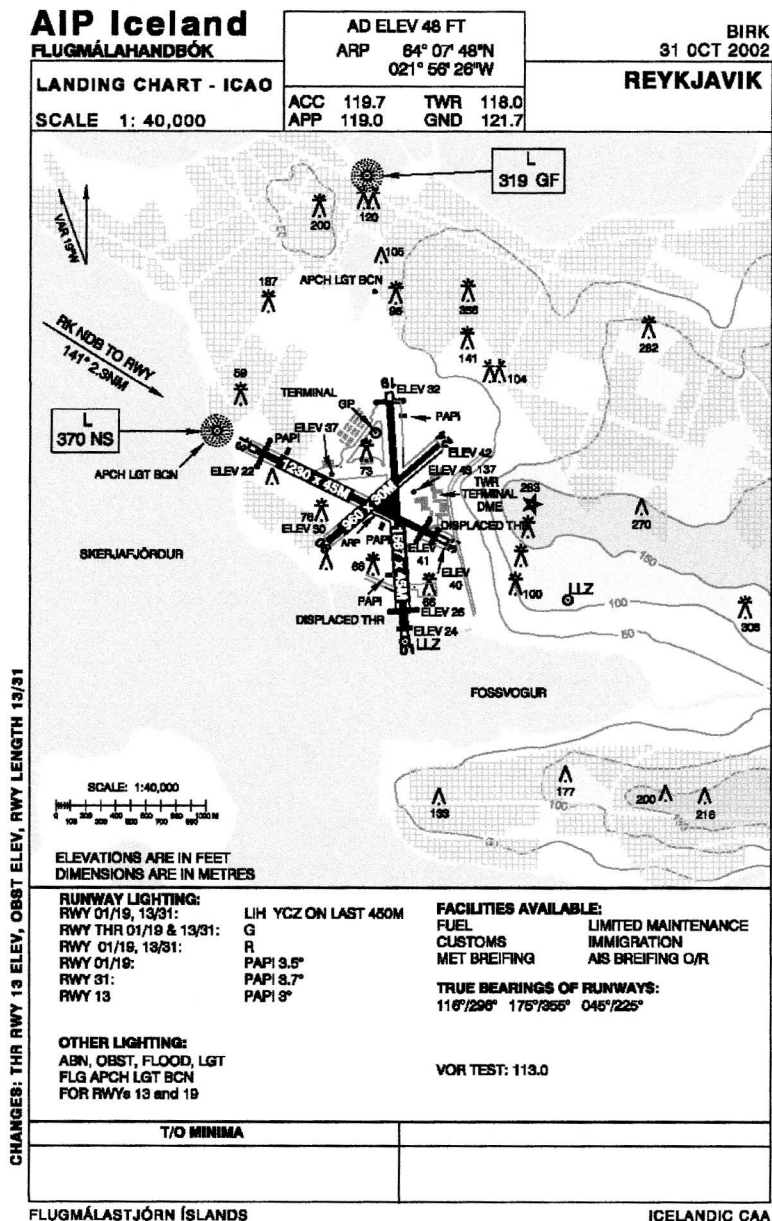
## Appendix C - AIP Iceland, chart of Reykjavik Airport

The controller at Reykjavik Tower was looking towards the area where he expected the aircraft to appear on the approach when he saw the aircraft flying east of the extended centreline for runway 19. According to the controller the aircraft was on a south-easterly heading when it turned right, flew over runway 24 and landed at 19:05 hrs on runway 19, just after passing the intersection of runway 13/31 (see Appendix C for a chart of Reykjavik Airport).
