### Report on Serious Air Traffic Incident

Case no.: **20-085F016**

Date: **22. August 2020**

Location: **Short final for Runway 01 at Keflavik Airport**

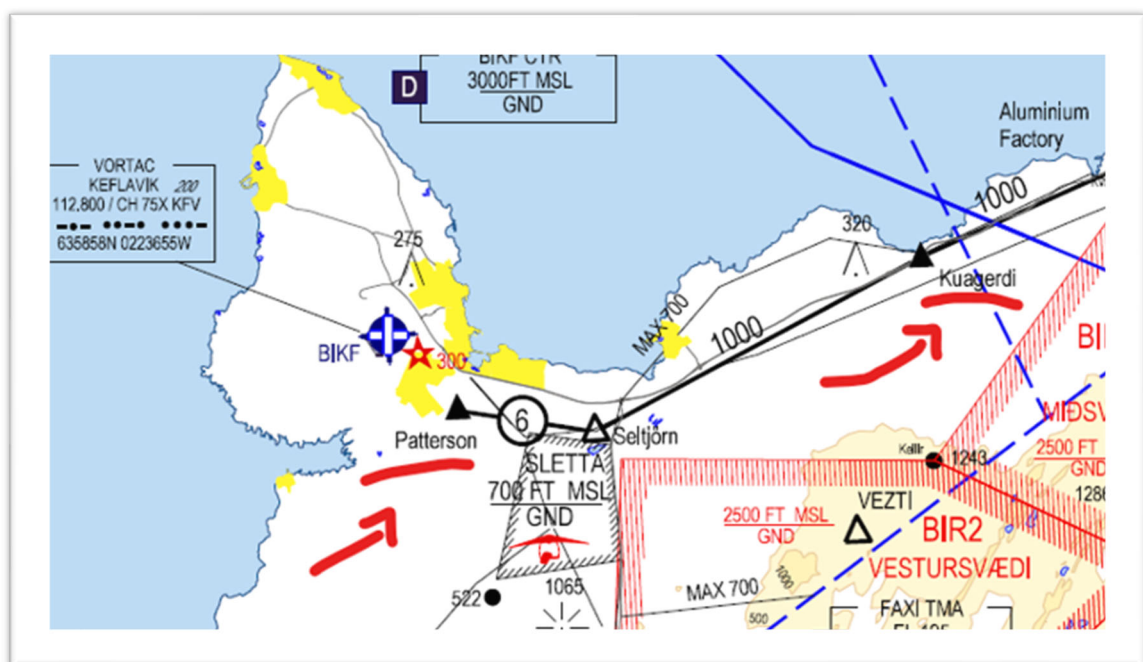
**Figure 1: VFR chart showing both PATTERSON and KUAGERDI, Class D airspace**

Figure 1 shows that PATTERSON is marked with a black filled-in triangle. AIP Iceland states that such points are compulsory reporting points.

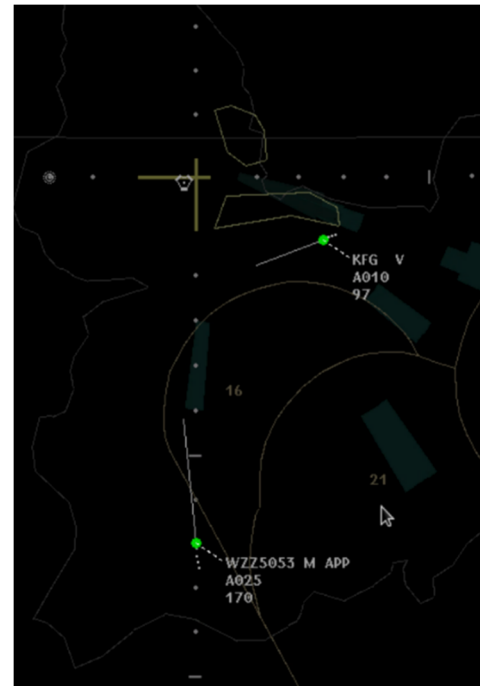
**Figure 2: HA-LXG 7 NM from BIKF**

When the passenger aircraft (HA-LXG) was on the final approach (see Figure 2 to right), approximately 7 NM from the threshold, the crew was cleared to land on Runway 01.

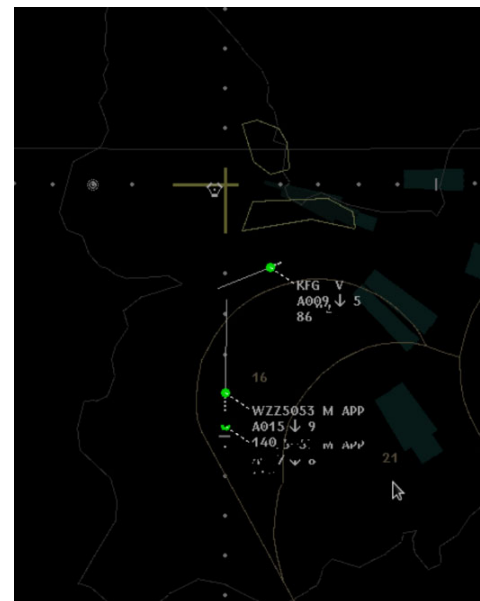
**Figure 3: HA-LXG 4 NM from BIKF**

When HA-LXG was approximately 4 NM from Runway 01 (see Figure 3 to right), its flight crew noticed traffic on the Navigation Display, coming from the east, and approaching final for Runway 01, in front of them.

The flight crew of aircraft HA-LXG then decided to perform a go-around and during the first phase of the go-around, they received a TCAS<sup>5</sup> TA<sup>6</sup>.

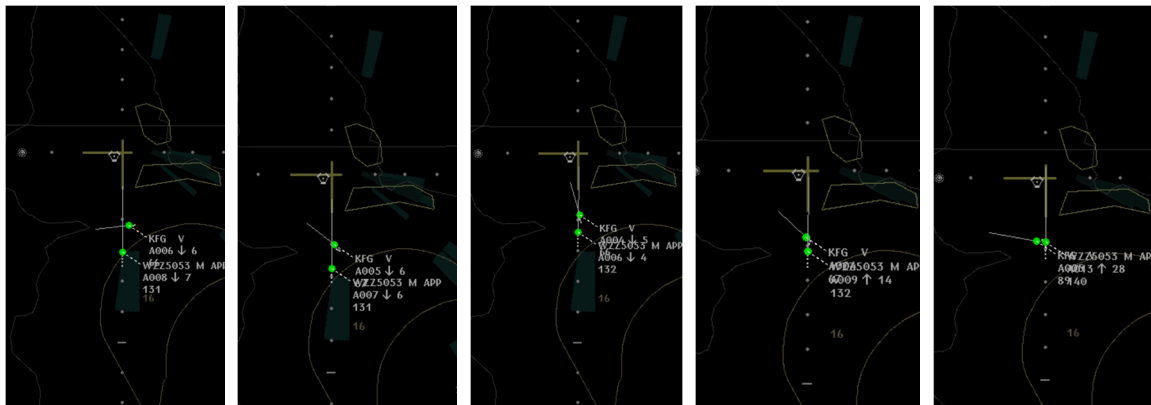
**Figure 4: Surveillance data of HA-LXG and TF-KFG**

According to the surveillance data, the minimum vertical distance between the two aircraft was 225 feet, and at the same time the distance was 0.59NM, but when the minimum lateral distance between them was 0.27NM while the vertical distance was 600ft. Both aircraft landed safely at the airport shortly after.
