Report on the stranding of Wilson Skaw

Case nr.: **23-021-S-011**

Date: **18th of April 2023**

Description: **Vessel stranded when hitting an underwater rock**

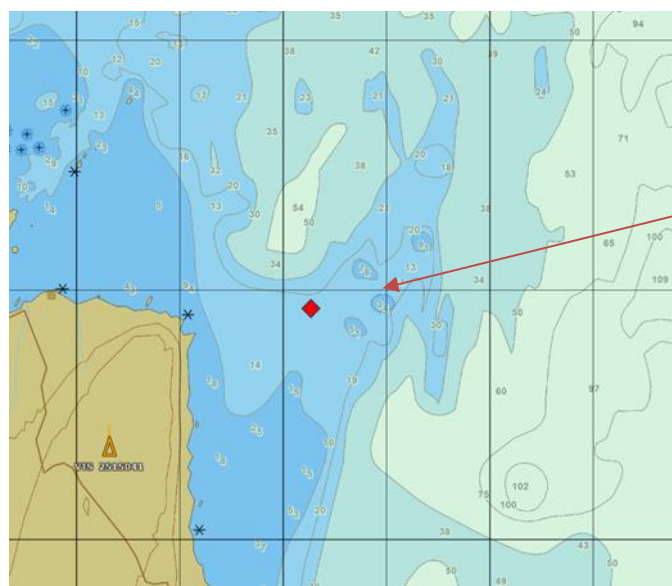
Figure 1

Underwater rock on the Wilson Skaw grounding site (fig.1).

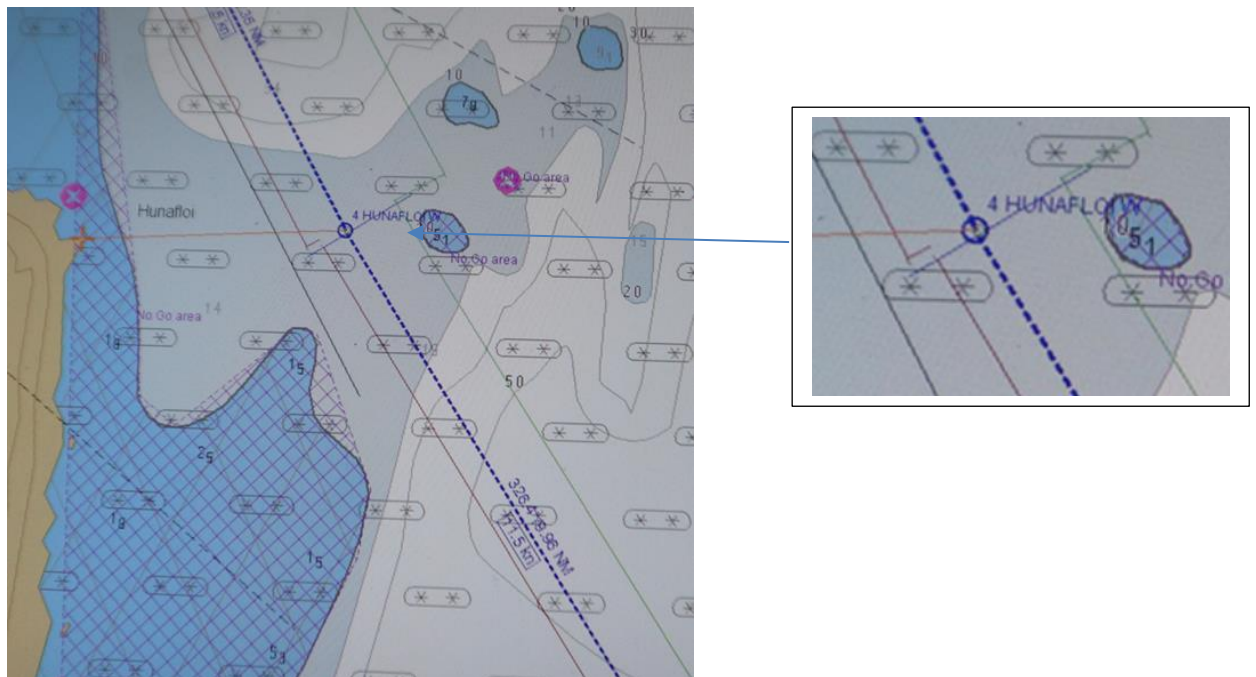
When Wilson Skaw stranded, she was in CATZOC (Category Zone of Confidence) area D (Figure 18). CATZOC C gives position accuracy of +/- 500 metres and depth accuracy of 2.5 metres on 10 metres depth as shown in chart. The position accuracy of CATZOC D is not defined, but instead it is stated that it is worse than C. Furthermore, in case of CATZOC, the seafloor coverage and typical survey characteristics, state: **“Full area search not achieved,**

Figure 18 CATZOC are D.

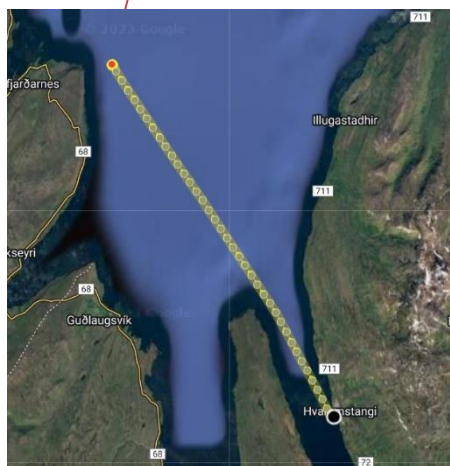
Figure 20

The route Wilson Skaw took was further to the South (Figure 20).

The distance difference between Wilson Skaws route and the certainly safe route is about 3 NM.

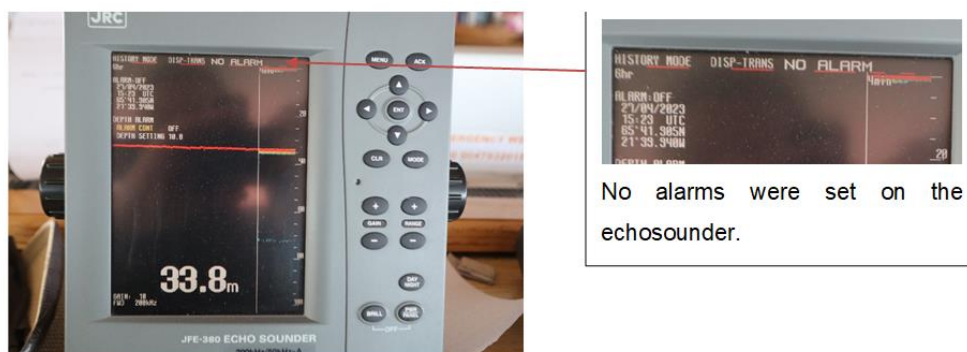
Figure 21

The echo sounder had a display fitted to the rear of the officer’s chair on the bridge but had the depth alarm off figure 21. This is not considered as a contributing factor. The speed of the vessel when she stranded was too high and the underwater rock appeared on the screen to sudden for the officer on watch to respond by reducing the speed or to make a turn.

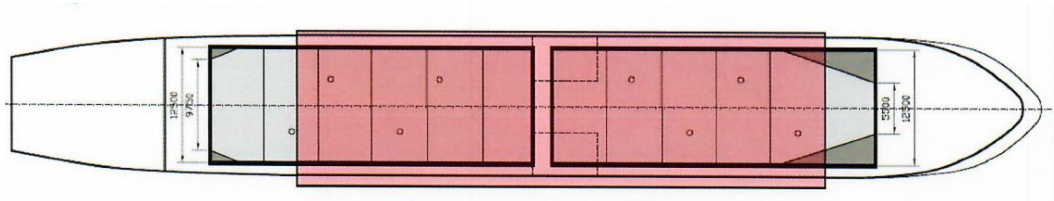
After Wilson Skaw stranded, on the 18th of April, divers from the Icelandic Coast Guard inspected the vessel. The conditions were bad for diving. Nevertheless, they noticed that Wilson Skaw sat on a volcanic rock about 25 meters aft from the stern all the way to 75 metres aft from the stern of the ship, meaning that roughly 50 metres or more were sitting on a rock (see figure 22).

Figure 22 red area shows where the ship sat.

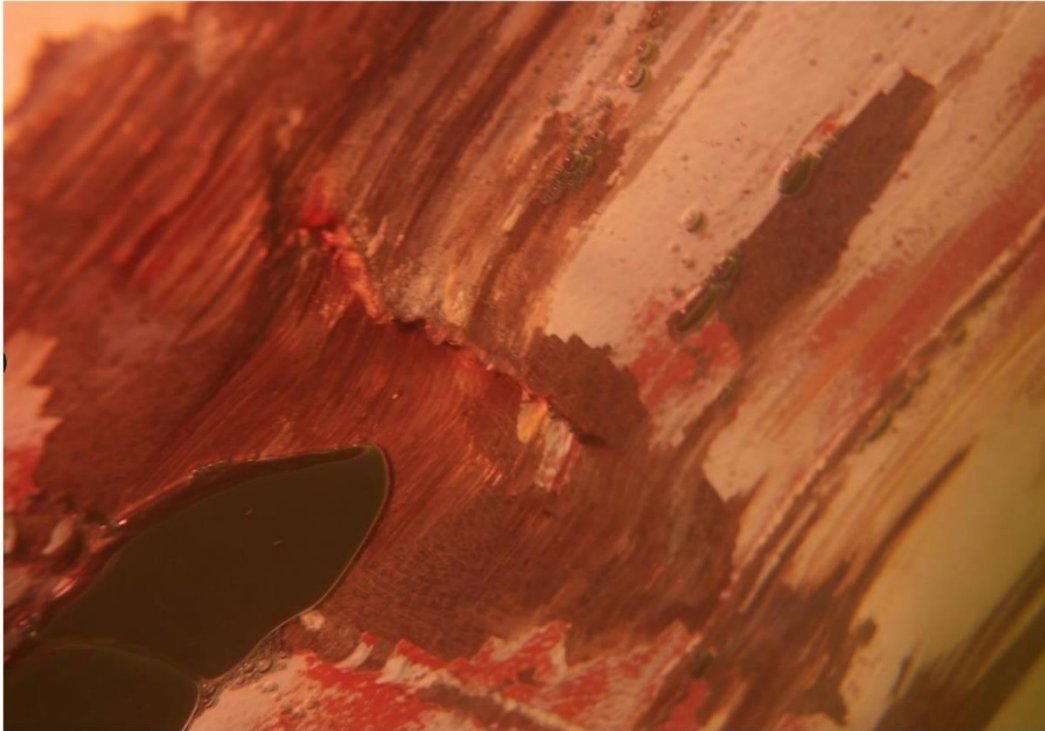
Figure 23

The bulbous bow was severely damaged, there were multiple cracks running alongside the front, from frame 157 to frame number 144. From frame 144 to frame 95, there were multiple damages on the hull, combination of cracks, dents etc. From frame 91 to frame 65 there were a lot of cracks present, including an 11-meter crack running alongside portside from frame 85 to 71. Approximate location 3,5 meters from turning of the bilge keel, the bilge keel portside and starboard side were severely damaged. One propeller blade was bent at the radius 0.8. Damage was also found on the rudder.

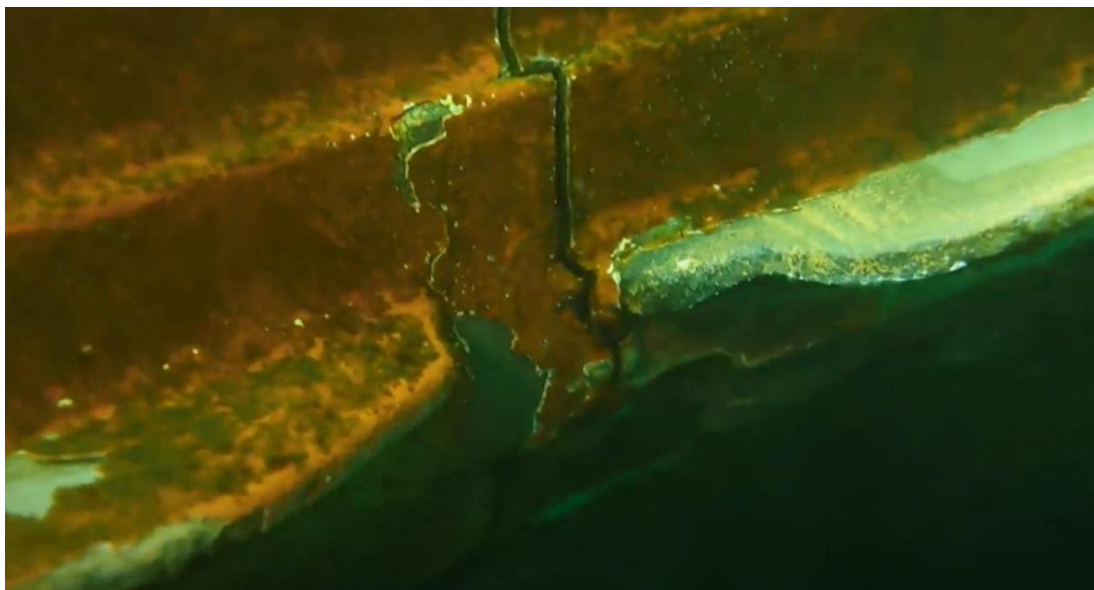
Figure 28 From frame 65 to frame 30 the damage gradually reduces to the stern.

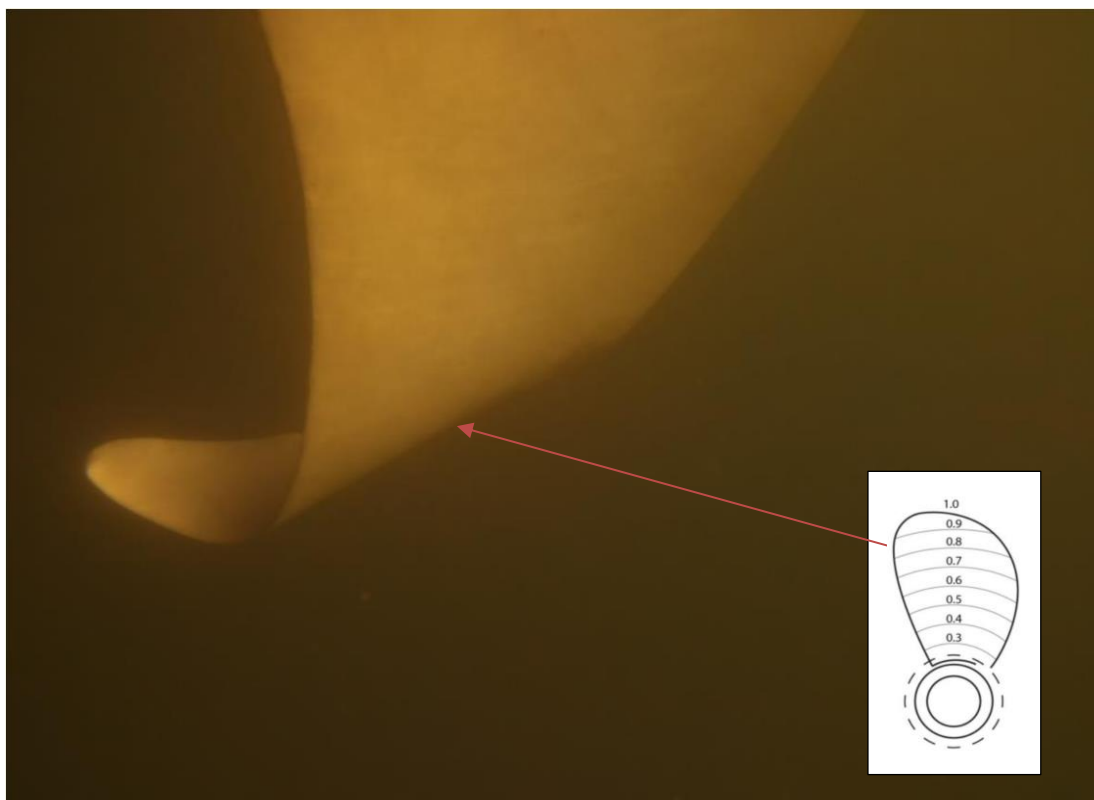
Figure 29 One blade bended at the radius 0,8.

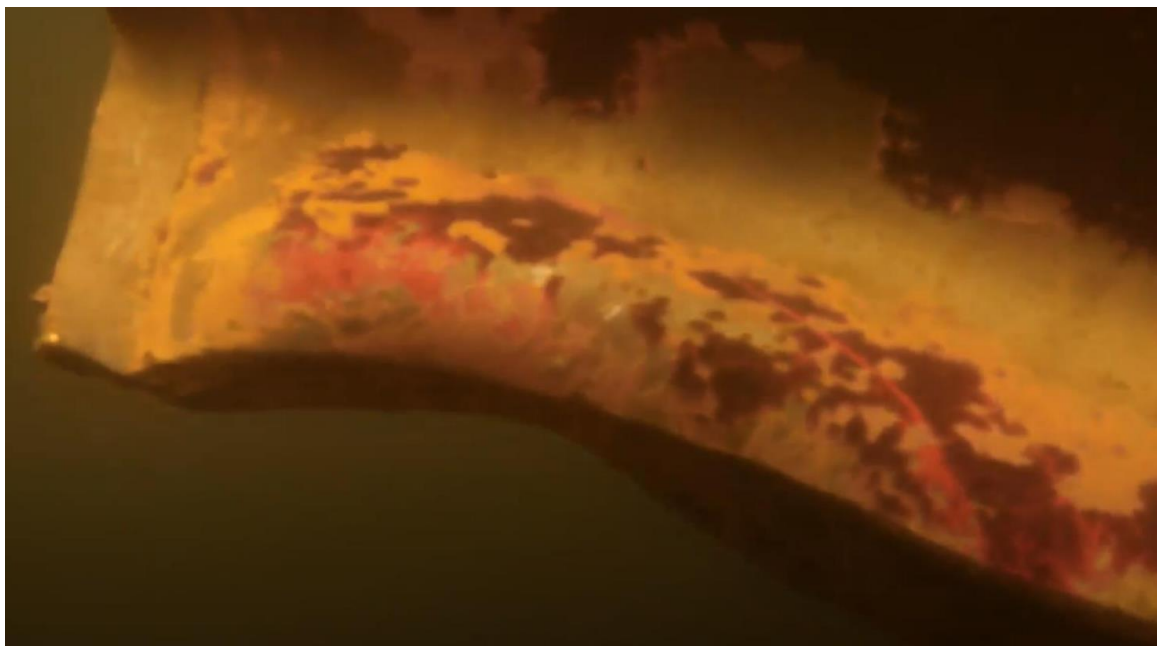
Figure 30 lower part of the rudder
