### Final report on aircraft serious incident

Case no.: **18-199F035**

Date: **1. November 2018**

Description: **In-flight shutdown of Engine no. 2 due to loss of oil pressure**

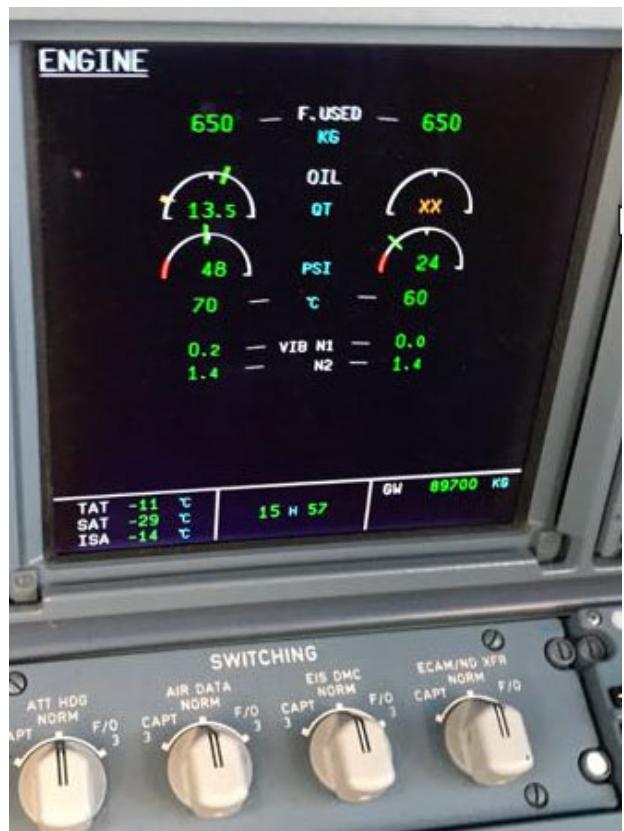
The flight crew took a picture of the engine display at 15:57 (see Figure 1 ), showing the “XX” for Engine no. 2 oil quantity as well as Engine no. 2 oil pressure had dropped to 24 psi.

**Figure 1: Photo of the ECAM after the “XX” appeared**

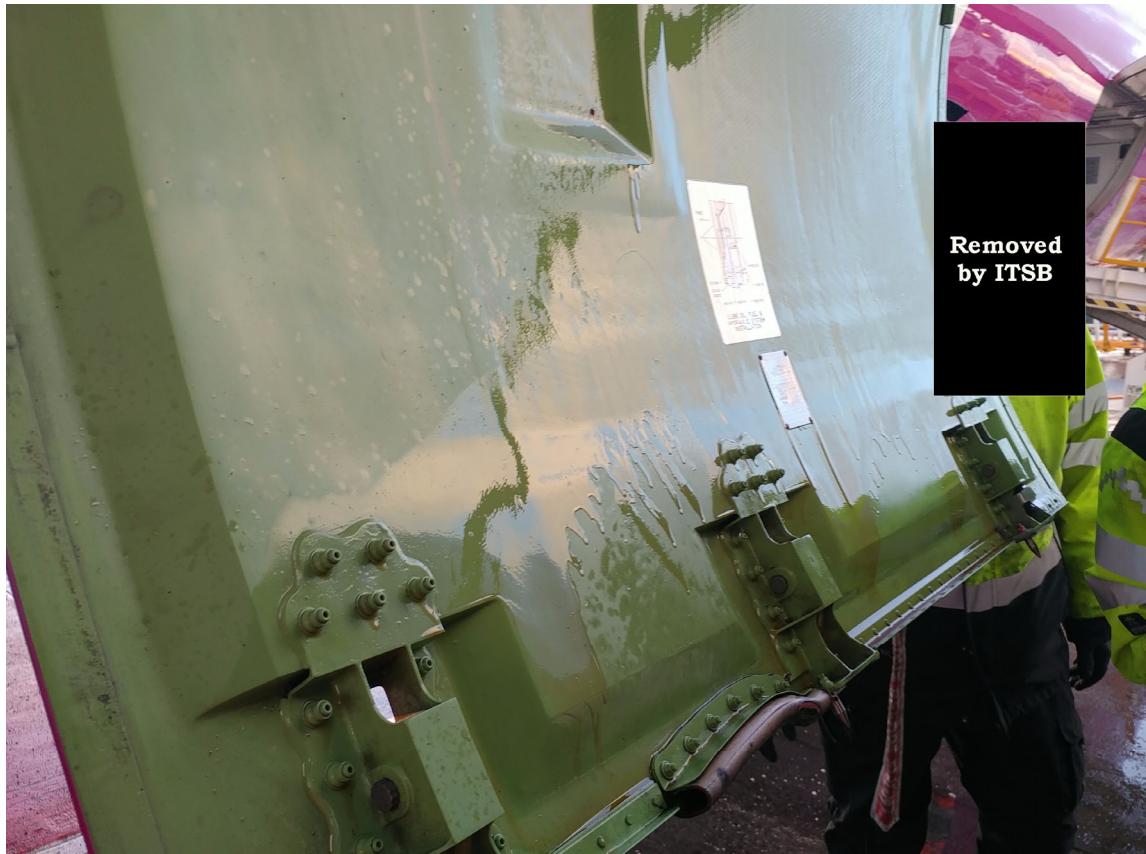
After the landing the aircraft was parked at the terminal and an inspection was performed on Engine no. 2. The inside of the Engine no. 2 cowling was found wet with oil. The oil drain plug on the main oil supply filter on Engine no. 2 was found loose along with a loose safety wire.

**Figure 2: Engine no. 2 - The inside of cowling wet with oil**

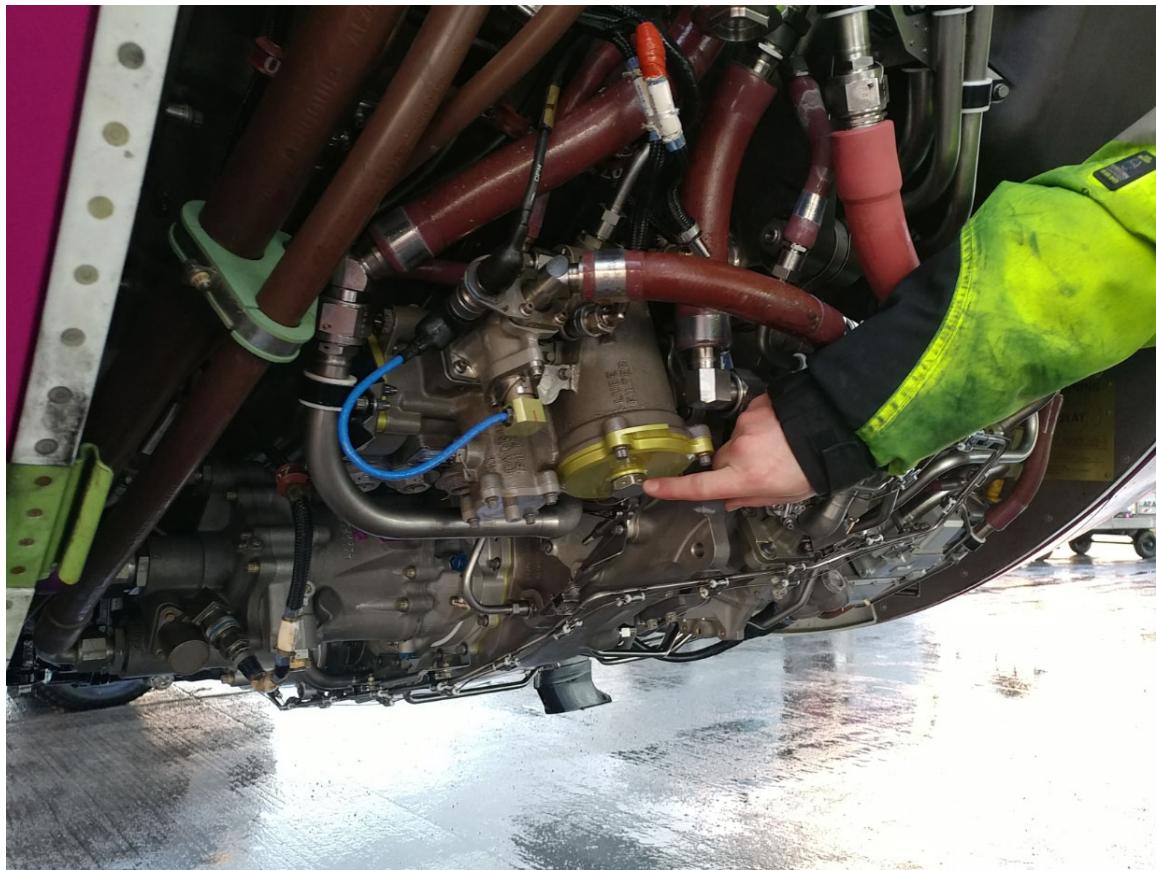
**Figure 3: Engine no. 2 - Leaking oil drain plug on oil supply filter**

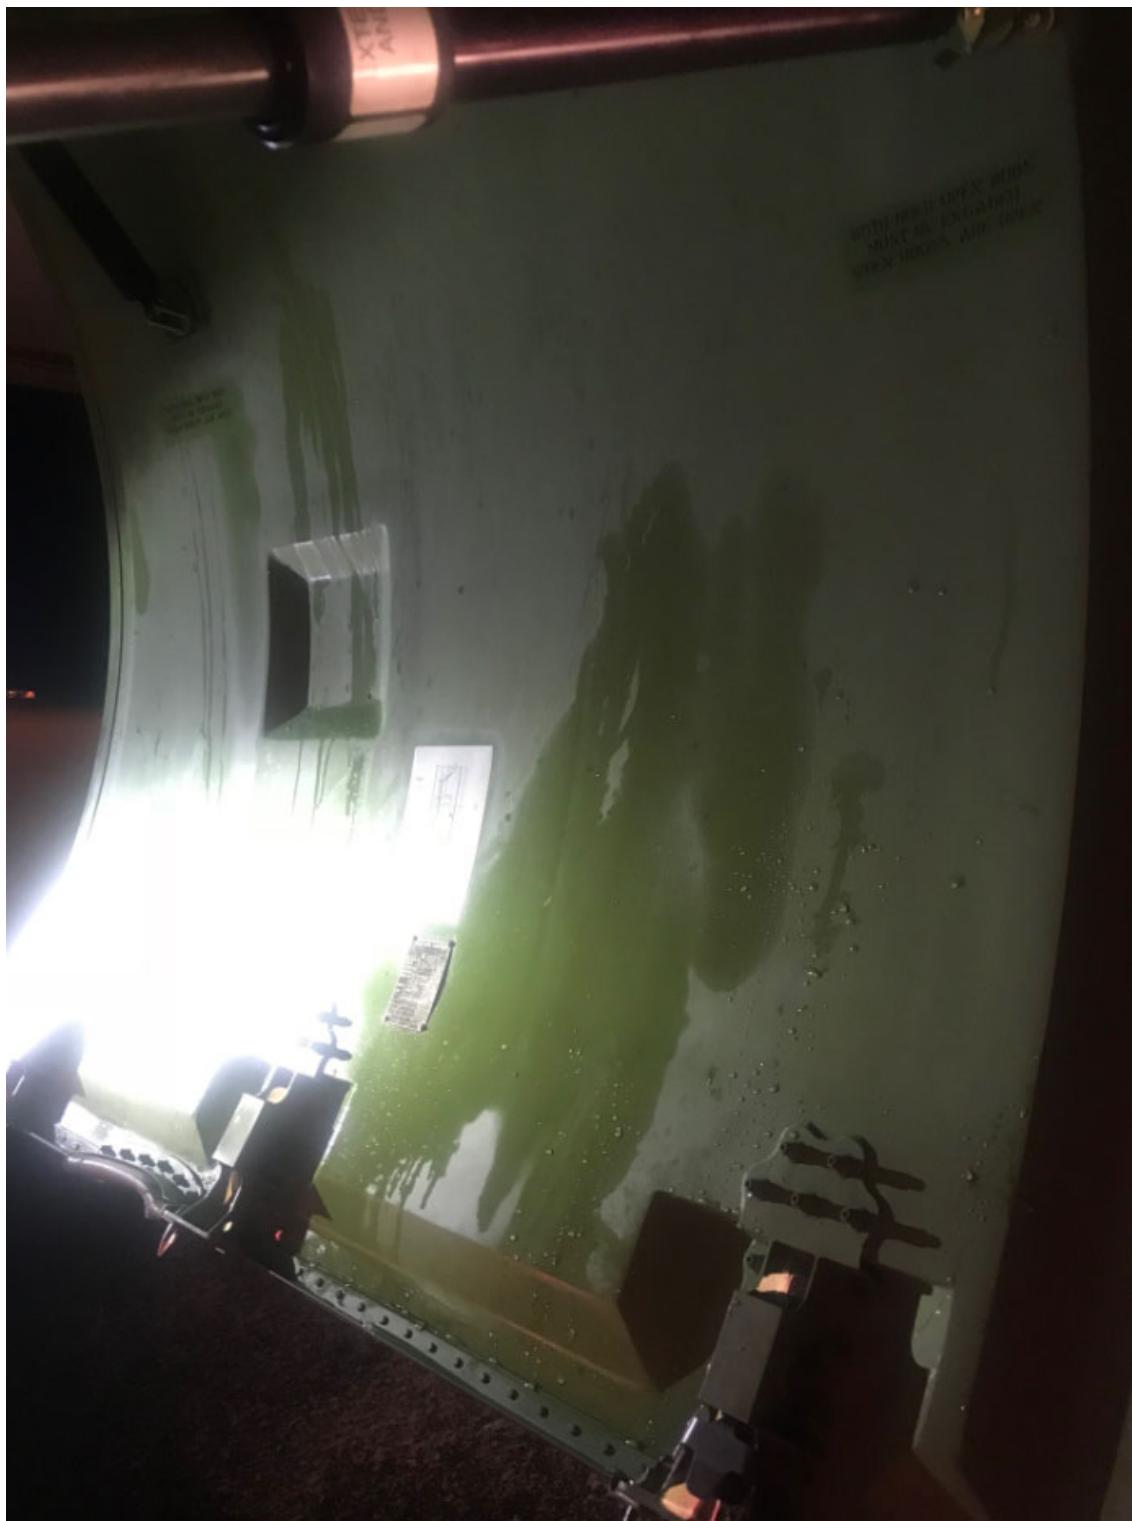
During further inspections of the oil leak, by the flight operator, on the evening of November 1<sup>st</sup>, a general inspection of Engine no. 1 (left engine) was also performed. During this inspection, an oil leak was also discovered on the inside of Engine no. 1 cowling and the same oil drain plug on the main oil supply filter for Engine no. 1 was found to be loose along with a loose safety wire.

**Figure 4: Engine no. 1 - The inside of the cowling was wet with oil**

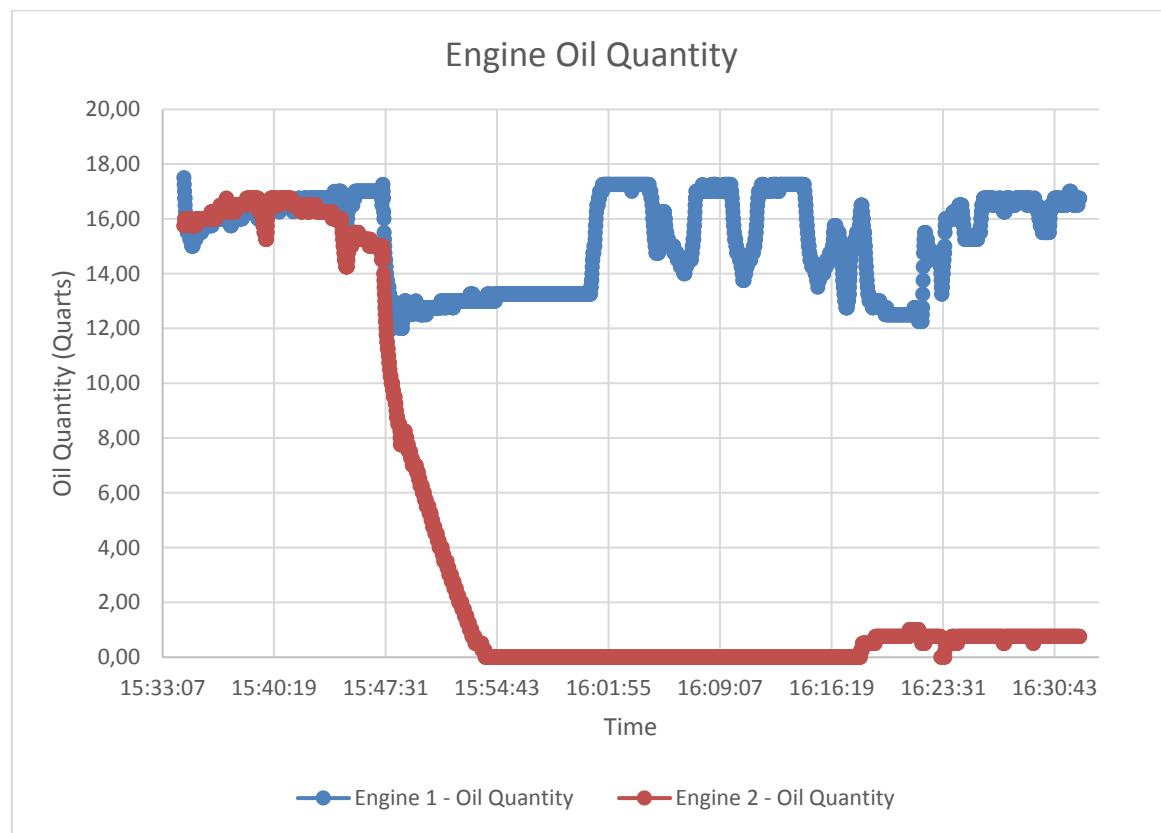
Both Engine no. 1 and Engine no. 2 incurred a sudden drop in the oil reservoir around 15:47:30 (see Figure 5). About 5 quarts of the sudden oil drop (for both engines) occurred because of oil gulping during takeoff. This happened as the high-power selection required additional volume of oil for the engine operation, which is taken from the oil reservoir.

**Figure 5: Loss of oil quantity**

For Engine no. 1, the drop in oil quantity stabilized at about 13 quarts at 15:47:54. This was at the same time as the aircraft nose pitched up at the end of the takeoff roll, when the aircraft was about to take off from Keflavik Airport.

For Engine no. 2 the oil quantity continued to drop during the climb and reached 0 quarts at 15:53:58, when the aircraft had reached 10,900 feet altitude.

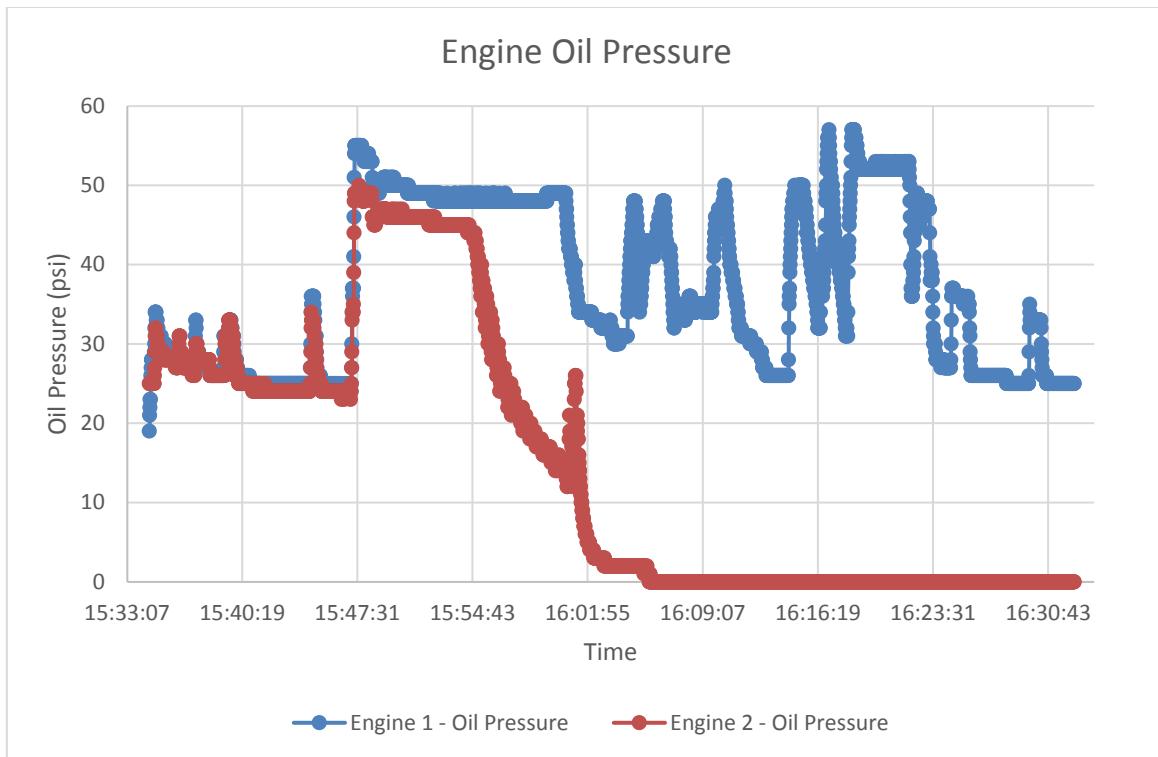
From the data derived from Figure 6 it is apparent that the engine oil pressure for both engines increased between 15:47:10 and 15:47:22, which coincides with the selection of takeoff power in the beginning of the takeoff roll of the aircraft at RWY 28 at Keflavik Airport.

**Figure 6: Loss of oil pressure**

The initial ECAM warning for low oil pressure for Engine no. 2 occurred at 16:00:15. From the data behind Figure 6 it is however apparent that the Engine no. 2 oil pressure started to drop around 15:54:30, or 32 seconds after the oil quantity for Engine no. 2 had reached zero.

The ITSB noted that the oil pressure value for Engine no. 1 oscillated between an upper value around 50-55 psi and a lower value around 25-35 psi after Engine no. 2 lost its oil pressure.

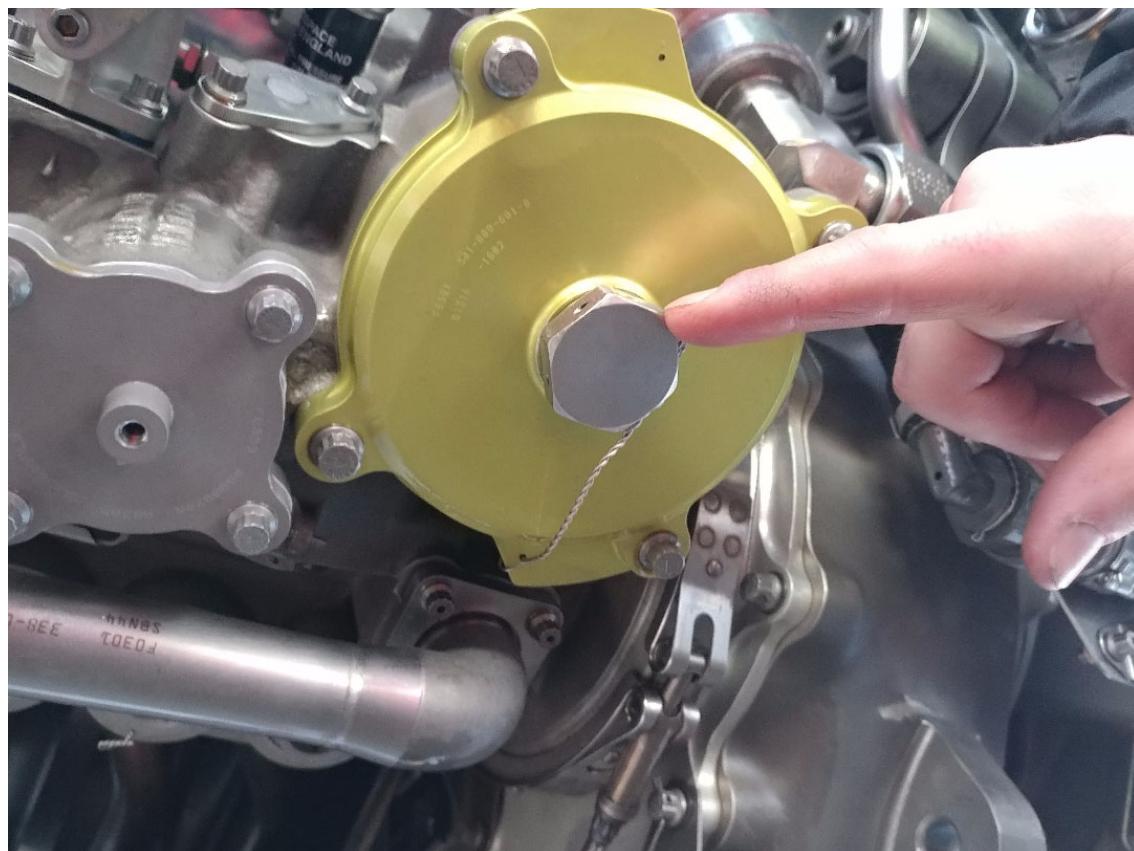
Inspections after the flight revealed that oil had leaked from the drain plug on the main oil supply filters for both Engine no. 1 and Engine no. 2. The drain plugs were found loose as well as their safety wires (see Figure 9).

The drain plugs could easily be turned by hand and did not meet the torque values stated in AMM task 79-21-10-920-002 [subtask 79-21-10-420-060-A].

**Figure 9: Main Oil Supply Filter – Oil leak indication and loose safety wire**

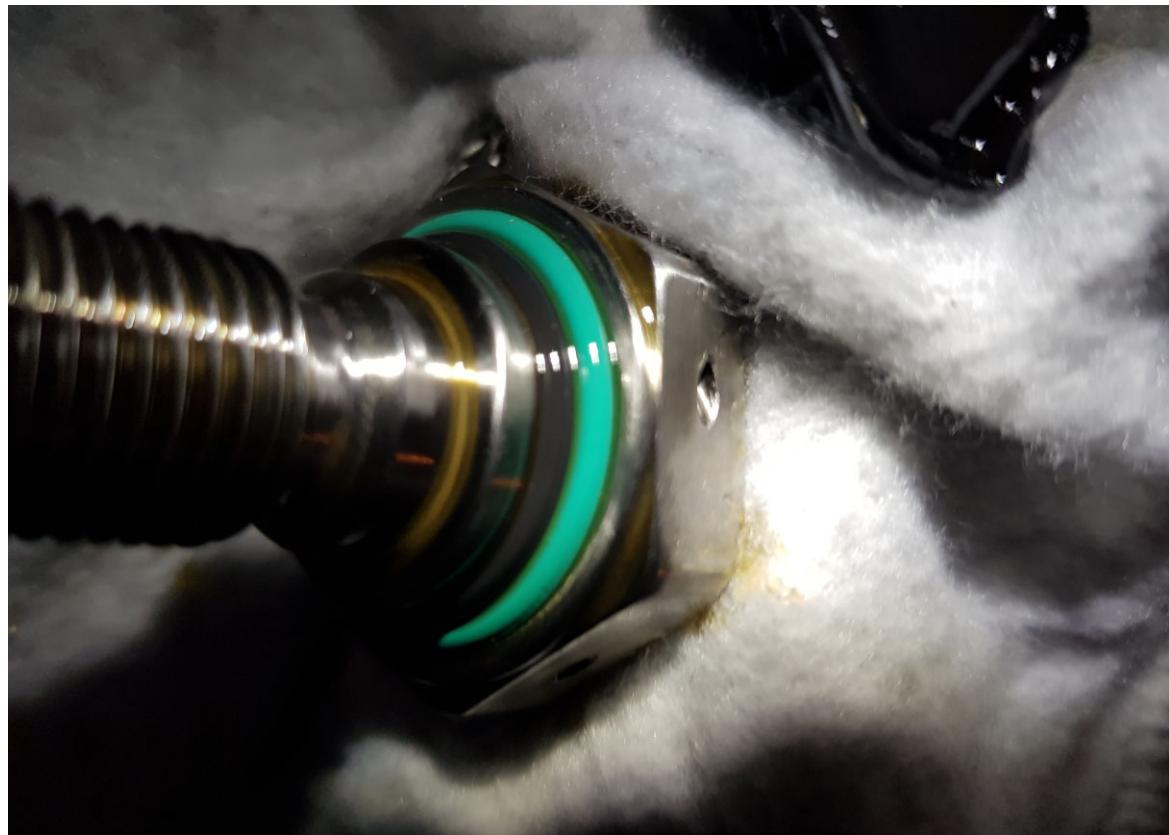
After removal of the leaking drain plugs (60), O-ring (50) was discovered nesting against the green back-up seal (80). See Figure 17.

Figure 17: Black O-ring (50) nesting against green Back-up Seal (80)

The investigation determined that the cause of the oil leak during this incident was an incorrect installation of the black O-ring, as can be seen in Figure 17.

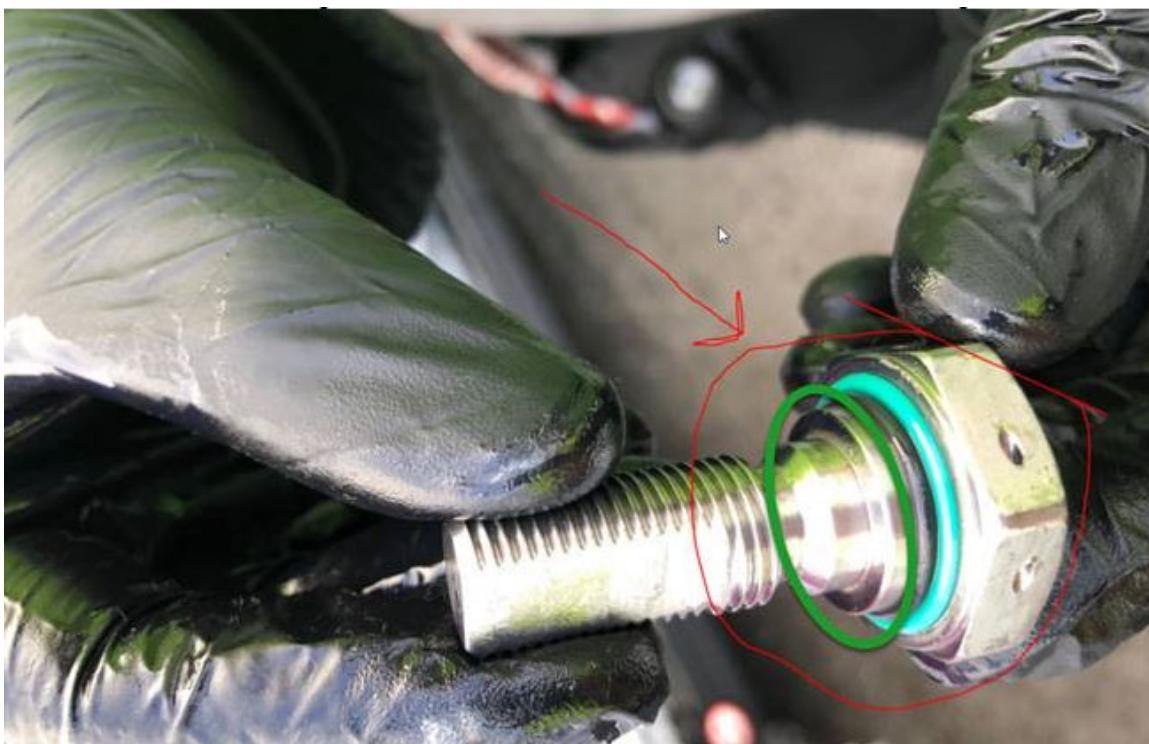
According to both Airbus and Safran Aircraft Engines, the black O-ring should have been located at the shoulder in the dark green circled area in Figure 18 (the one further away from the hexagon head).

**Figure 18: Correct location of O-ring (50) shown with the dark green circle**

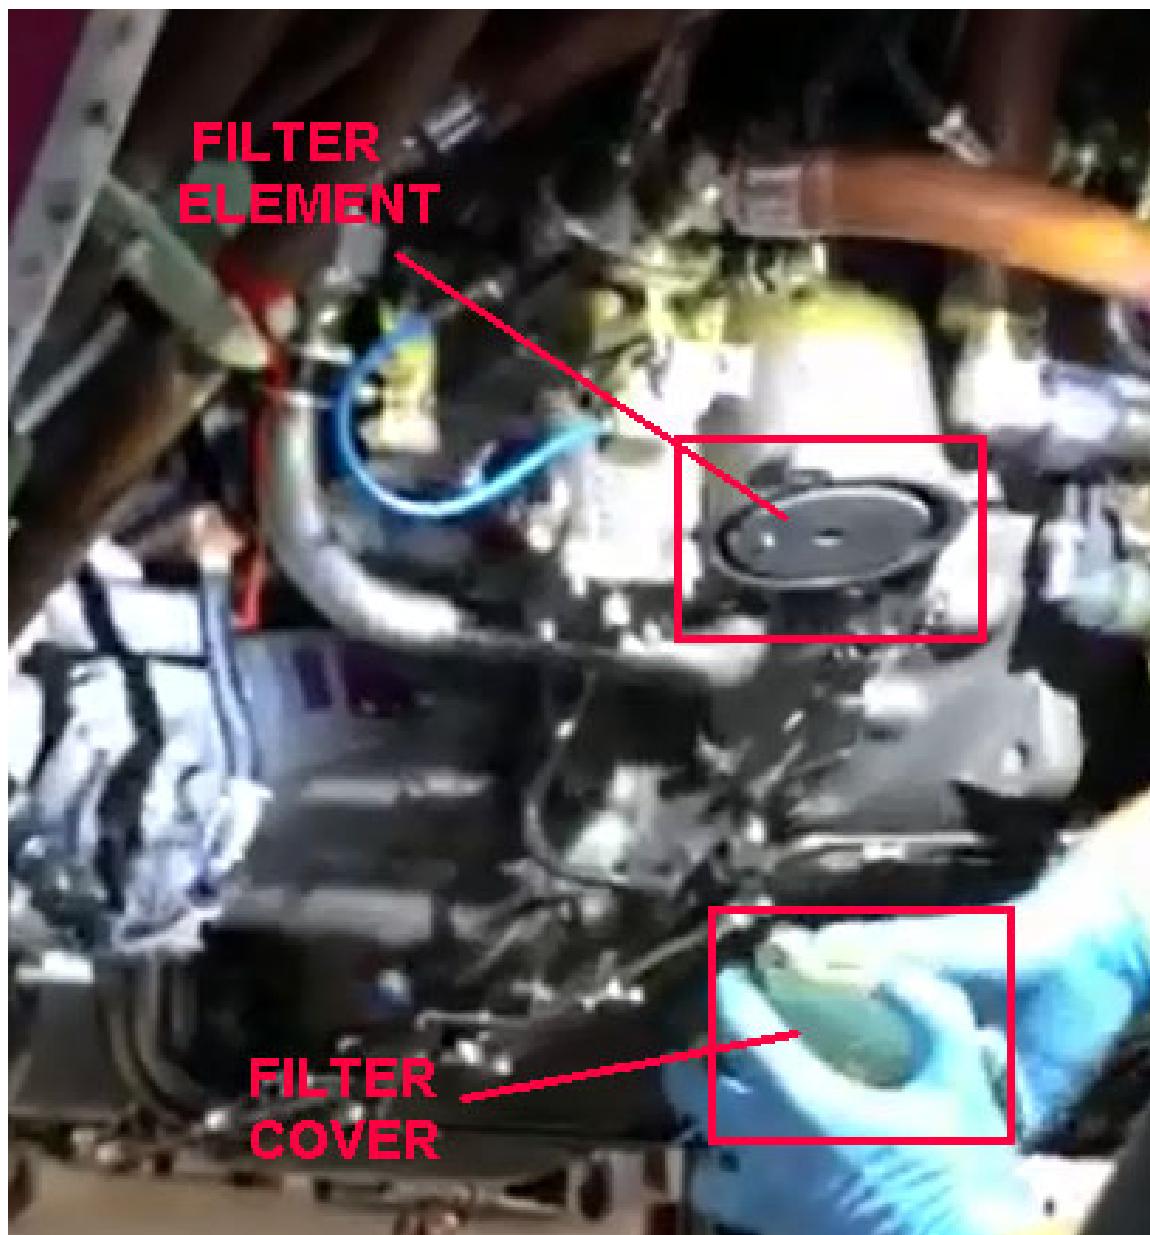
The upside down installation of the filter cover (40) and the drain plug (60) made it difficult to install the black packing (50) into the filter cover's (40) recess as it could fall down out of the recess (see Figure 19).

**Figure 19: Filter cover installed incorrectly**

The filter element should not be installed into the housing without being first installed onto the filter cover.
