Skýrsla um slys

Málsnúmer: **2023-038-S-021 Katla RIB bátur**

Dags: **15. júní 2023**

Lýsing: **Tveir farþegar slasast alvarlega**

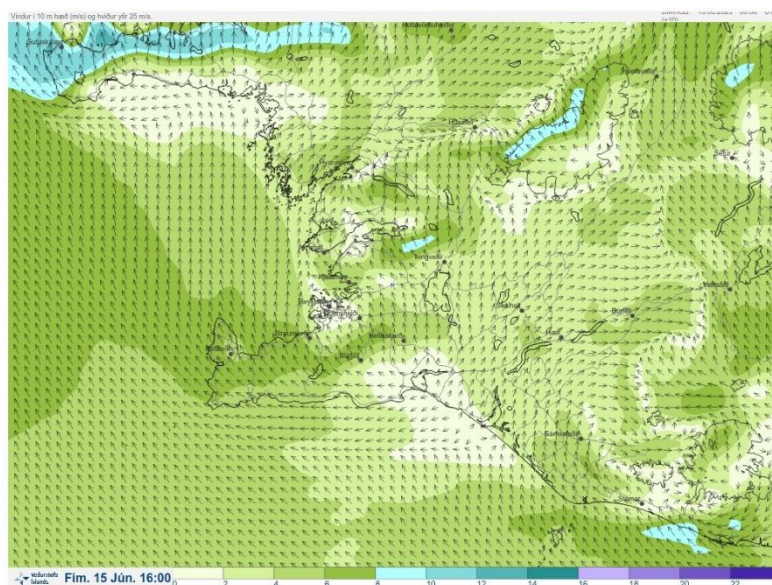
Spákort sýnir að þennan dag var nánast logn í Reykjavíkurhöfn og sléttur sjór. Mynd 1

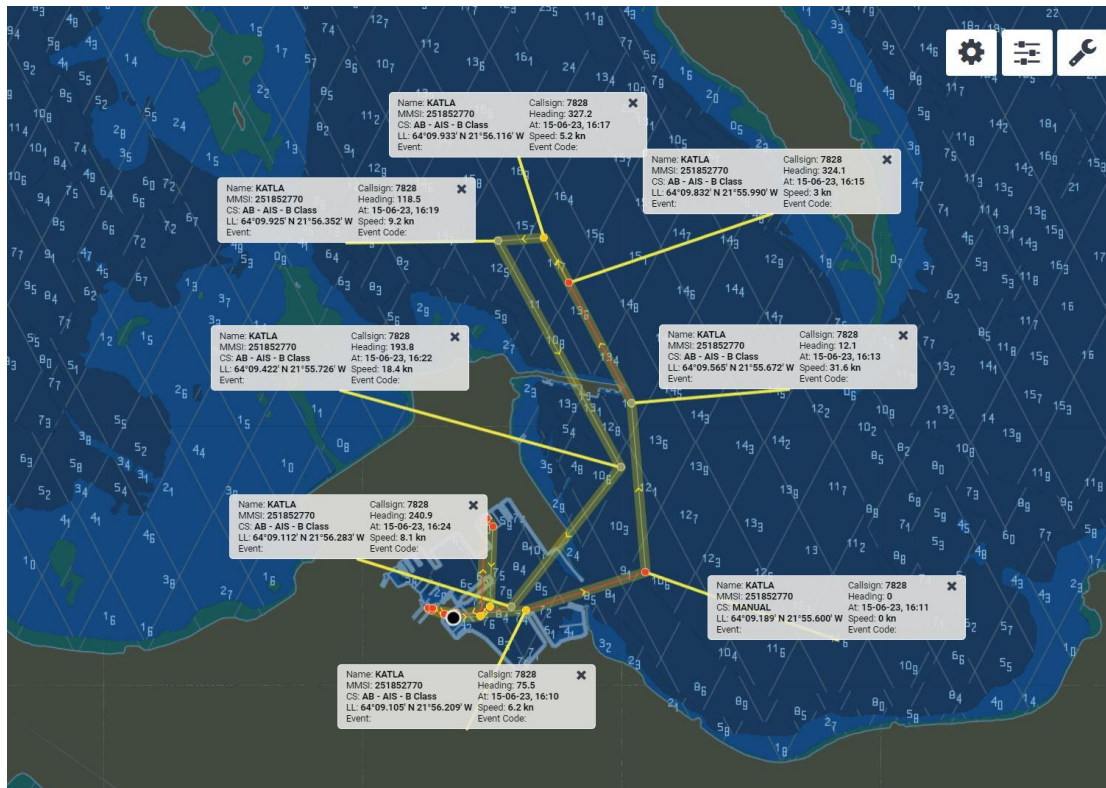
Mynd 2

Landhelgisgæsla Íslands mældi bátinn á sex hnúta ferð út úr höfninni en þegar hann hafði beygt í norður og kominn til móts við Eyjagarð var hann á 32 hnúta ferð (mynd 2). Samkvæmt framburði skipstjóra sigldi báturinn yfir kjölfar báts sem var nýbúinn að mæta RIB bátnum. RIB báturinn lyfti sér að framan og tveir farþeganna skullu niður. Gáfu þeir merki um að eitthvað

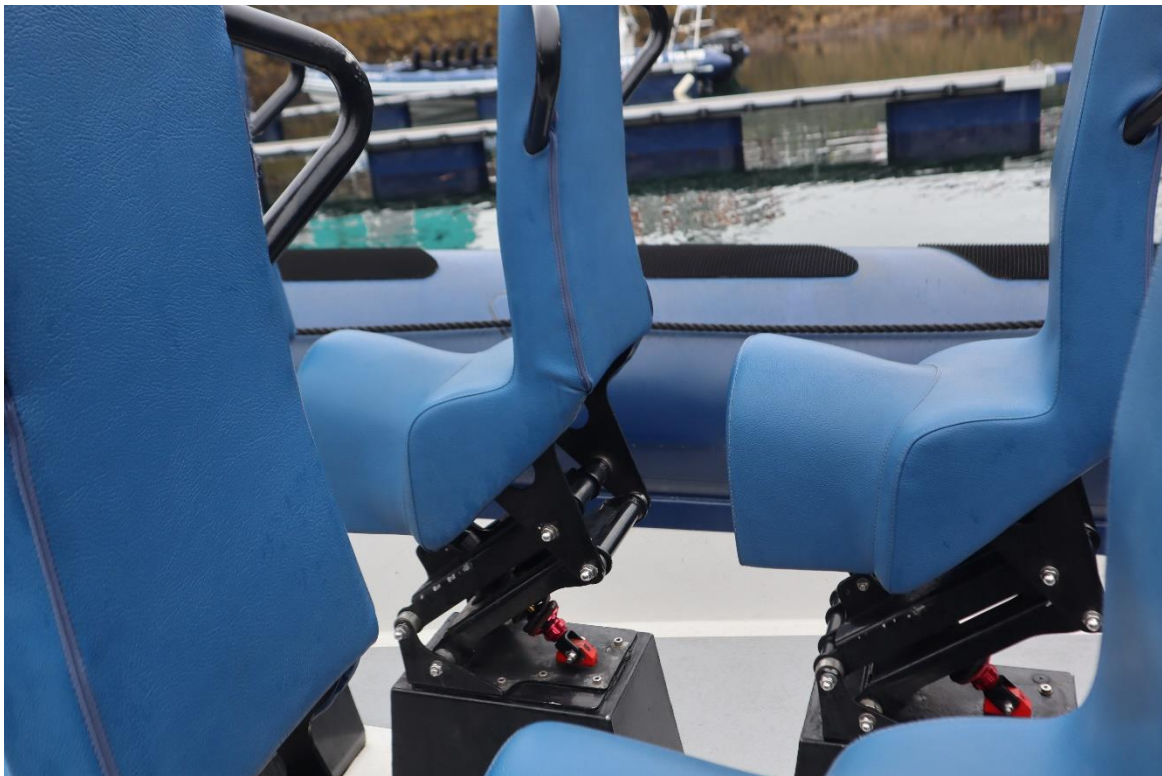
Mynd 3

Um borð í Kötlu voru fjaðrandi sæti (mynd 3). Sætin er hins vegar talsvert há, þrátt fyrir fjöðrun, sem leiðir til þess að lágvaxið fólk nær ekki að tylla fótum niður á þilfarið. Nái farþegar ekki fótastuðningi er hætt á að kraftur höggs leiði upp í gegn um sitjandann þegar bátar af slíkri gerð skella niður.

Helsta orsök slyssins var að bátnum var siglt á of miklum hraða yfir kjölfar annars skips og undirstöður sætanna voru of háar til að þau virkuðu sem skyldi þar sem ekki var unnt að stilla hæð þeirra til samræmis við hæð farþega.

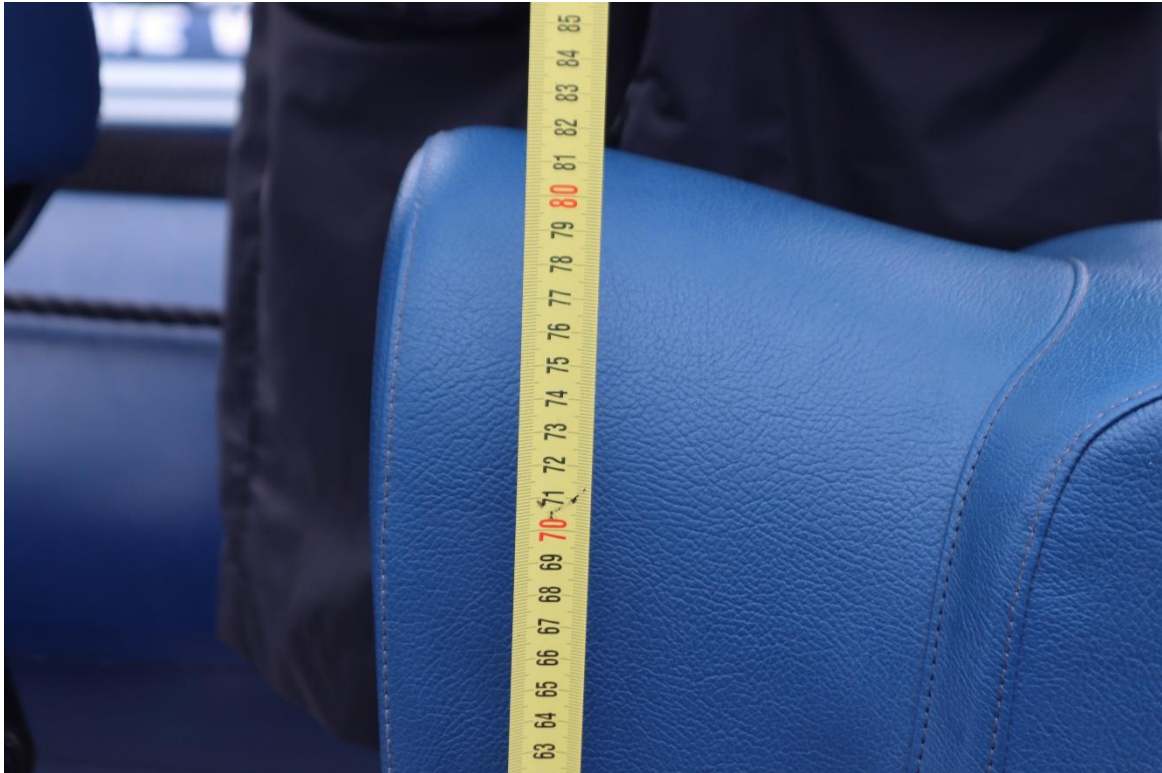
Mynd 4 sýnir mælingu á sæti niður á þilfar.

Í þessu tilfelli þurftu farþegarnir að standa en höfðu lítinn fótastuðning. Báðir hinir slösuðu voru 160 cm á hæð og náðu einungis að tilla tánnum niður.

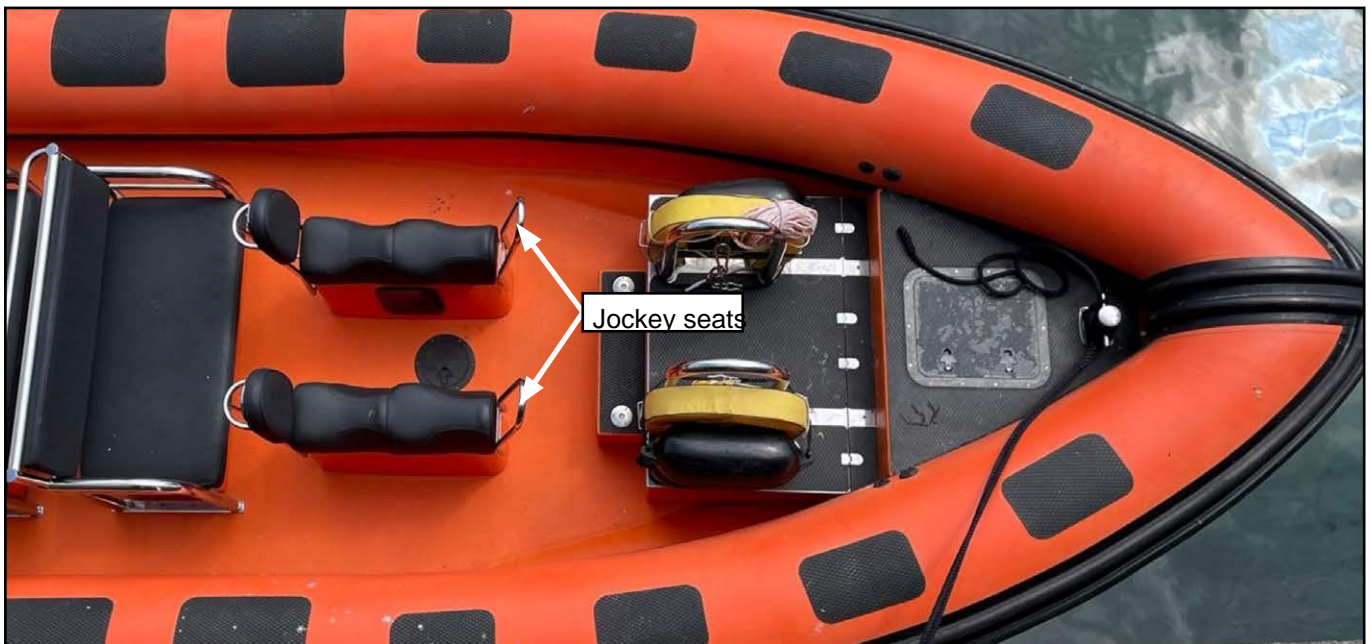
Figure 1: Front of RIB with jockey seats

On 7 June 2023, a passenger on a rigid inflatable boat (RIB) sea safari suffered a spinal injury that left them paralysed from the waist downwards. Twelve passengers had boarded the RIB and, once it was clear of the jetty, the two crew gave them a safety briefing and instruction on the wearing of lifejackets. The RIB then proceeded out to sea and was increasing speed in choppy sea conditions when it encountered a steep-sided wave. The boat fell off the wave and slammed violently into the trough, dislodging a passenger from a forward jockey seat (**Figure 1**). The passenger immediately lost feeling in their legs.

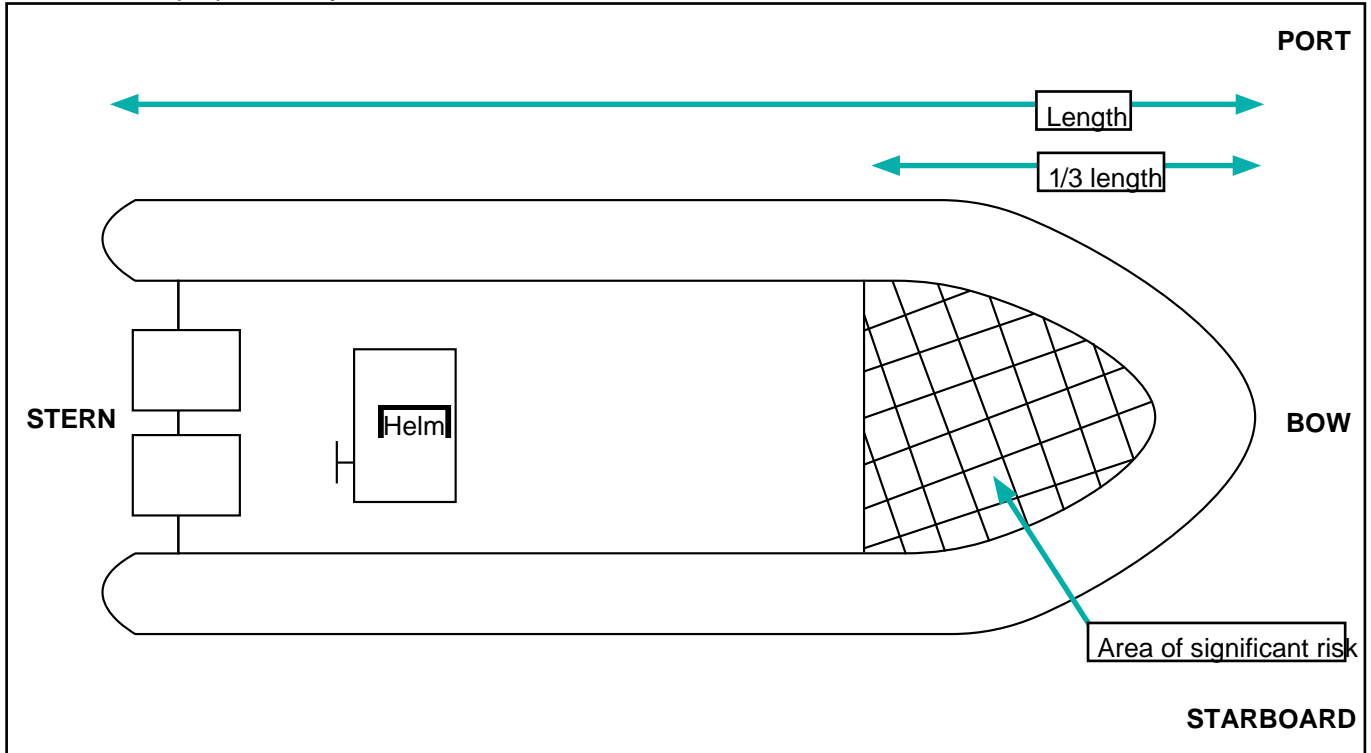
Figure 2: RIB outline highlighting the area of significant risk

Commercial passenger tours using RIBs, including sea safaris and thrill rides, have experienced a surge in popularity across the UK, with a corresponding increase in the occurrence of accidents. Since 2001, the MAIB has been notified of 54 accidents during RIB rides that have resulted in lower back injuries, 17 of which resulted in spinal fractures. Initial analysis of these previous accidents as part of this investigation indicates that passengers seated in the front third of a RIB's overall length (**Figure 2**) are exposed to a significantly higher risk of lower back injuries than those seated further back, as the vertical motions experienced are generally greater towards the bow.

There is a significantly higher risk of spinal fractures to people seated in the front area of RIBs, regardless of speed.

- Urgently review their operations and risk assessments, with reference to the CoP and MGN 436 (M+F). This review should assess and mitigate the risks associated with the requirement to seat passengers in the front area of a RIB and ensure that the risk assessment includes and addresses the variability of weather conditions and the ability of passengers.
- Review their passenger pre-departure briefing and ensure that it includes a specific explanation of how to use the seat(s) and their associated handholds, including how to maintain the correct posture and stability to mitigate against injury.
