Case no.: **24-011F005**

Location: **Over the Vestmannaeyjar islands**

Description: **Midair collision**

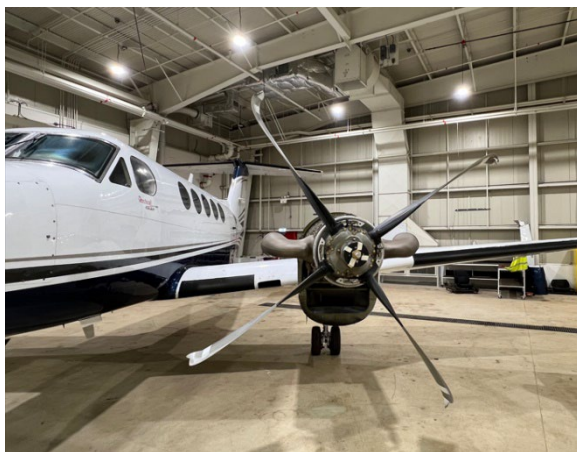
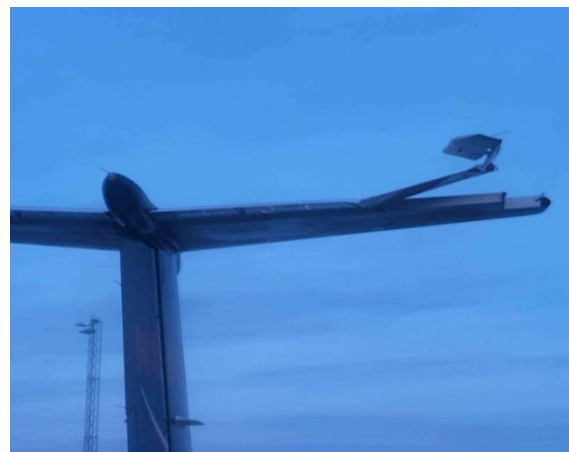
According to the pilots, aircraft N150YD, that was slightly ahead, above and to the left of N24SR, initiated a left turn as they had decided to circle around the islands on their way to Keflavik. The pilot of N24SR initiated a small climb, accelerated and also turned to the left to follow. At this point the pilot of aircraft N24SR felt a strong wash or wake from the other aircraft, which caused aircraft N24SR to turn tighter to the left, rapidly closing the gap between the two aircraft. According to the pilot of aircraft N24SR, he reacted by breaking right, by applying the right aileron, and decreasing the power to back off. Unfortunately, aircraft N24SR continued to close in on aircraft N150YD. According to the pilot, he thought it might have occurred because he was caught in the wing vortices of aircraft N150YD. The left propeller of aircraft N24SR came into contact with the right elevator of aircraft N150YD, and both the propeller and the elevator were damaged.

After the impact, the pilot of aircraft N24SR reduced the speed to increase the distance from aircraft N150YD, observed the damage and reduced the power on his left engine as the propeller was damaged. Both pilots communicated regarding the impact and the

Both aircraft landed safely at Keflavik Airport. The pilot of aircraft N150YD did not utilize flaps during the landing, as he did not want to risk altering the stability configuration of the aircraft.
