### Final Report on aircraft accident

Case no: **M-03114/AIG-23**

Description: **Loss of engine power and emergency landing**

Aircraft	
<b>Type:</b>	Xair-F
<b>Registration:</b>	TF-142
<b>Year of manufacture:</b>	2013
<b>Serial number:</b>	1050
<b>Engine:</b>	One, 70 HP Hirth 3503E18H piston engine
<b>CofA<sup>2</sup>:</b>	Valid Airworthiness Certificate, issued by the Reykjavik Ultralight club <sup>3</sup>

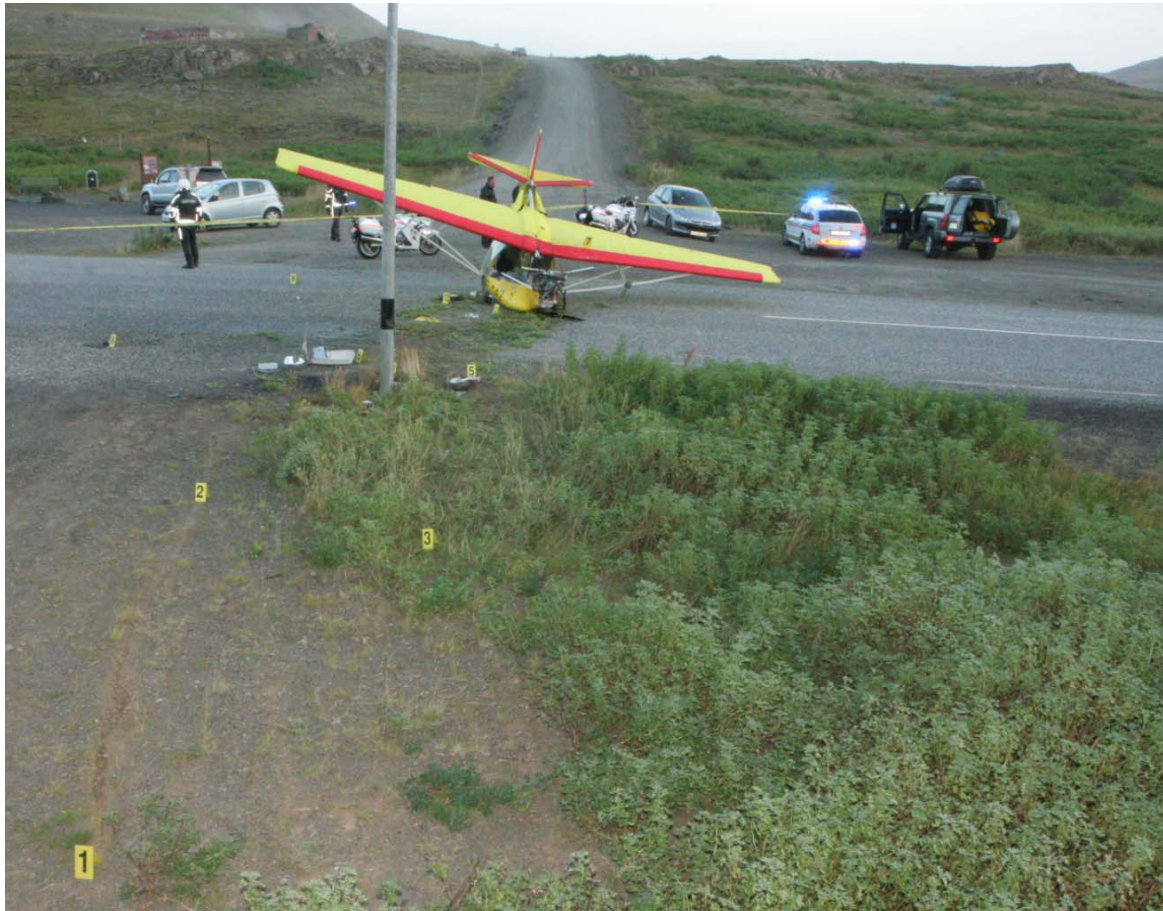
At 18:15 on August 28<sup>th</sup> 2014 an ultralight pilot took off from the ultralight air strip at Úlfarsfell. After less than 15 minutes of flying the ultralight's engine lost power. At this time the ultralight was flying at low altitude along Road 35 in Mosfellsdalur, near Helgafell about 0.5 km from Road 1. The pilot looked for a possible landing site and noticed a gravel road extending out from Road 35. As the ultralight was about to glide across Road 35 on its way to the emergency landing site, its left wing hit a light pole. The ultralight turned 180° and came to rest in the middle of Road 35 (64°10' 42.96" N and 021°40' 8.51" W). See Figure 1.

**Figure 1: TF-142 at the accident site**

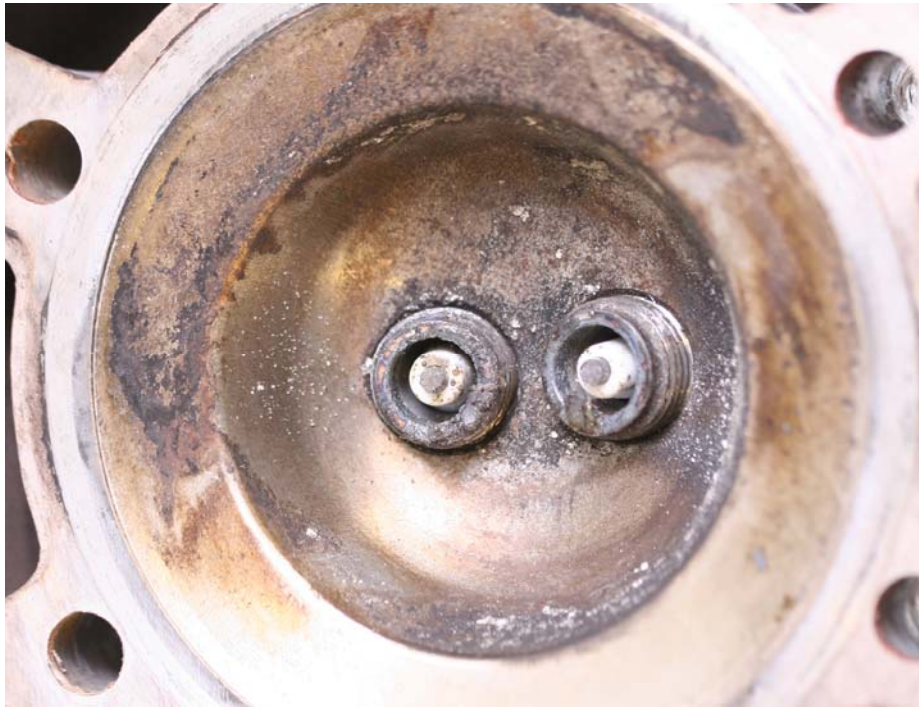
Ultralight TF-142 was equipped with one 70 HP Hirth 3503E18H piston engine with dual ignition and fuel injection system. During the ITSB<sup>4</sup> investigation the spark plugs were found damaged and the engine heads were burned. See Figure 2 and Figure 3. The pilot had changed the spark plugs prior to the flight. The pilot had purchased “NGK BR 8 ES” as the new replacement spark plugs, using Table 4.1 in the engine’s Operator’s Manual as reference (see Appendix A).

**Figure 2: Rear head with the spark plugs installed**

The ITSB concludes that the cause of the accident was that the spark plug replacement was conducted using incorrect information in the engine's Operator's Manual.

That Göbler Hirthmotoren KG updates its Operator's Manual for Hirth engine 3503 with the correct spark plug information in Table 4.1 of Chapter 6. Specifications – 3503 engine.

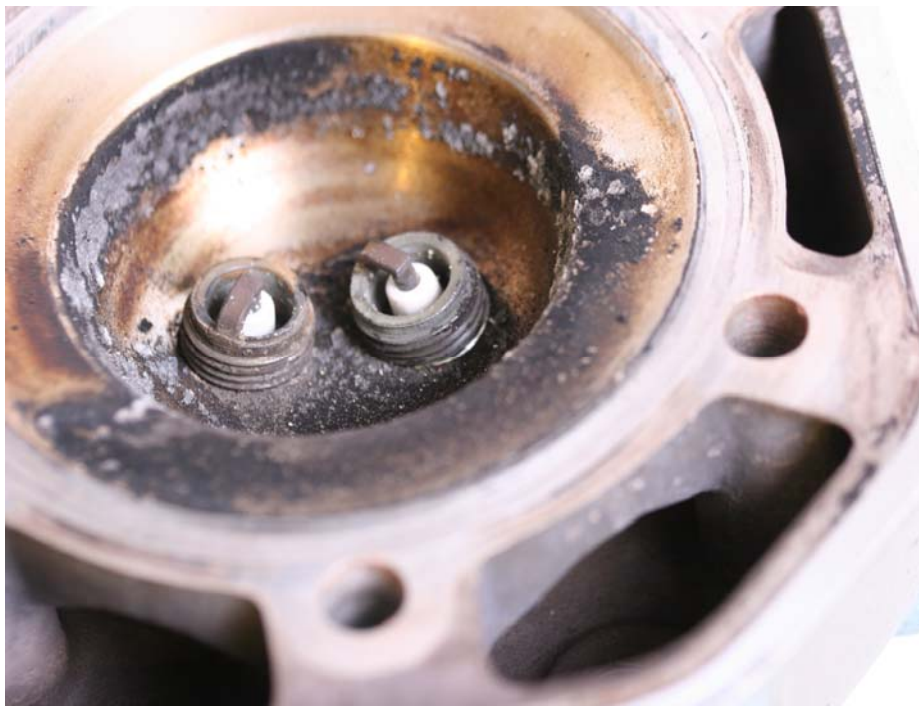
**Figure 3: Forward head with the spark plugs installed**

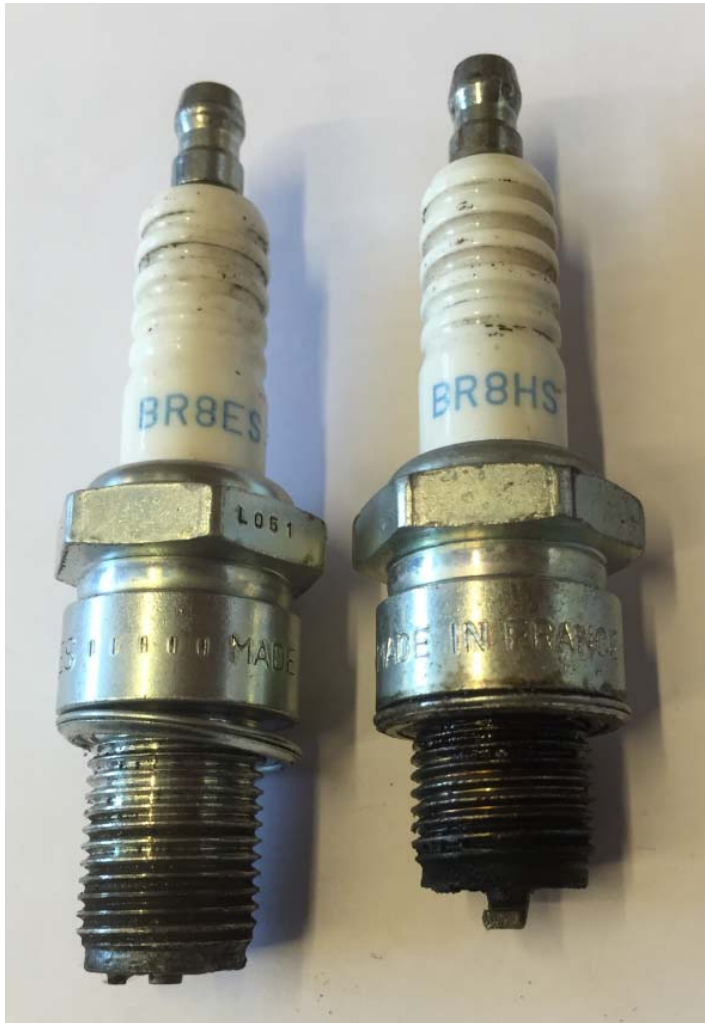
The investigation revealed that “NGK BR 8 ES” spark plugs were too long and not allowed per Hirth Engine 3502/3503 Spare-parts list (See Appendix B). Figure 4 shows one of the “NGK BR 8 ES” spark plugs that was installed prior to the accident on the LH side. It also shows on the RH side one of the “NGK BR 8 HS” spark plugs that was removed as part of that spark plug replacement.

**Figure 4: Installed BR 8 ES spark plug on LH side / Removed BR 8 HS spark plug on RH side**

The investigation revealed that the NGK BR 8 ES spark plugs that were installed prior to the accident were also not allowed per the Hirth-Information 0046/1N spark plug list for the Hirth 3503 engine (see Appendix C).

Interestingly the removed NGK BR 8 HS spark plugs were also not allowed for the Hirth 3503 engine according to all three manufacturer's references found in Appendix A – Appendix C.
