# FINAL REPORT AIRCRAFT SERIOUS INCIDENT

**Smoke in flight deck and cabin, engine  
shut down and an emergency landing**

**M-01409/AIG-09**

**Boeing 757-200**

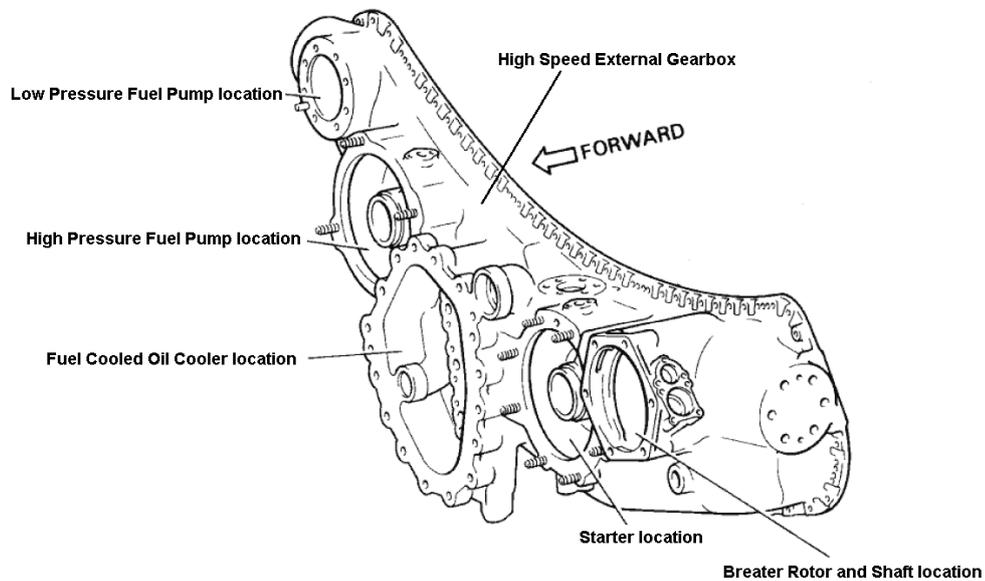
Figure 8 – The high speed external gearbox and the locations and its subcomponents

Several subcomponents installed on the high speed external gearbox, were also inspected as part of the investigation. See Figure 8.
