AIRCRAFT ACCIDENT REPORT

Fire during landing roll

M-01508/AIG-04

**TF-ARS
Air Atlanta Icelandic
Zia International Airport
Dhaka, Bangladesh
March 25, 2008**

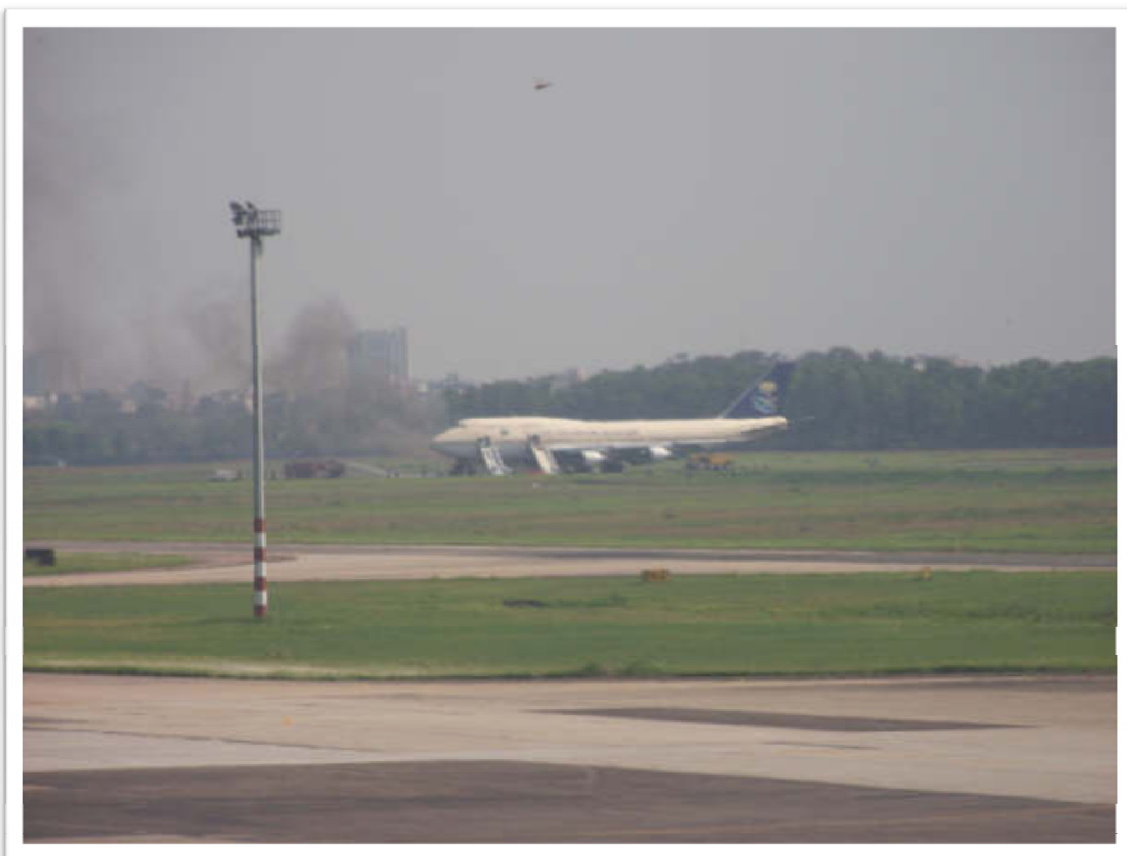
Figure 5: Fire vehicles at the accident site

The fire and rescue team was at the aircraft approximately 2 ½ minutes after the smoke/fire was observed and started extinguishing the fire immediately. The fire department used three vehicles to extinguish the fire by using a total of 1,050 liters of foam and 38,000 liters of water.
