FINAL REPORT AIRCRAFT ACCIDENT

Ditching

TF-SIF

Aerospatiale SA 365N

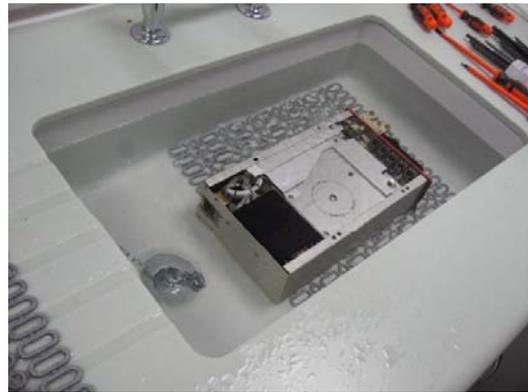
The aircraft was equipped with a Cockpit Voice Recorder (CVR) of 30 minutes duration. The recording medium was magnetic tape. The aircraft was not equipped with a Flight Data Recorder (FDR). The CVR was removed from the aircraft at the accident site, while still under water, and placed into a wet container. The CVR was kept in water until the data was downloaded. The process of downloading

Figure 7: CVR in water before further processing

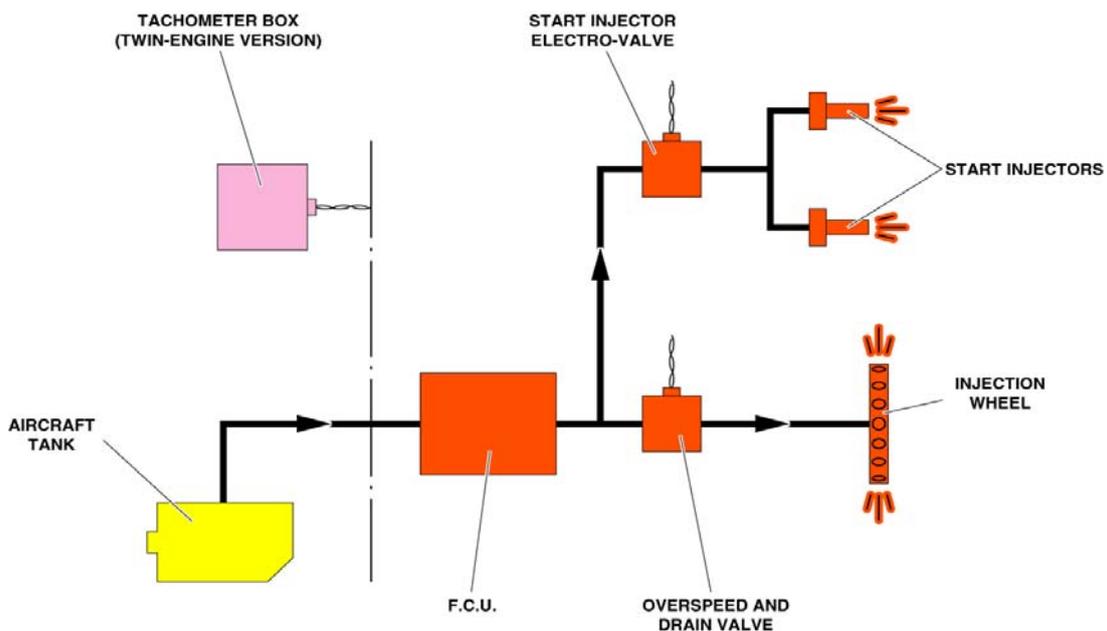
- a) Fuel Control Units (as a part of the engine fuel system).
- b) Over-speed and drain valves (as a part of the engine fuel system).
- c) Starter injector electro-valves (as a part of the engine fuel system).
- d) Tachometer Boxes.
- e) Airframe fuel system.
- f) P2 pipes (as a part of the air entering, in the engine fuel system).

Figure 10: Schematic of the analyzed components
