AIRCRAFT INCIDENT REPORT

**Report by the Danish Accident Investigation Board into the
incident to Boeing 757, TF-FIJ at Kastrup Airport, Denmark on 28
June 2001**

M-04001/AIG-09

HCL 40/01	Accident	
Aircraft type:	Boeing 757-208	Aircraft registration: TF-FIJ
Engines:	2 Rolls Royce RB211-535E4	Type of flight: Scheduled, IFR
Crew:	8 – no injuries	Passengers: 182 – no injuries
Place of occurrence:	Copenhagen Airport, Kastrup (EKCH)	Dato og tidspunkt: 28.06.2001 at 2001 hrs UTC

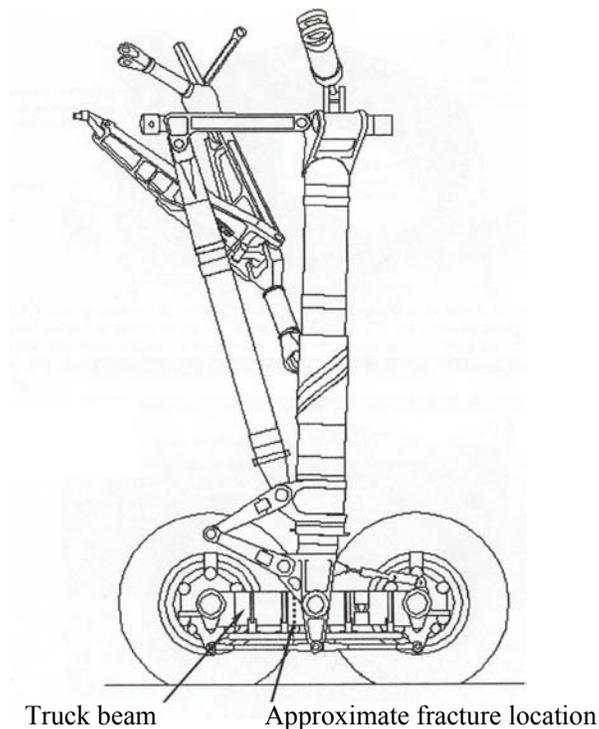
The affected gear was the right hand main landing gear.

On the drawing below, a main landing gear assembly of a B-757 is shown.

The part of the main landing gear assembly that failed was the truck beam assembly.
