### Final report on aircraft serious incident

Case no.: **18-104F018**

Date: **16. June 2018**

Description: **Foreign Object Damage**

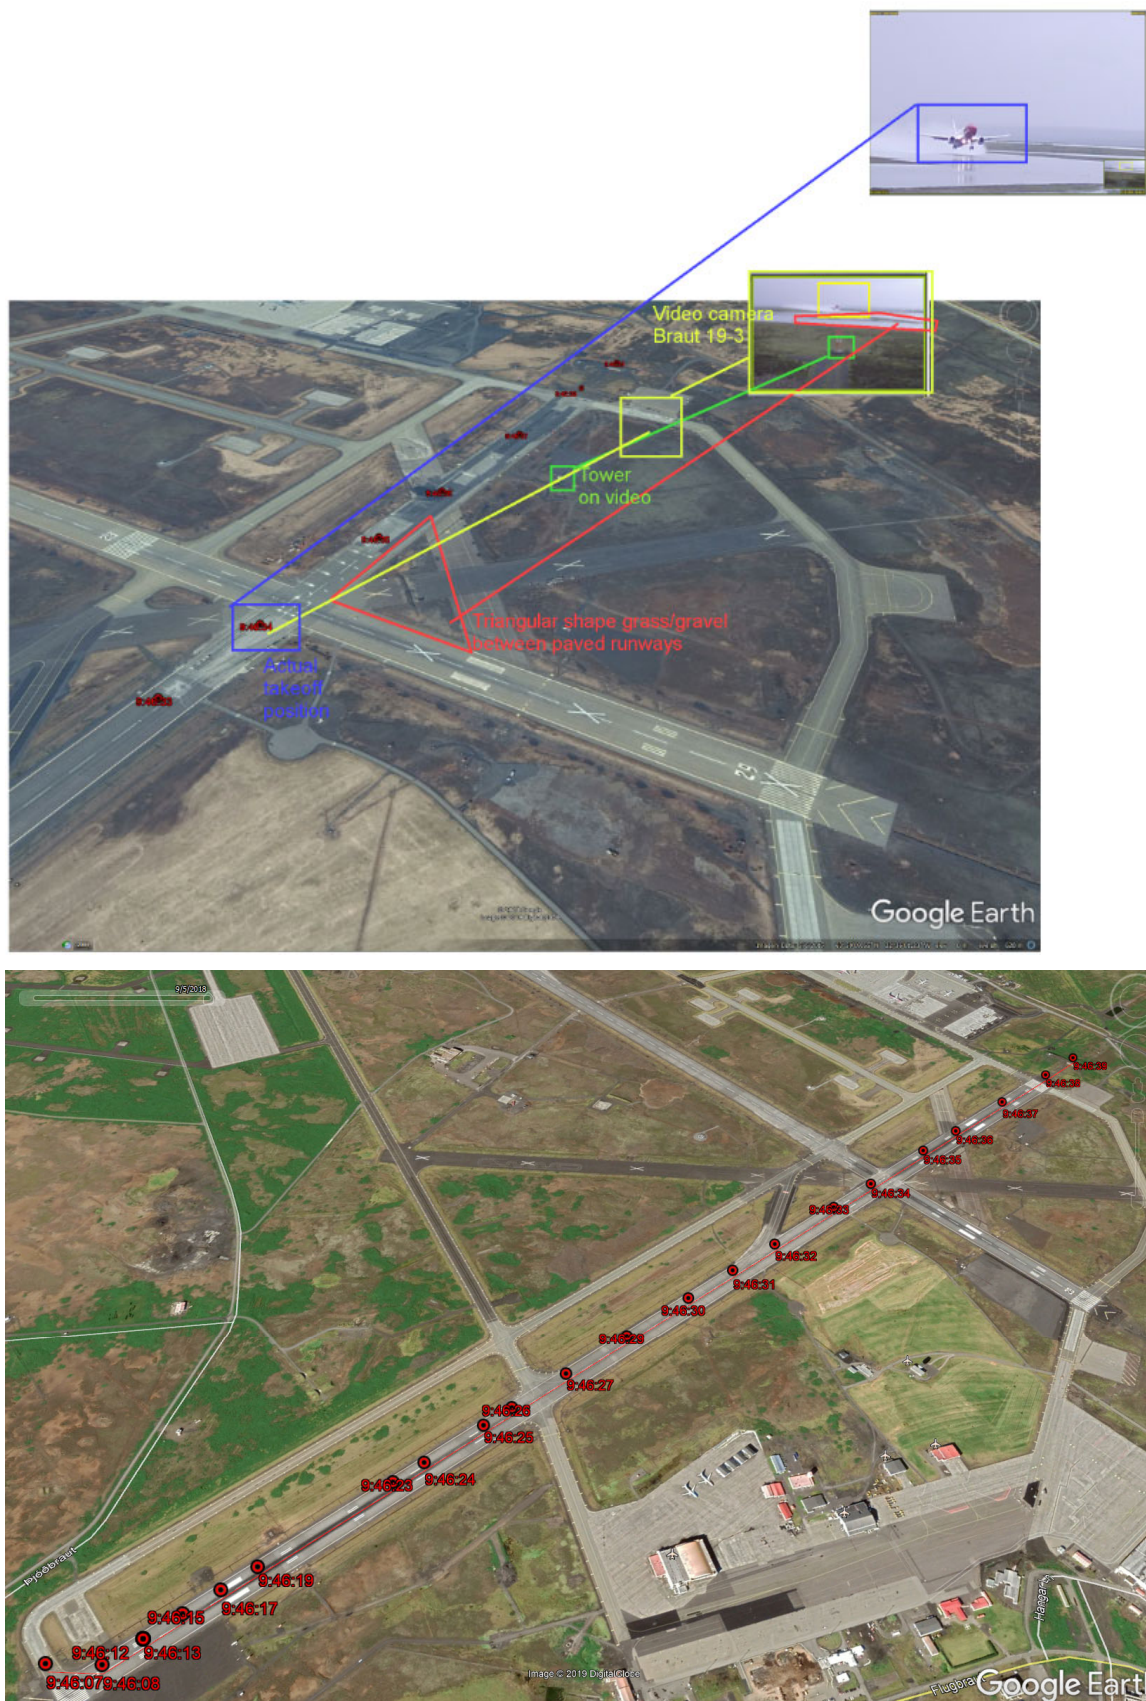
Figure 9: The takeoff run and the liftoff (9:46:34) of aircraft EI-FHD at Keflavik Airport

The crew of aircraft EI-FHD reported abnormal vibration during the aircraft's takeoff run at RWY 01 at BIKF airport. In addition, inspection of RWY 01 and its surrounding area revealed debris on the left side of RWY 01 between taxiway S-2 and high speed RWY taxiway A-1.

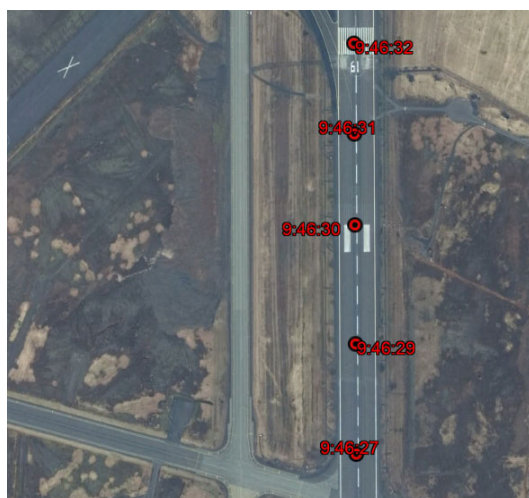
According to the FDR data, the aircraft passed this area of the runway during its takeoff run between 9:46:27 and 9:46:32.

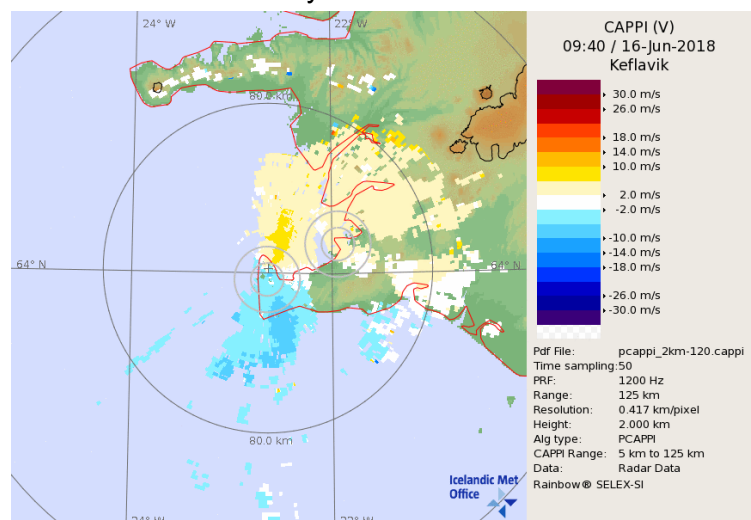
Weather data around the time of the takeoff period of the aircraft was investigated. The wind was very light (< 10 m/sec) in the area and it is unlikely to have caused the fluctuations in the lateral acceleration during the takeoff run of the aircraft.

**Figure 13: Wind around BIKF Airport at 9:40**

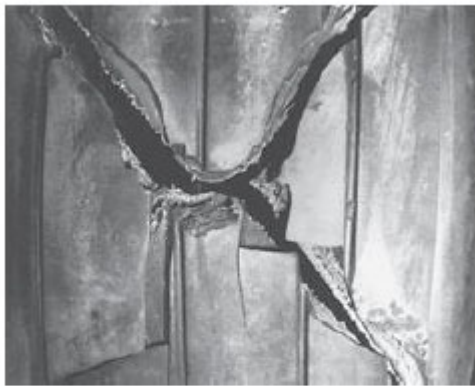
**Impact Break**

According to a tire care and maintenance document<sup>14</sup> from the tire manufacturer, the damage to the tire in Figure 4, most closely resembles two kinds of damage:

- Thrown Tread
  - Caused by partial or complete loss of tread down to tread fabric ply or casing plies
  - Can happen if the tire deflates
- Impact Break
  - Could be caused by extreme hard landing (not the case here)
  - Could be caused by a penetration by a foreign object

Rupture of tire casing in tread or sidewall area, usually from extremely hard landing or penetration by a foreign object.

Action: Remove from service.

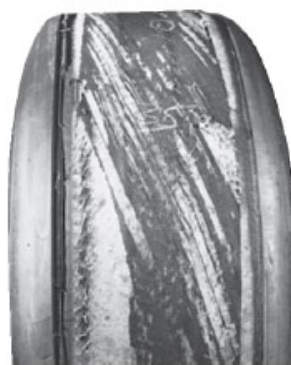
**Thrown Tread**

Partial or complete loss of tread down to tread fabric ply or casing plies.
