Final report on aircraft serious incident

Case no.: **17-042F012**

Date: **28. April 2017**

Description: **Runway excursion during landing**

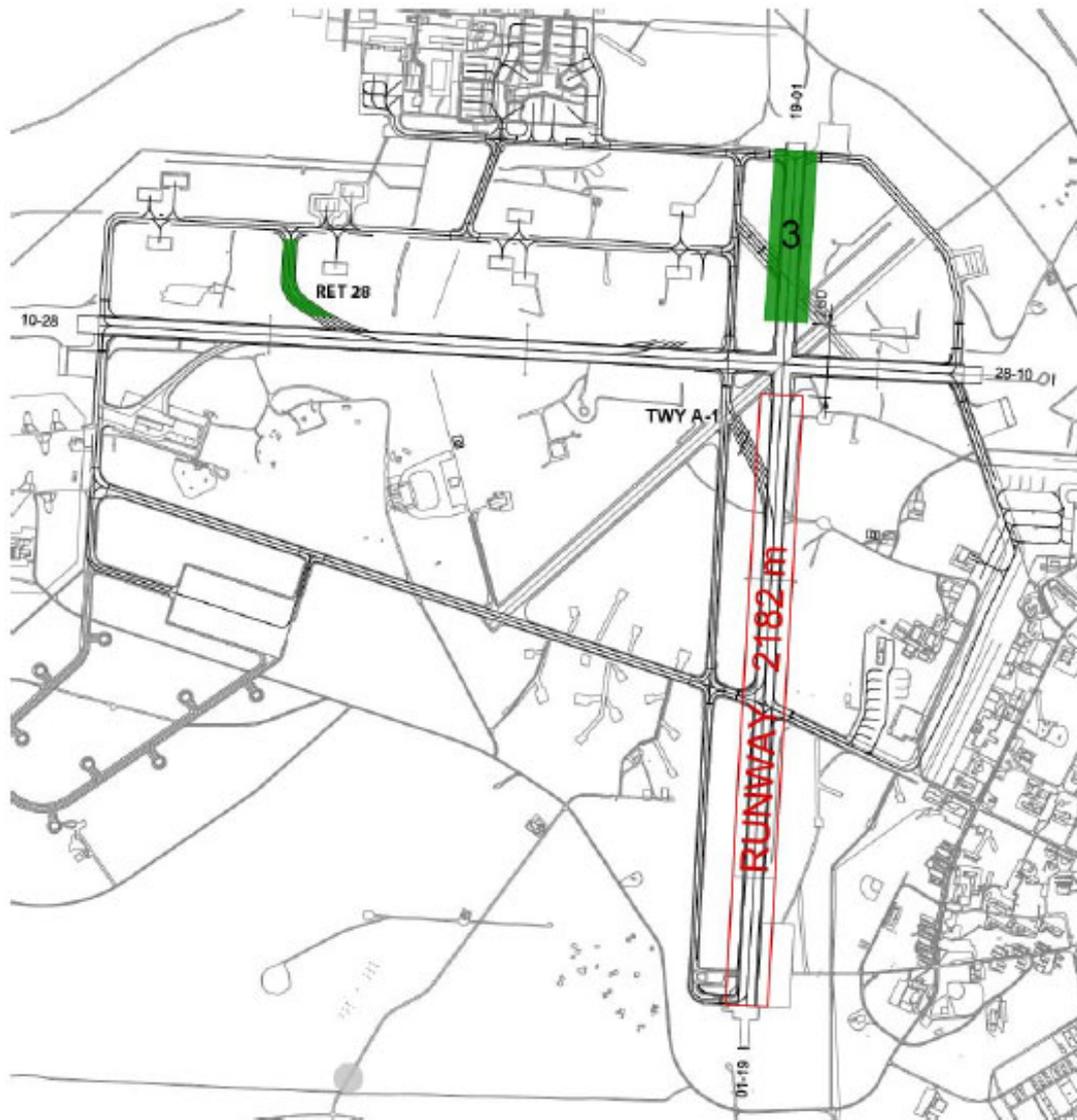
Figure 4: RWY 19 displaced threshold south of RWY 10/28 (AIP SUP 004/2017)

In Phase 3 of the Runway Reconstruction Project, the part of RWY 19 that was north of RWY 10/28 was under reconstruction and no lights were on that portion of the RWY. Therefore, between the approach lights north of RWY 19 and the displaced threshold of the runway south of RWY 10/28, there was a long gap with no lights.

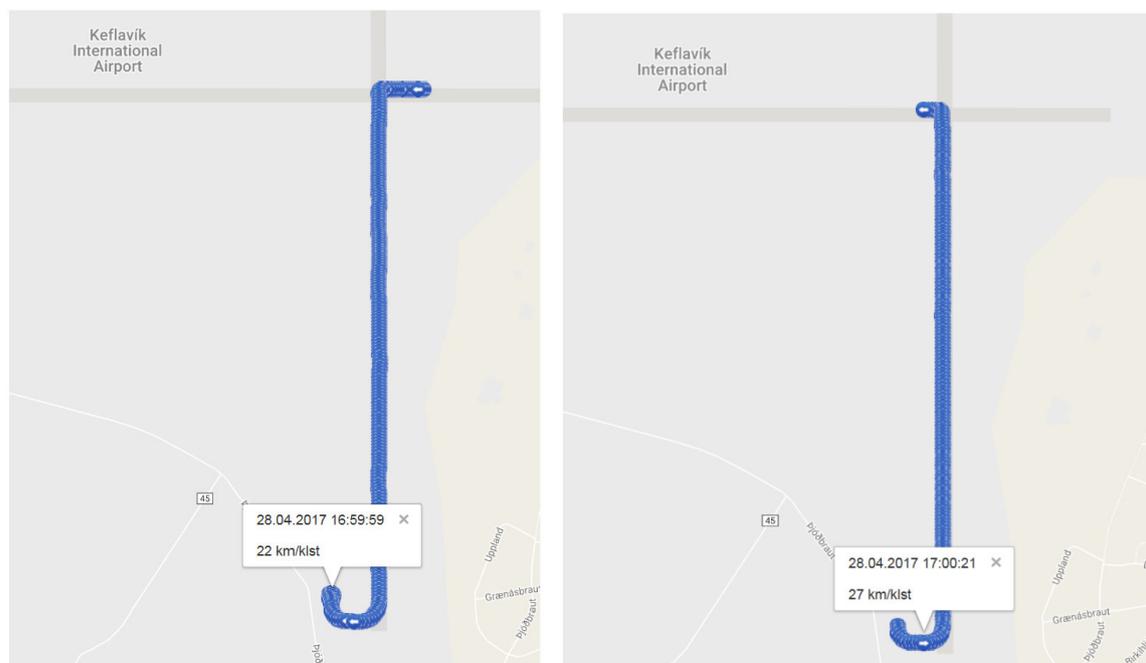
Figure 5: Snowplows cleared RWY 19 between 16:52 and 17:06

Therefore, between 16:52 and 17:06 a combined width of 50 meters around the centerline of RWY 19 was cleared of snow, all the way from RWY 10/28 and to the far exit at taxiway E-1.

This meant the complete length of RWY 19 (2182 meters) was cleared of snow, just before the flight crew of flight 6F108 finished the landing checklist, after having passed through 2500 feet on its first final approach.

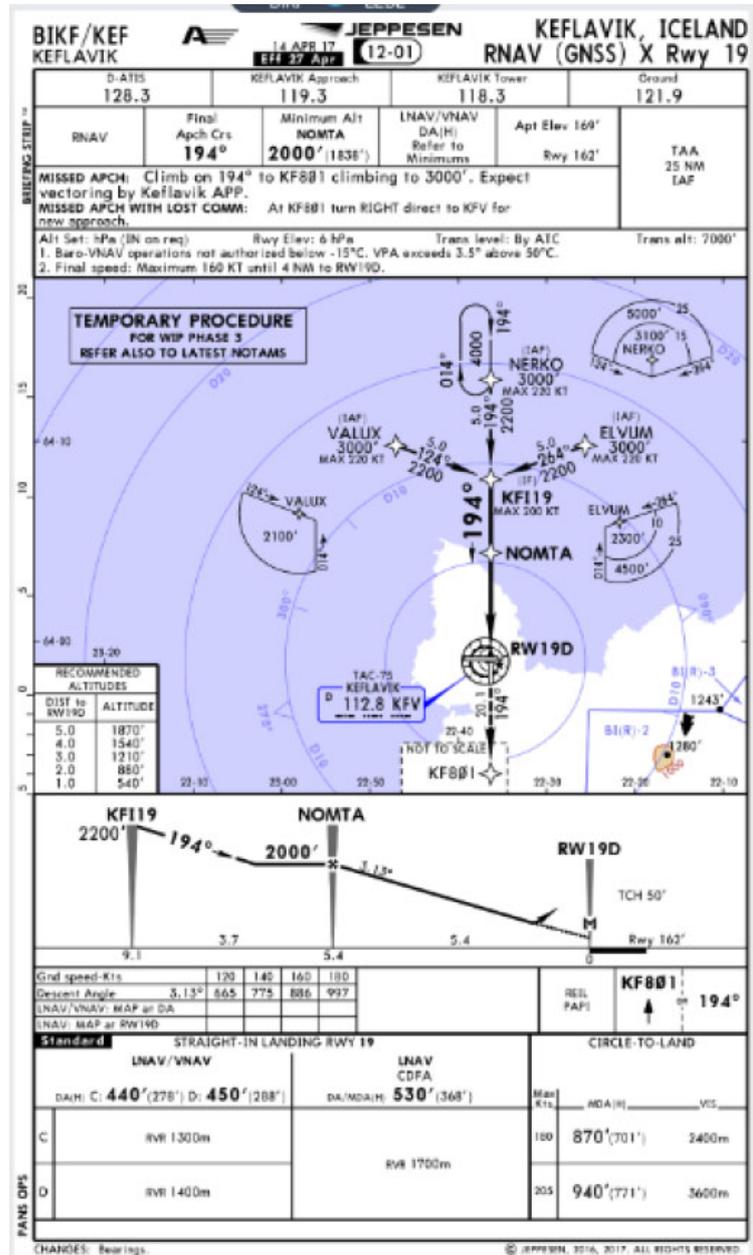
Figure 6: BIKF RNAV-X Approach chart for RWY 19

According to the RNAV-X chart in Figure 6, for RWY 19 at BIKF, the Decision Altitude (DA) was 440 feet for LNAV/VNAV approach and the minimum Runway Visual Range (RVR) was 1300 meters.

According to the RNAV-X chart in Figure 6, the minimum Runway Visual Range (RVR) to start the approach was 1300 meters and the Decision Altitude (DA) was 440 feet.

According to the RNAV-X chart in Figure 6, the Decision Altitude (DA) was 440 feet for LNAV/VNAV approach and the required runway visual range (RVR) was 1300 meters, or a minimum visibility of just under 900 meters.

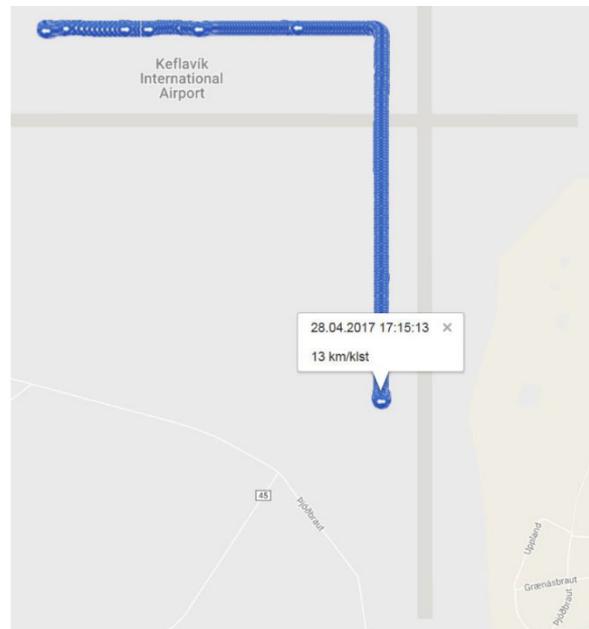
Figure 11: Clearing Echo and Kilo taxiways

The supervisor and the ATCO then agreed on that the snowplows should continue clearing taxiway Echo towards the north.

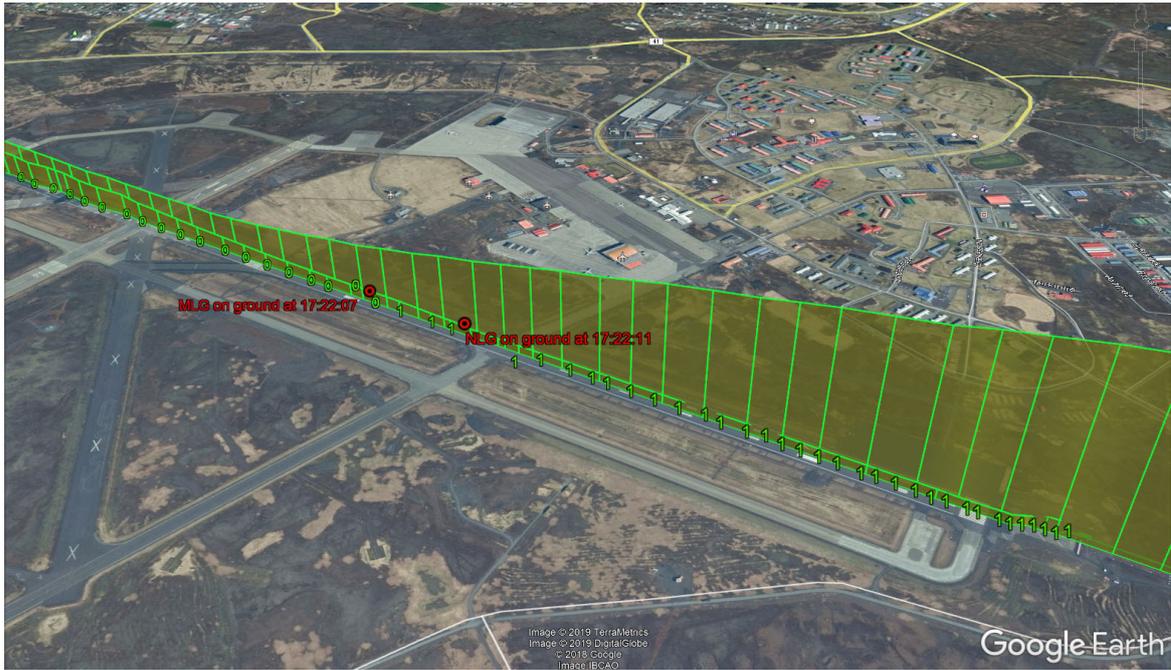
Figure 16: Aircraft profile during landing

It was snowing extensively during the landing of flight 6F108. The ITSB therefore suspects that the depth perception of the PF was most likely degraded due to illusion during the landing, which may have contributed to the extended float.

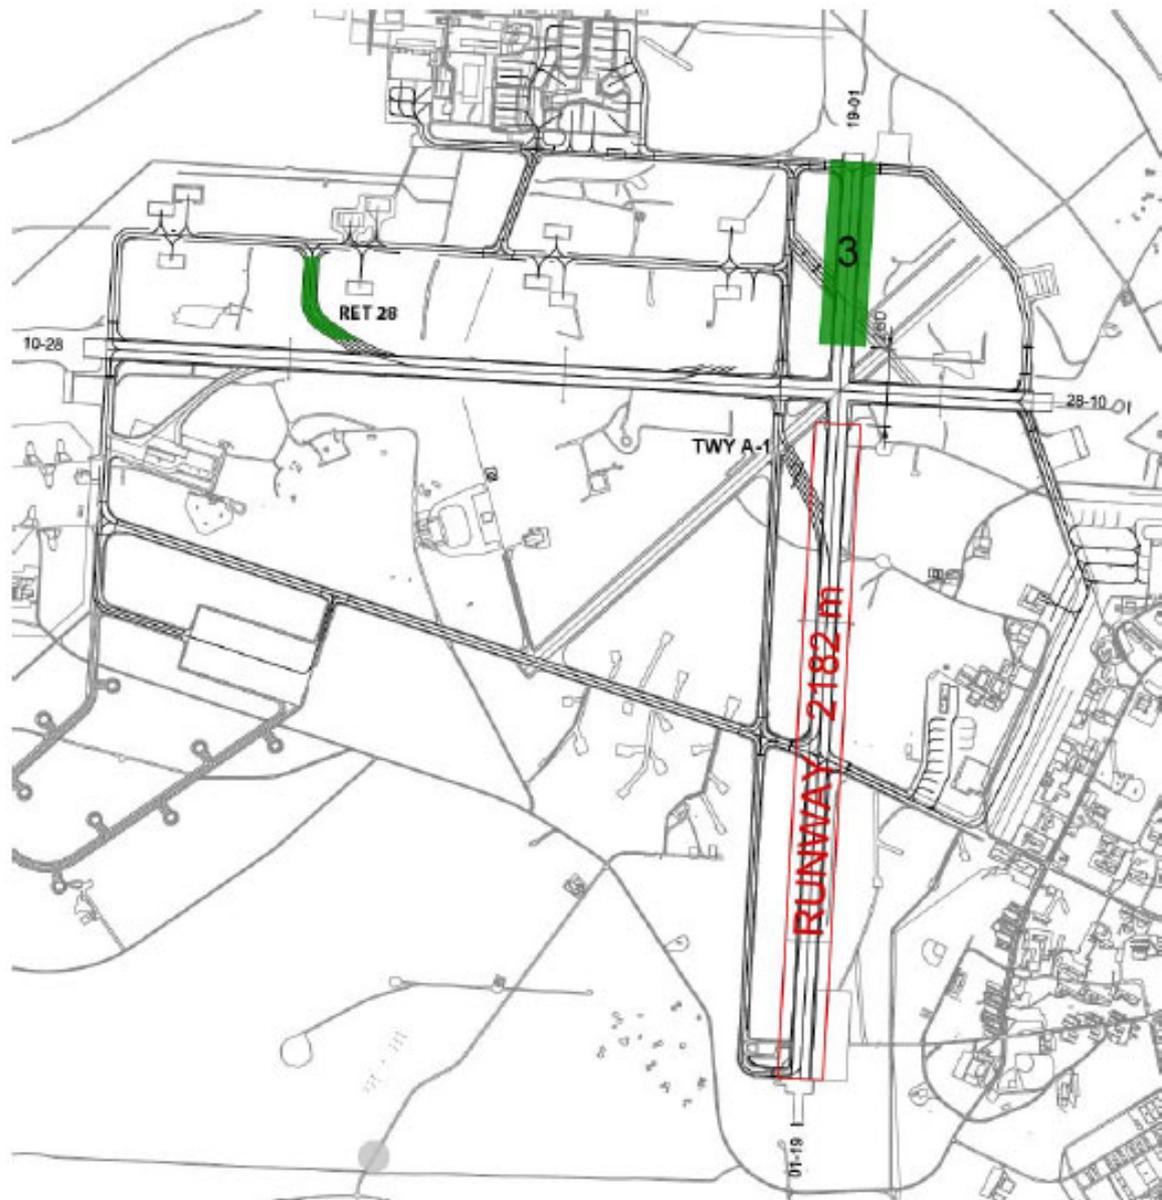
Figure 18: RWY 19 had a displaced threshold and LDA of 2182 meters

When the runway excursion occurred, Phase 3 of the Runway Reconstruction Project was in effect. During Phase 3, RNAV-X was in use for RWY 19. The Landing Distance Available (LDA) for RWY 19 was 2182 meters, with a displaced threshold just south of RWY 10/28.

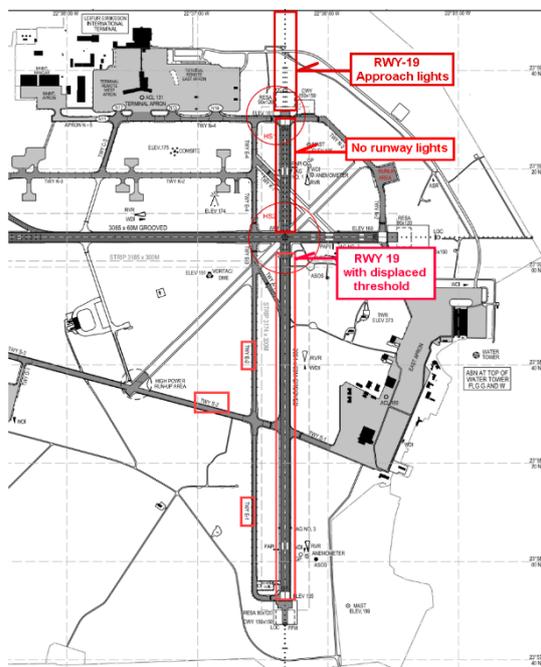
During Phase 3 of the Runway Reconstruction Project, the part of RWY 19 that was north of RWY 10/28 was under reconstruction and no lights were on that portion of the RWY.

Therefore, after the approach lights north of the RWY, there was a long gap with no lights until the displaced threshold of the runway south of RWY 10/28. This resulted in the flight crew losing visual sight of the approach lights, after passing over them, without having the runway yet in sight.

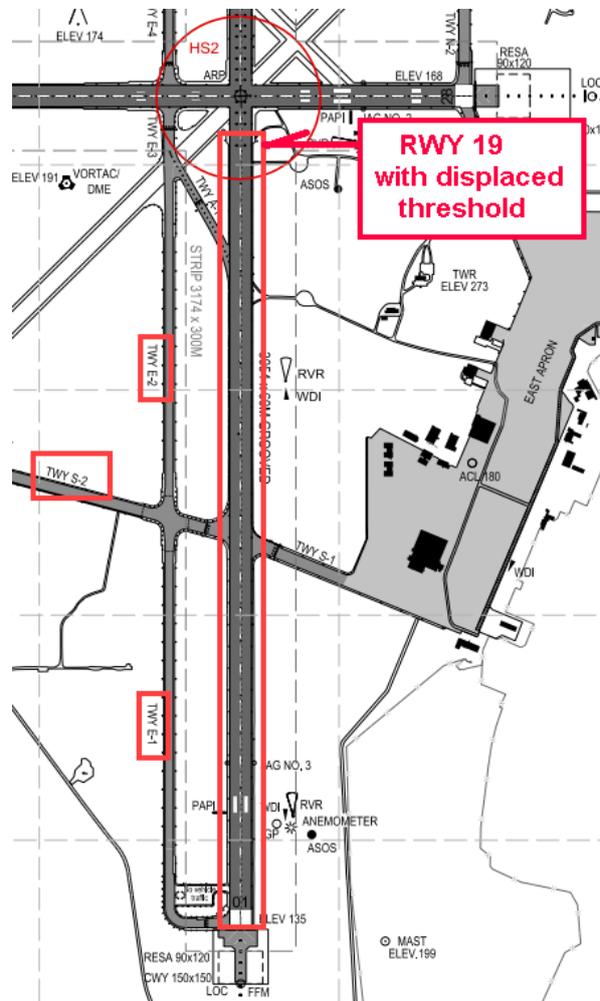
Figure 21: RWY 19 and its taxiways

The investigation determined that the snow removal supervisor did not inform the tower at which taxiway [Sierra-2] they vacated RWY 19.

After the first landing attempt, the five snowplows only managed to clear 25 meter width around the centerline of about 1070 meter length of the runway 19 from the runway threshold to taxiway Sierra-2, before vacating the runway at taxiway S-2 at 17:14.

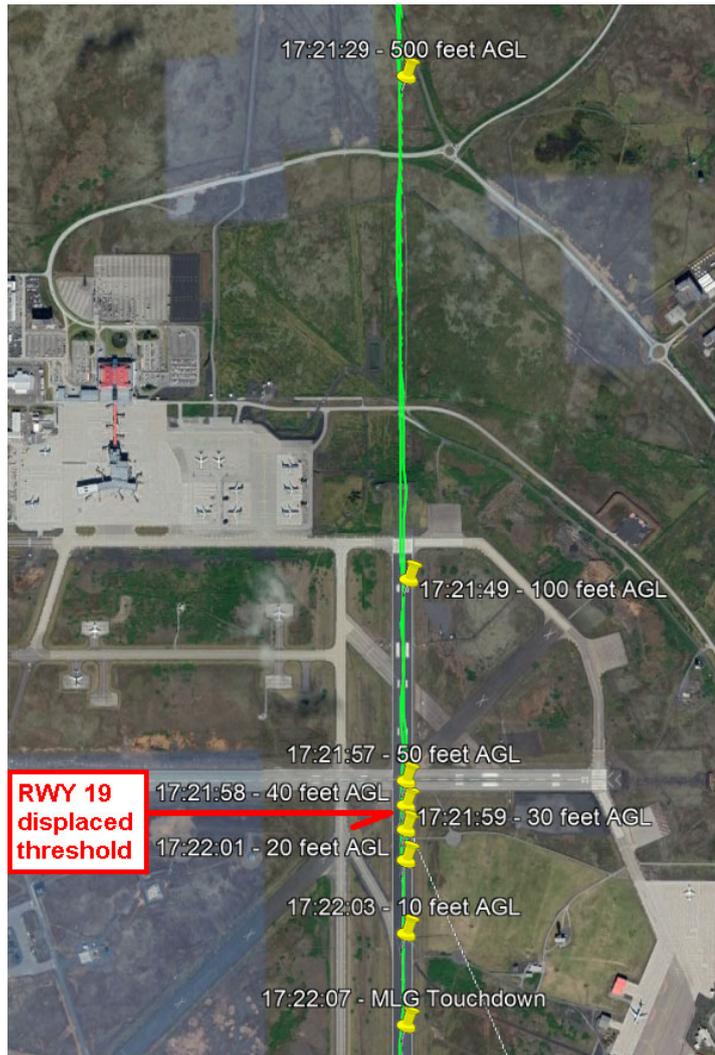
Figure 23: The Final approach (Google Earth+FDR data)

- The aircraft passed through 50 feet AGL at 17:21:57
- The aircraft passed through 40 feet AGL at 17:21:58
- The aircraft passed through 30 feet AGL at 17:21:59
- The aircraft passed through 20 feet AGL at 17:22:01
- The aircraft passed through 10 feet AGL at 17:22:03
- The Main Landing Gear touchdown was at 17:22:07
