Report on the stranding of Wilson Skaw

Case nr.: **23-021-S-011**

Date: **18th of April 2023**

Description: **Vessel stranded when hitting an underwater rock**

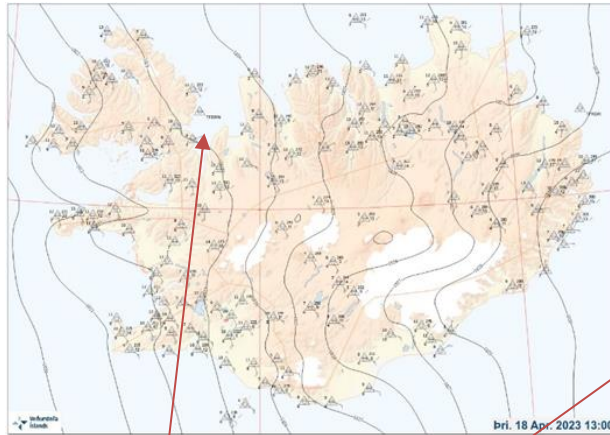
Figure 2

Weather on the grounding
site on the 18th of April at
13:00 from Icelandic Met
Office (fig 2 & 3).

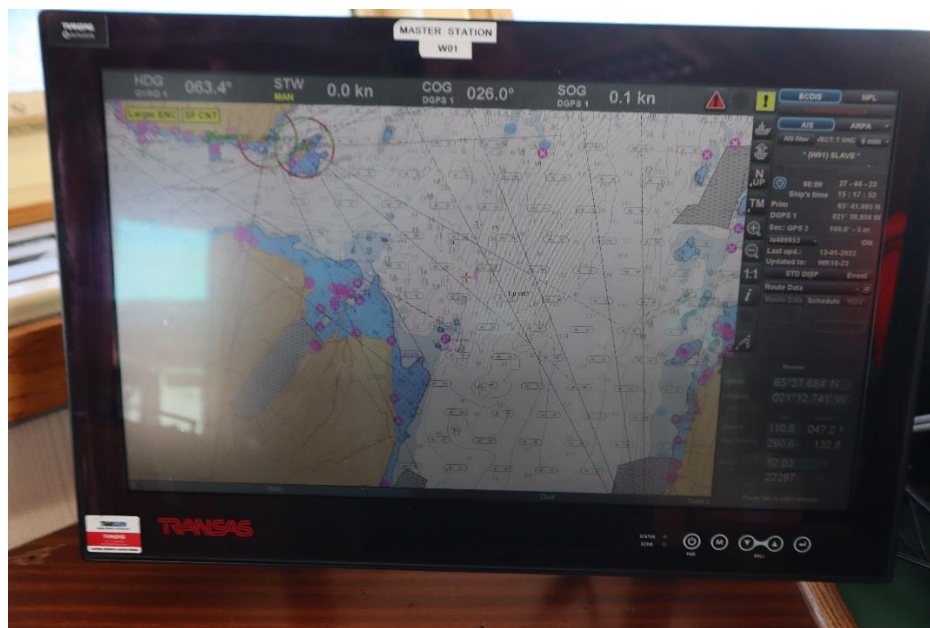
Figure 4: One of two ECDIS on board Wilson Skaw

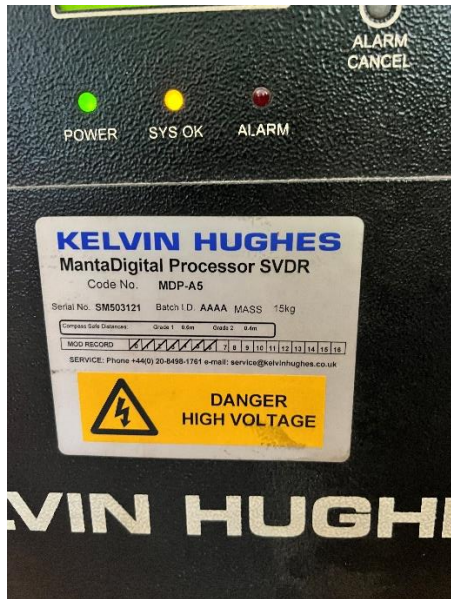
Figure 5: S-VDR

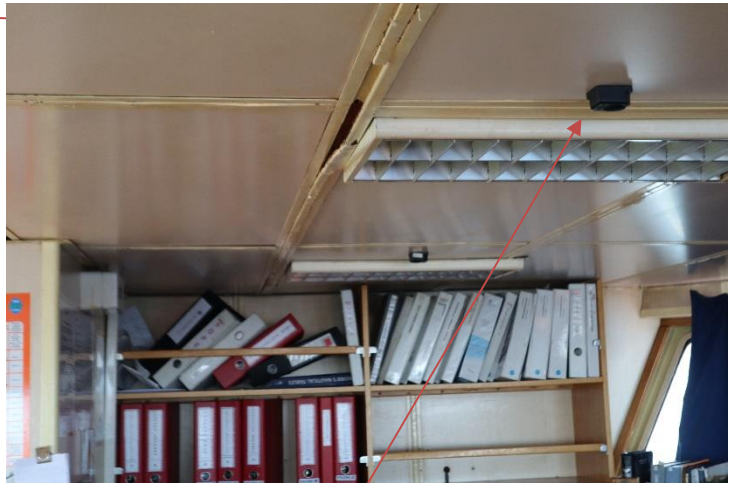
Figure 6: Microphone for the S-VDR over the chart table

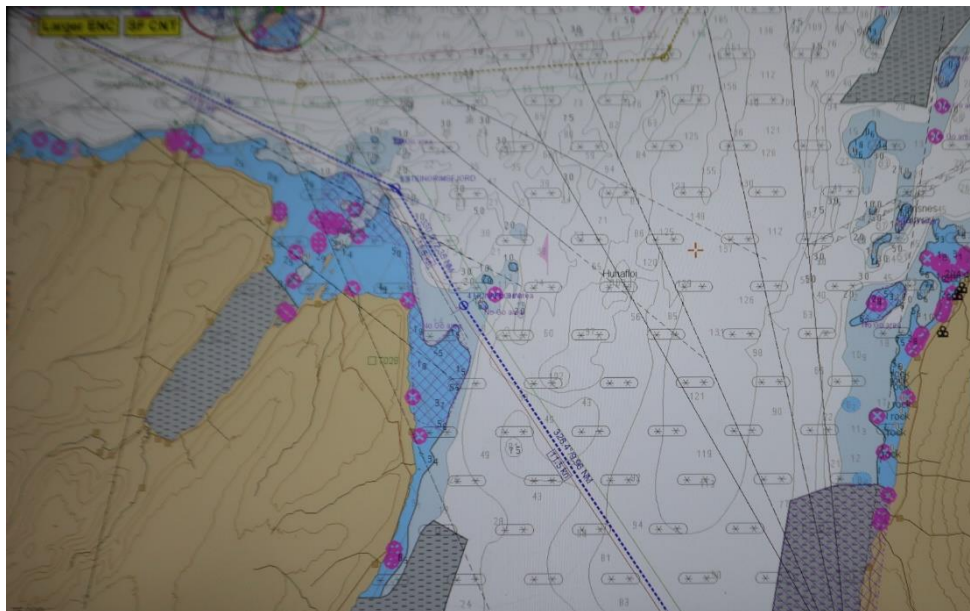
Figure 8.

The voyage input in the vessels ECDIS is shown in figure 8.

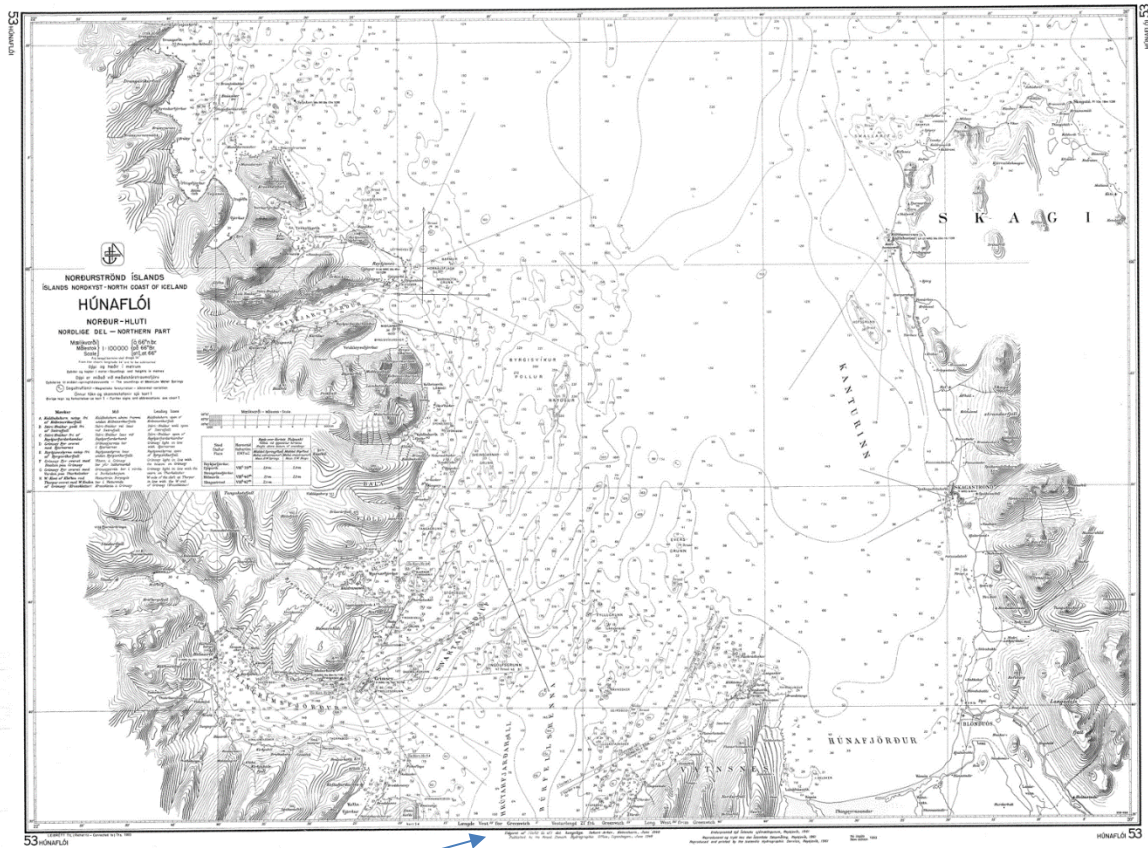
Figure 10

The ECDIS was updated only a few days before the incident. The bathymetry data that the electrical charts was based on is mostly from Danish charts since 1948 (Figure 10). Closer to shore the depth was surveyed with a led line and a sinker.

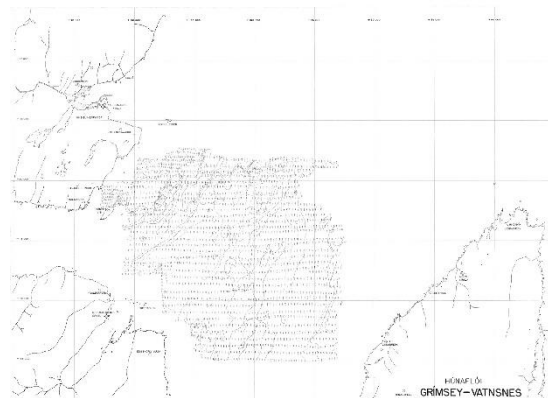
Figure 11 shows bathymetry data from the Royal Danish Hydrographic Office (Kongelige Søkort - Arkiv), Copenhagen, June 1948.

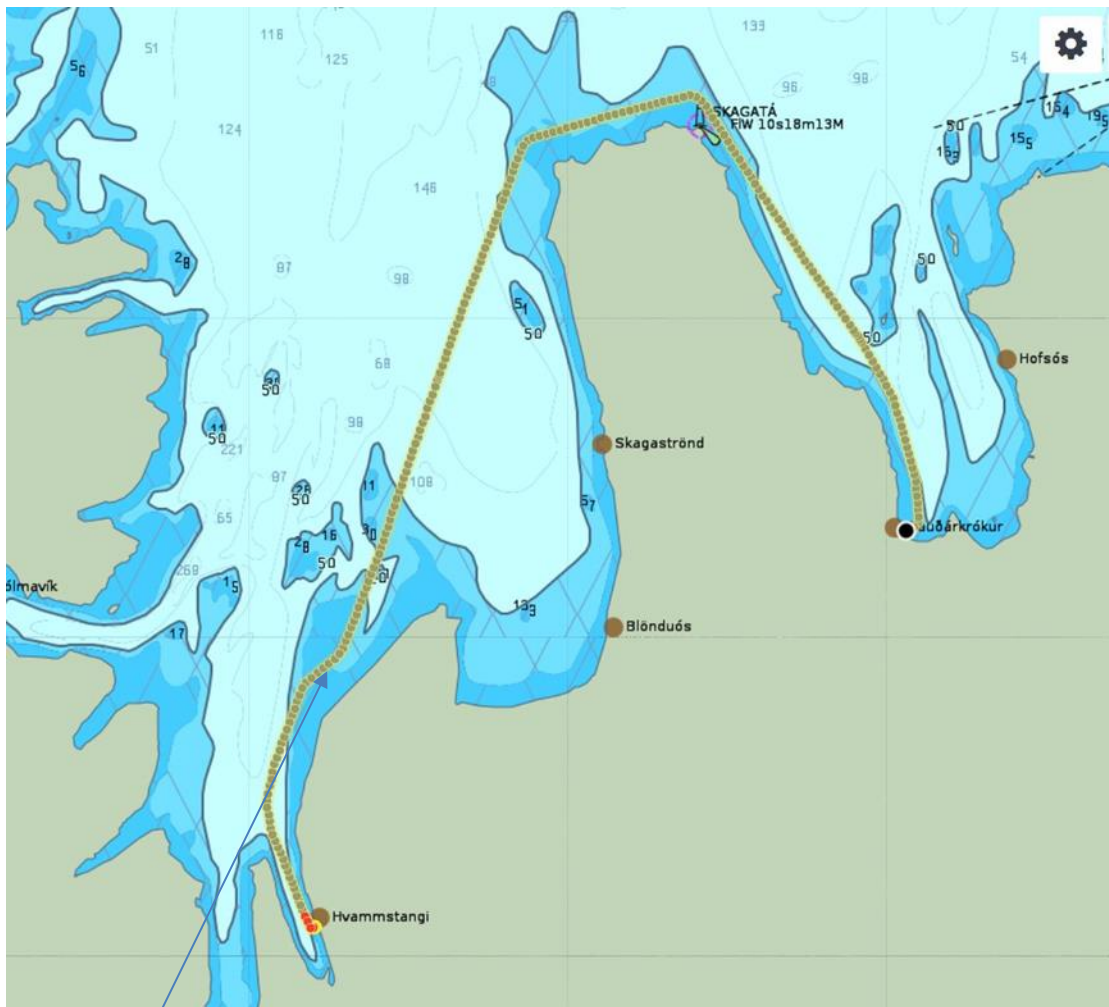
As can be seen in Figures 14-16 Wilson Skaw went from waypoint 7 (Vatnsnes) to waypoint 12 (Midfjörður) in a CATZOC area D.

Figure 14 Voyage Sauðárkrúkur-Hvammstangi

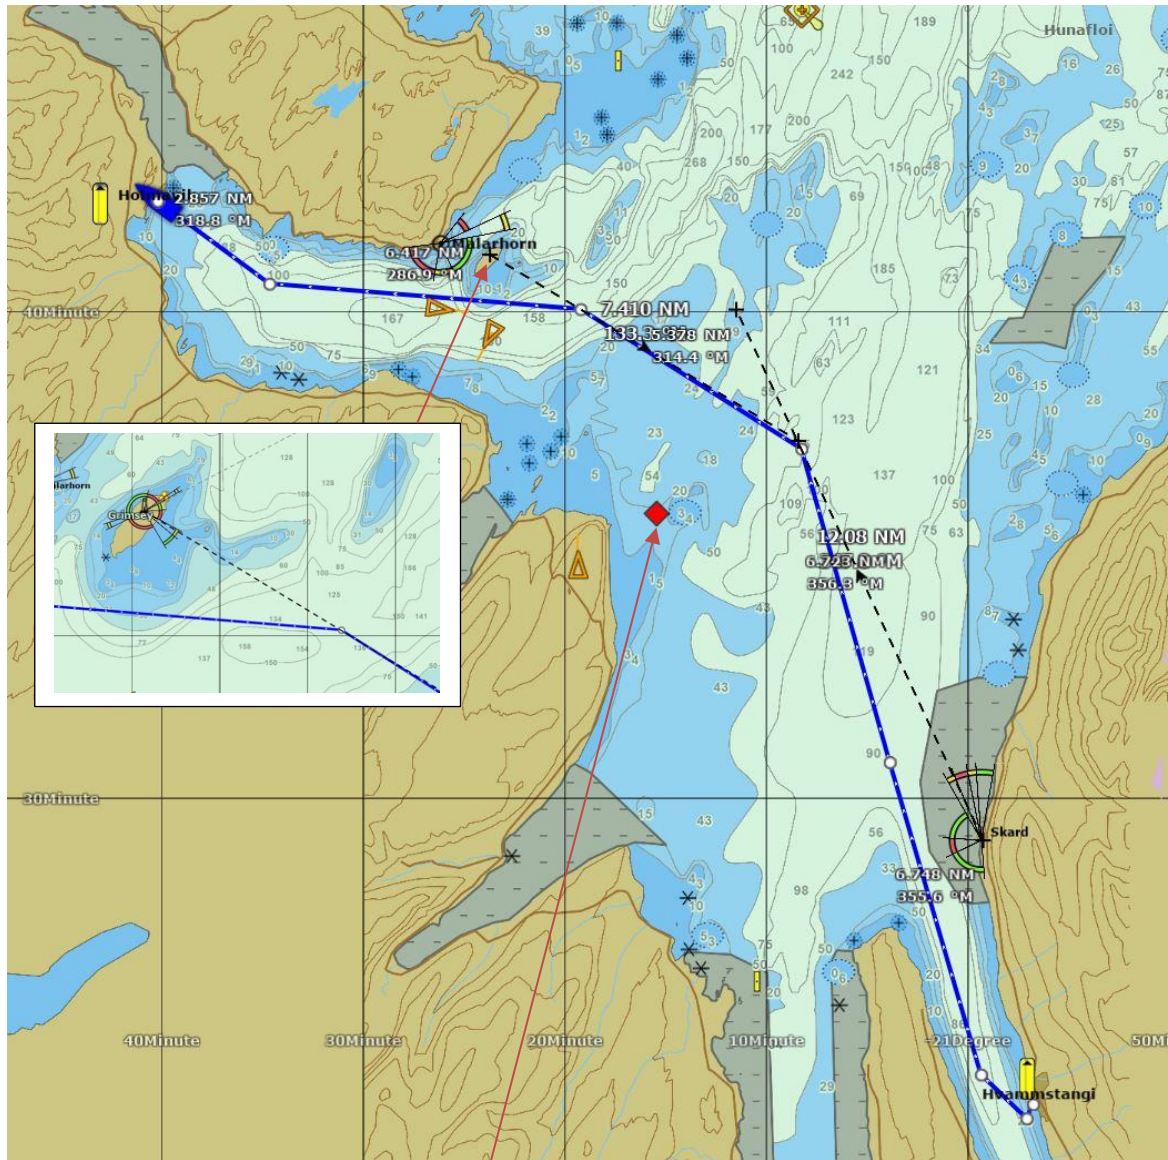
Figure 19

Maps issued by Icelandic Coast Guard Hydrographic Department suggest a sailing route by light sectors as shown in Figure 19. Such a route is also shown in electronic charts like the one that was being used on board Wilson Skaw.
