### Final report on aircraft serious incident

Case no.: **18-199F035**

Date: **1. November 2018**

Description: **In-flight shutdown of Engine no. 2 due to loss of oil pressure**

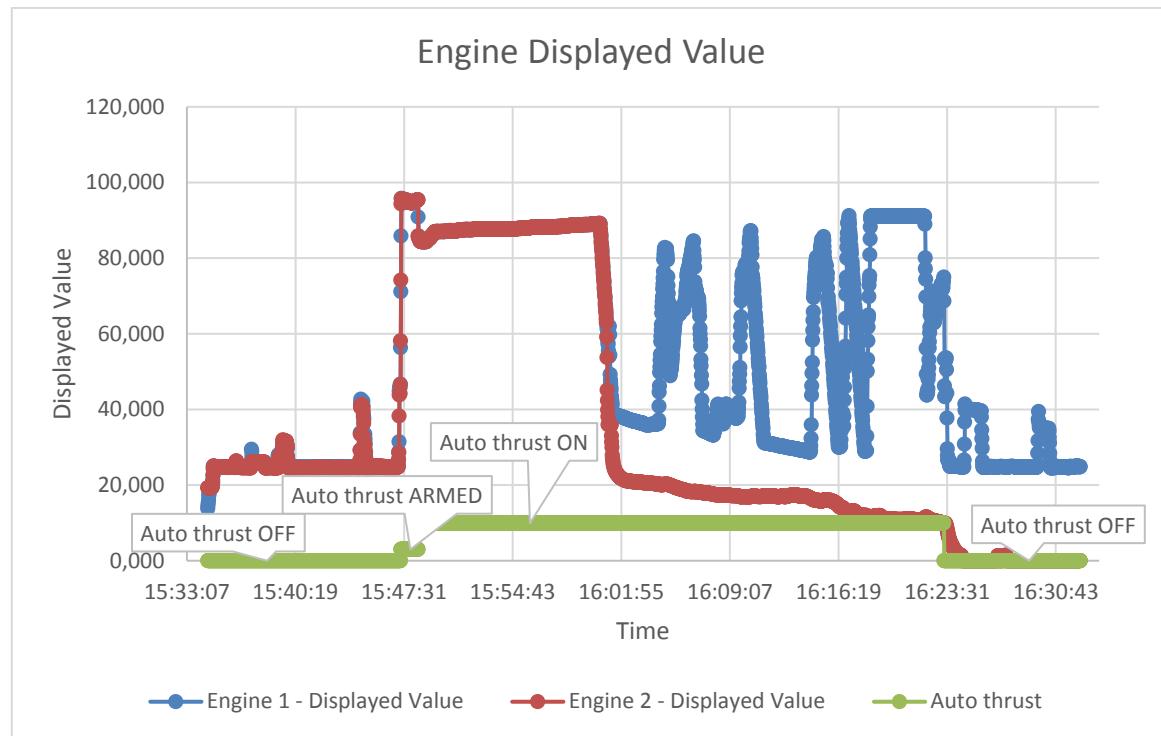
**Figure 7: Engine displayed value**

Comparison of the engine pressure (Figure 6), the engine displayed value (Figure 7) and the engine throttle value (Figure 8) parameters, revealed that Engine no. 1 did not operate continuously at high-power after Engine no. 2 shutdown.

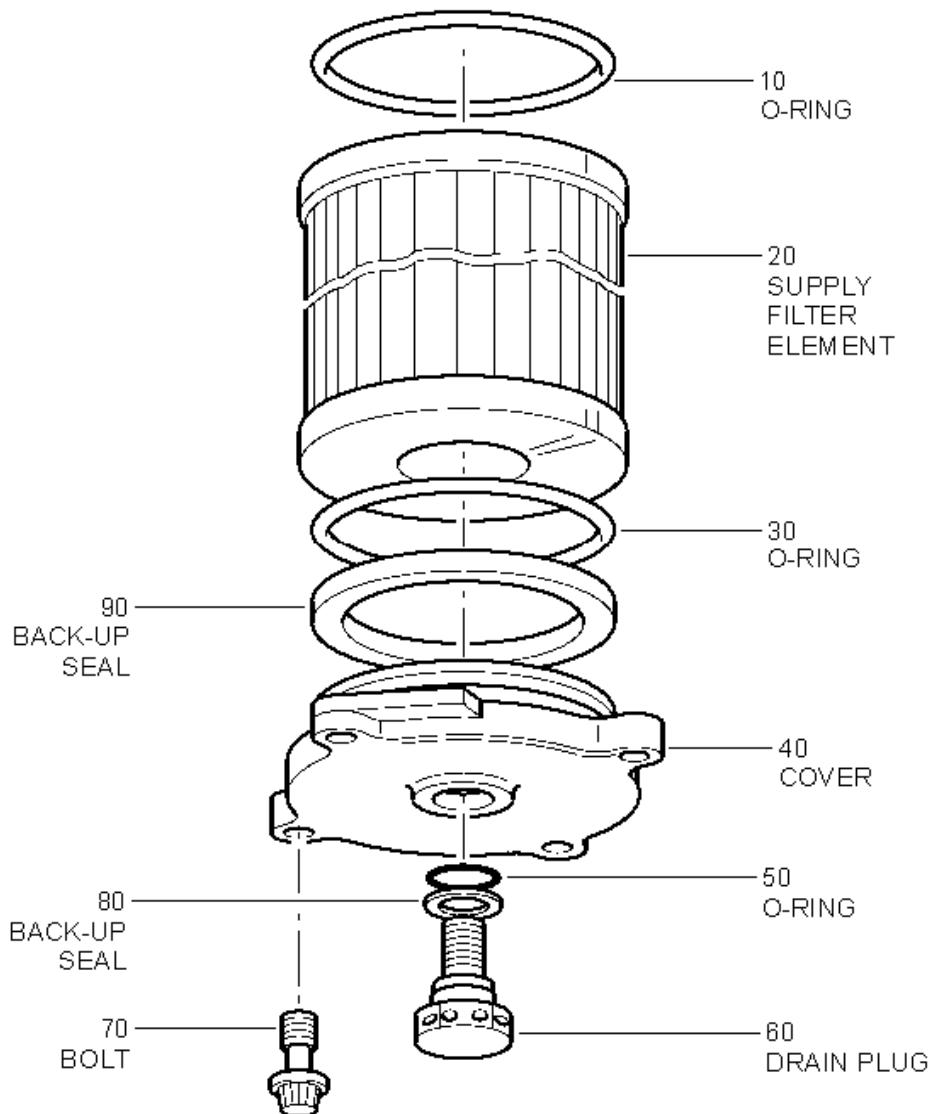
**Figure 10: Main Oil Supply Filter**

Nevertheless the underlying instructions (a)-(e) in part (4) are only instructions to attach the filter (item 20 in Figure 10) to the filter cover (item 40 in Figure 10), to lubricate packings (item 40 in Figure 10) and to install O-ring packing packings (item 40 in Figure 10). See Figure 11 for details.

With regards to the oil leak, the investigation determined that Adria Tehnika technicians describing a “*more desirable way of installing*” O-RING item 50 in Figure 10 on the drain plug instead of installing it into the filter cover as per the AMM. This is incorrect, as stated in the caution in subpart (e) of part (4):

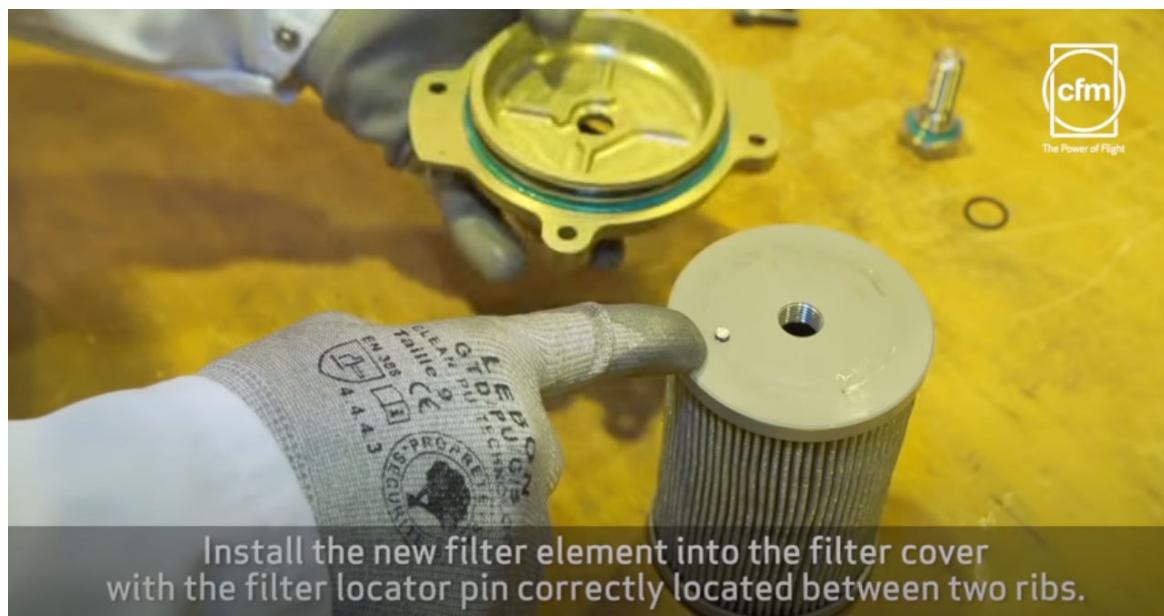
Figure 13: The filter locator pin

Safran Aircraft Engines, on behalf of CFM, has issued a training video<sup>15</sup> of the correct installation of the oil supply filter. Figure 13 to Figure 16 show part of this process. This video highlights the importance of installing the filter element (20) into the filter cover (40) [as per AMM subtask 79-21-10-420-060-A part (4)], before installing it into the lube filter housing of the engine [as per AMM subtask 79-21-10-420-060-A part (7)].
