# AIRCRAFT INCIDENT REPORT

Fairchild Hiller, FH-227B.

Corporation, N564LE.

Keflavik Airport, Iceland (N63°59'06"W022°36'20").

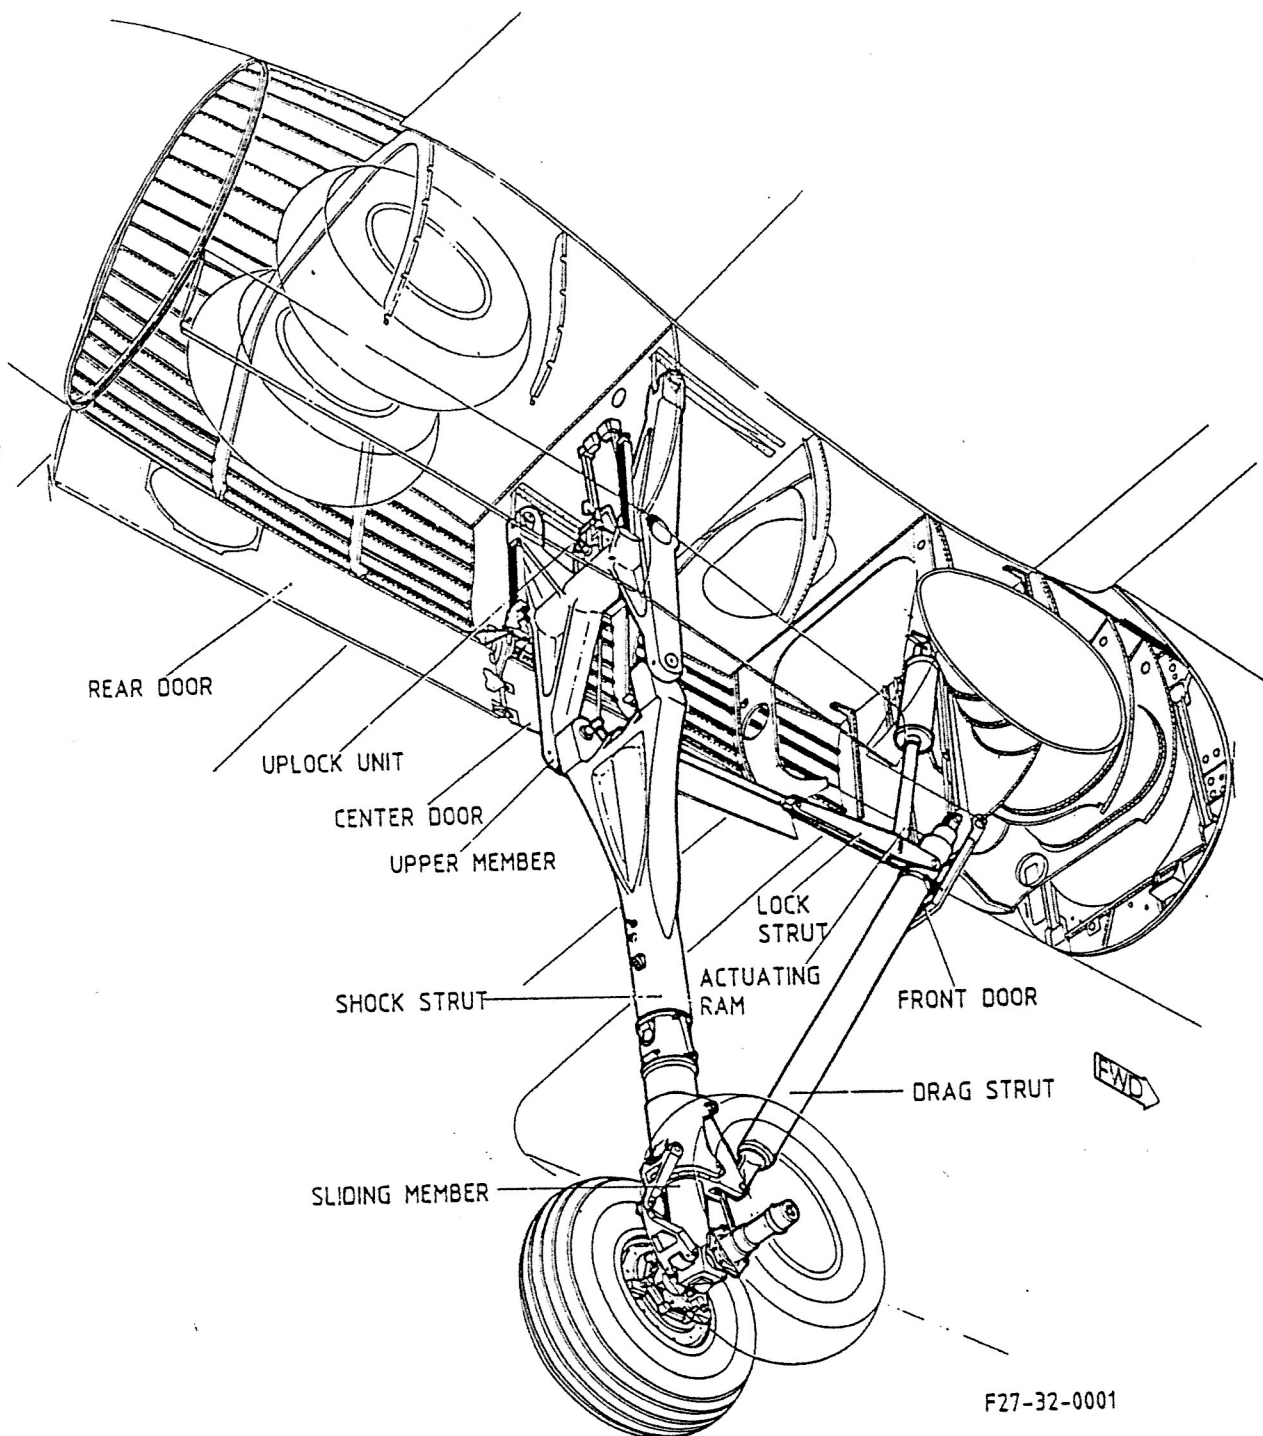
FIG. 1 MAIN LANDING GEAR - GENERAL ARRANGEMENT (MK 200, 400, 600)

The aircraft suffered a failure of the right hand main landing gear lock strut assembly during flight. As structural integrity is required of the lock strut assembly to maintain the rigidity of the main landing gear in the down position to carry the aircraft on ground, the landing gear collapsed towards retracted position when it took weight when the aircraft landed.

During the landing roll, when the landing gear collapsed toward the retracted position, with the drag strut and the fore member of the lock strut remaining in the down position, held by the actuating ram, the drag strut failed due to excessive bending load at the pin where the fore member of the lock strut was attached to it.

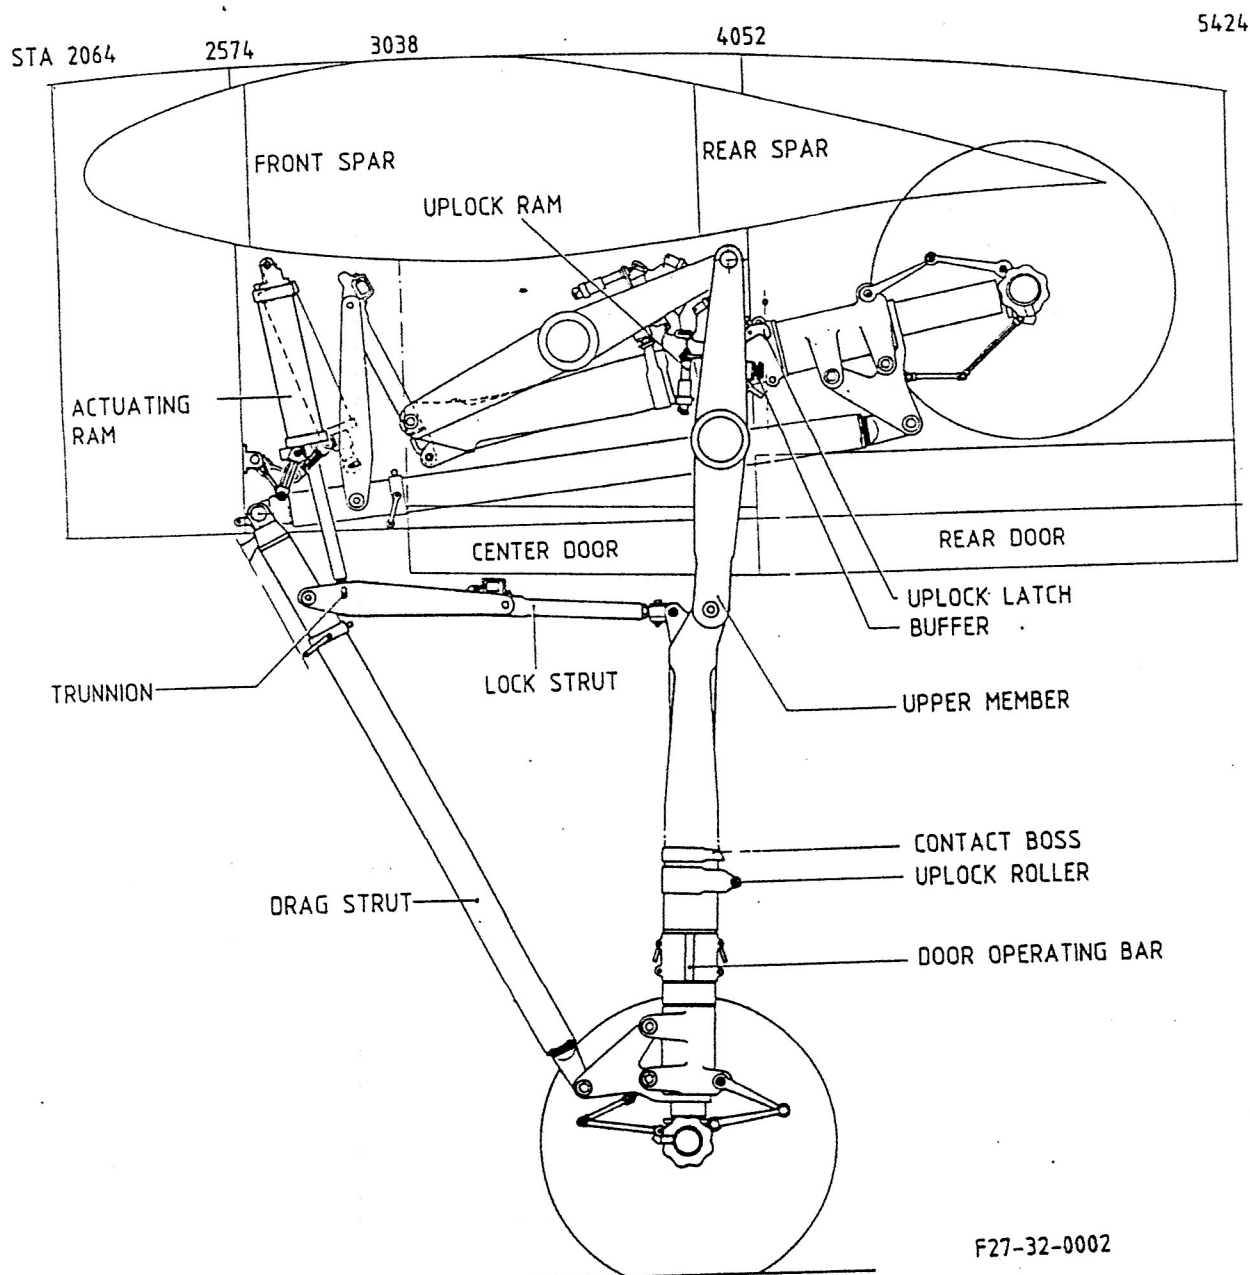
FIG. 3 MAIN LANDING GEAR - KINEMATICS (MK 200, 400, 600)

The nature of the failure indicates that the pin may have started to yield during the retraction checks of the landing gear in Billund, due to overload caused by the lack of lubrication of the pin and the up-lock roller. The resistance in the lock strut joint may have been increasing with each retraction of the gear, causing the pin to fail completely when the gear was pulled into the up-lock position after the last retraction prior to the accident after the take-off from Aberdeen.

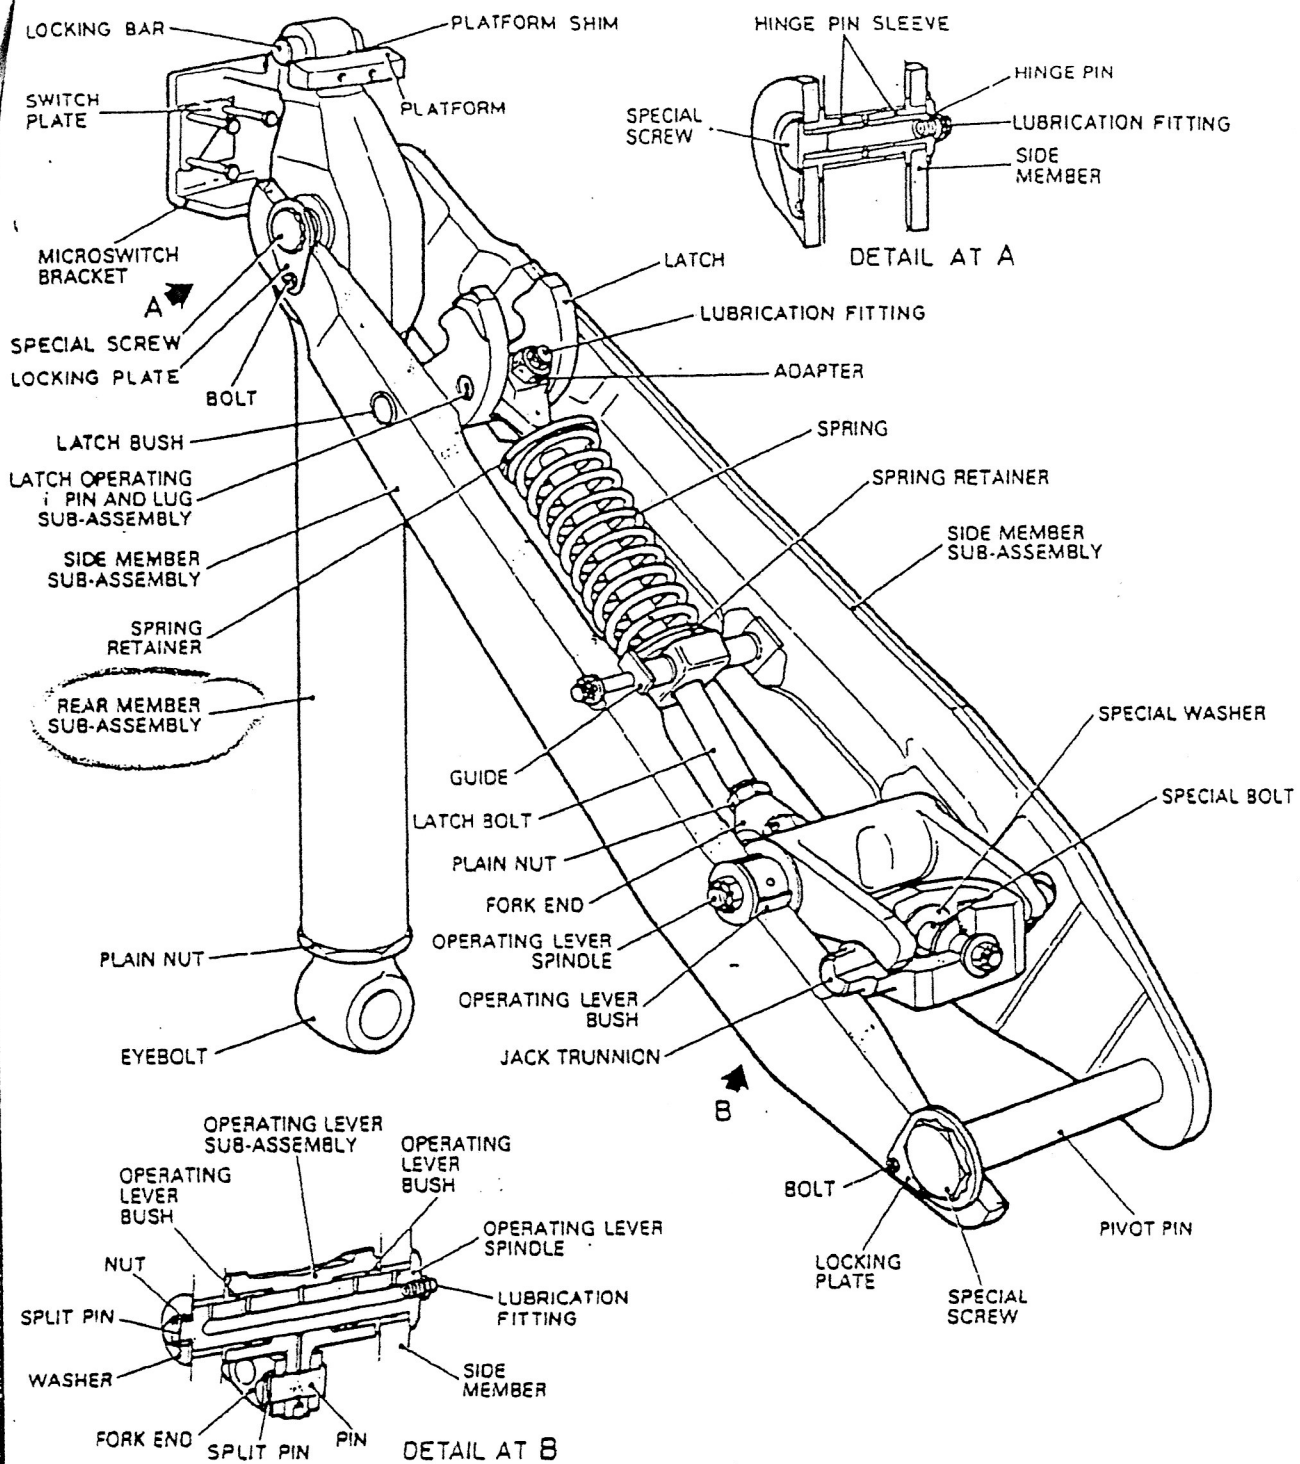
Lock Strut  
Figure 1

The examination of the broken and the bent hinge pin that connects the fore and rear members of the lock strut and the failed lugs on the fore member indicates, that the failures took place in overload as the gear was pulled up into the up-lock.

The failed lock strut, Mfg. Serial Number DRG36/65, was fitted, on 26. June 1986, in an overhauled condition with the time limit of 16,000 hrs to be removed at 48,885 hrs, airframe time. Thus the lock strut time in service since installation was over 12 years and 2,520 flight hours.

The in-flight observations provided by the pilots of the aircraft and the subsequent investigation of the failed landing gear lock strut assembly and the condition of the landing gear indicate, that the cause of the failure was overloading of the hinge pin that connects the fore and the rear members of the lock strut.

The aft lugs of the lock strut member, at this moment possibly cracked open but still holding the two ends of the failed hinge pin embedded in the lug holes by the pulling force that broke the pin, were now hit by the upper part of the shock strut and knocked off. The broken off bits of the lugs and the pin ends were found on the runway where the landing gear collapsed.
